Arboricultural Impact Assessment
Northern Sydney Asset Management Unit
Narrabeen North Public School

23 June 2020

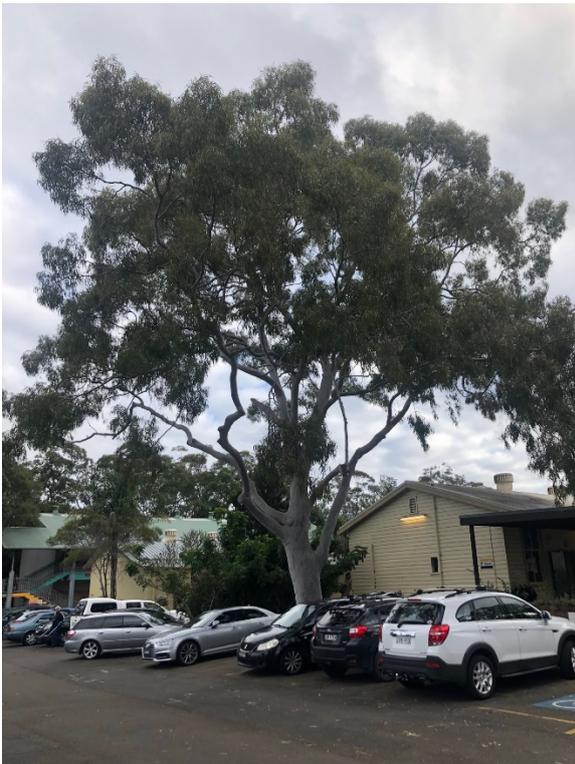
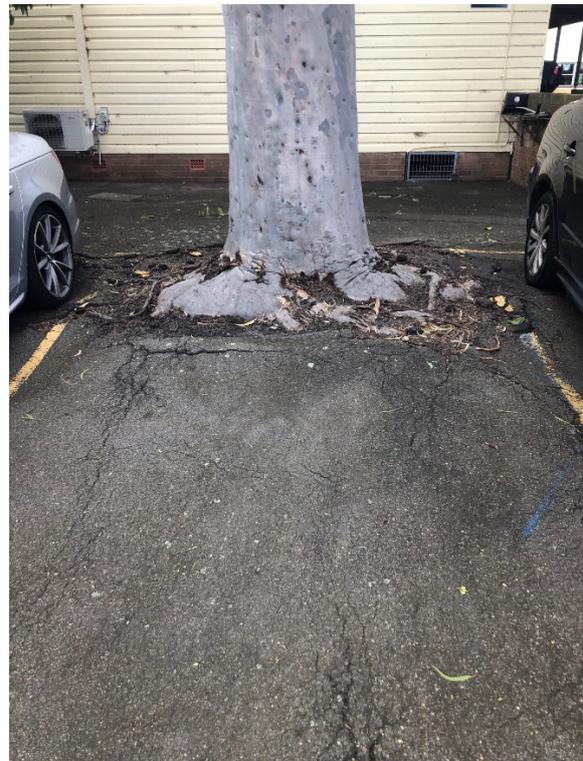
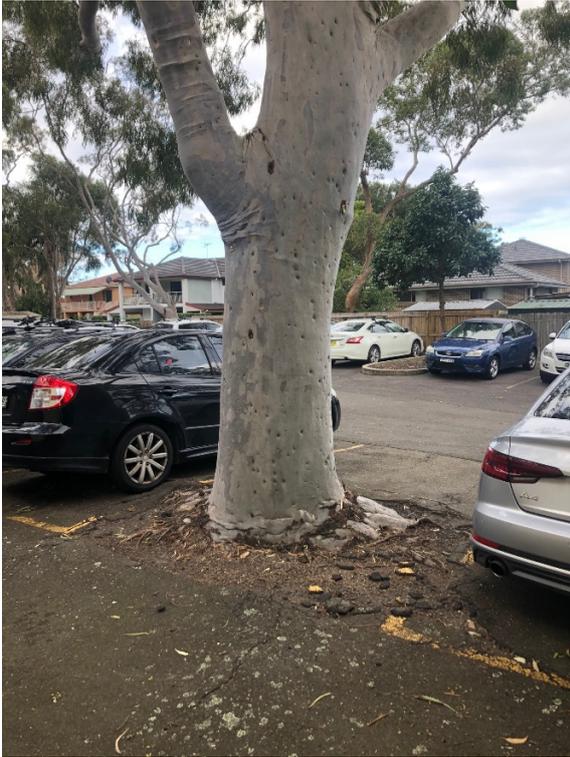
Figure 1. Tree 38 in its growing environment.
(Justin Herbert, 18 June 2020).

Figure 2. Tree 38. (Justin Herbert, 18 June 2020).

Figure 3. Tree 38. (Justin Herbert, 18 June 2020).

- 6.3.1 Trees 38 and 41 were recommended for retention and require specific protection measures during construction to ensure they remain viable following the completion of works. Tree 40 is deemed to be retainable due to its location inside the TPZ of Tree 41.

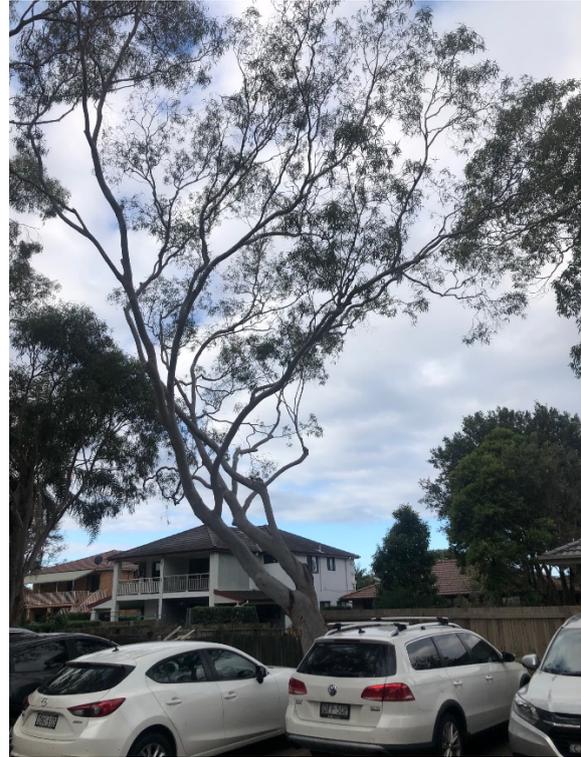
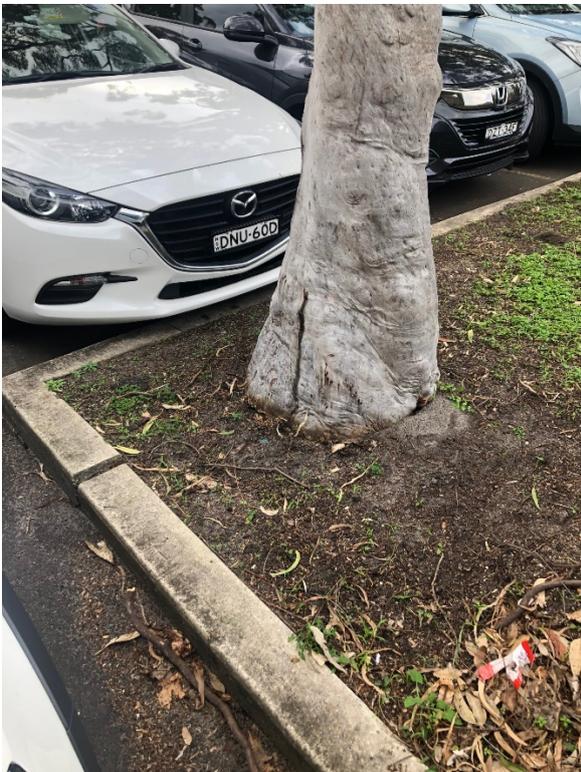
Figure 4. Tree 39 in its growing environment.
(Justin Herbert, 18 June 2020).

Figure 5. Tree 39. (Justin Herbert, 18 June 2020).

- 6.2.1 Pending the approved location of the demountable building between Trees 38 and 41, Category B Tree 39 may require removal should pad footings be located within its SRZ. Should this tree require removal a suitable species of similar crown potential must be replanted within the subject site.

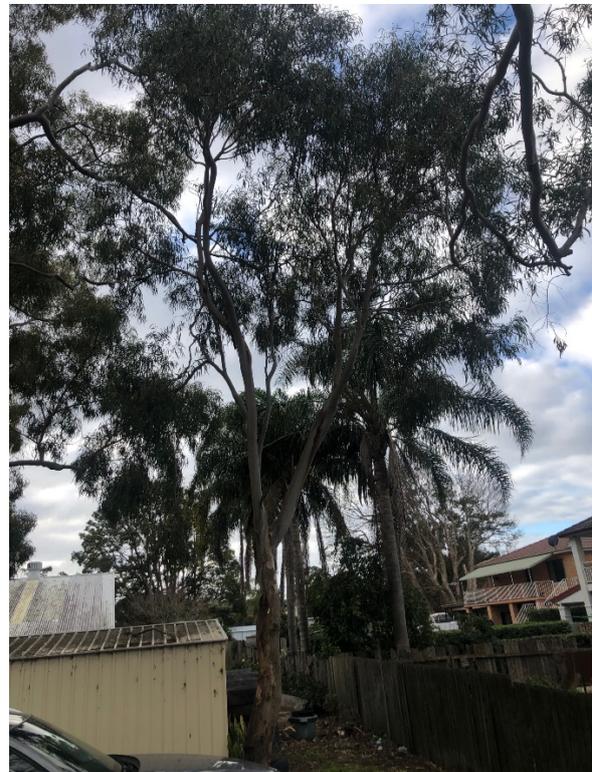
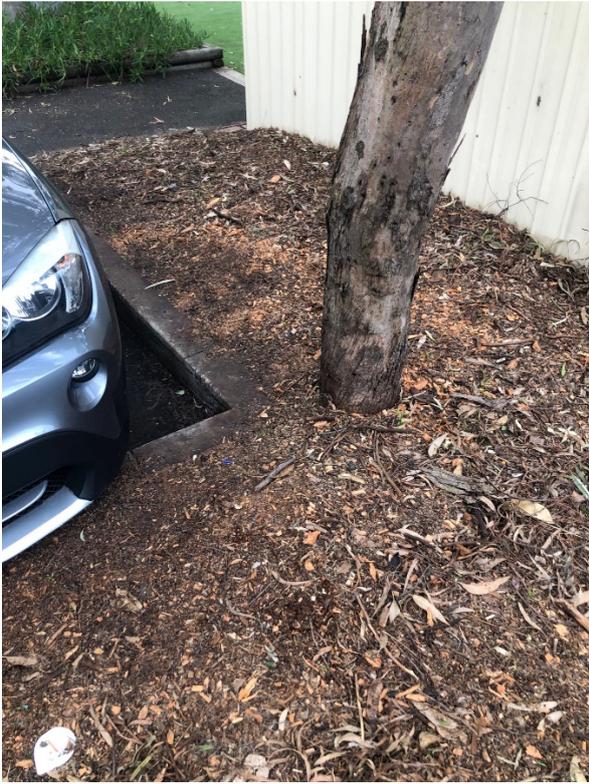
Figure 6. Tree 40 in its growing environment.
(Justin Herbert, 18 June 2020).

Figure 7. Tree 40. (Justin Herbert, 18 June 2020).

40	<i>Eucalyptus tereticornis</i>	Forest Red Gum	1	24	29	2.9	26.06	2.0	5-10	<5	Good	Fair	Semi-Mature	25-50	Co-dominant stems;Deadwood/stubs < 30mm;Soil compaction;Suppressed;Wound(s);	Amenity value/shade;		- 18-06-2020 : Justin Herbert : Tree assessed. - 27-08-2019 : Alex Austin : Tree assessed.	C	12	Retain tree with generic protection requirements (i.e. protective fencing and restriction of activities within the TPZ).
41	<i>Corymbia citriodora</i>	Lemon-scented Gum	1	104	94	12.5	489.30	3.2	10-15	15-20	Good	Fair	Mature	25-50	Co-dominant stems;Epicormic growth;Mechanical damage to root(s);Previous failure(s);Resin exudation/kino;Soil compaction;Soil grade changes;Wound(s);	Amenity value/shade;Attractive landscape feature;Significant due to age/size;Dominant landscape feature;		- 18-06-2020 : Justin Herbert : Tree assessed. - 18-06-2020 : Justin Herbert : Tree assessed. - 27-08-2019 : Alex Austin : Tree assessed.	A	12	Retain tree with specific protection requirements (i.e. Generic measures plus supervision of works within the TPZ and/or use of root sensitive construction techniques).

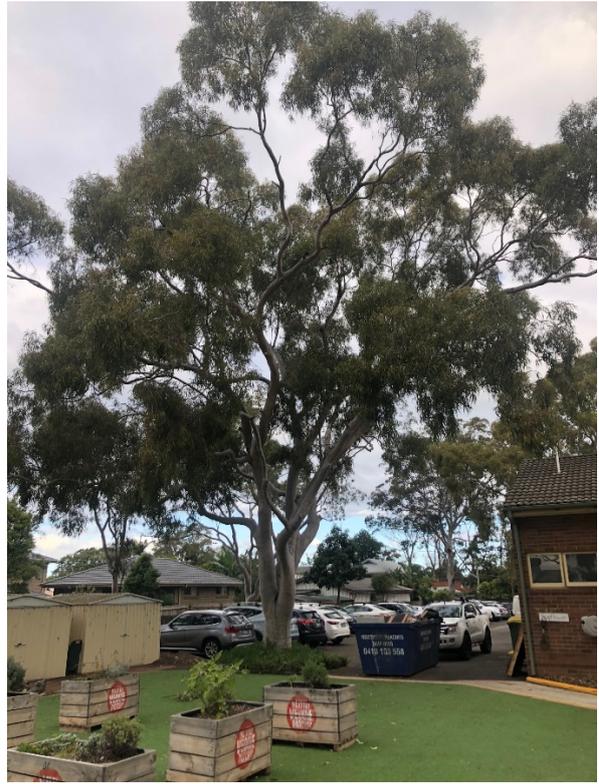
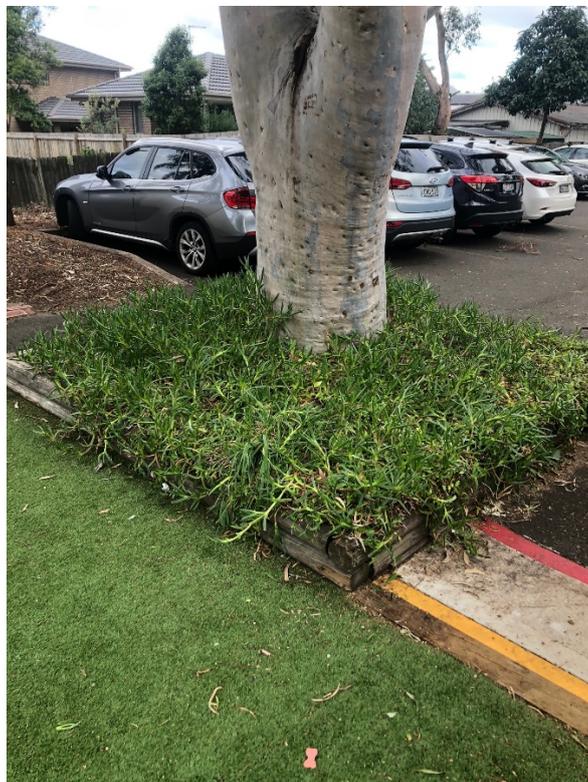
Figure 8. Tree 41 in its growing environment. (Justin Herbert, 18 June 2020).

Figure 9. Tree 41. (Justin Herbert, 18 June 2020).

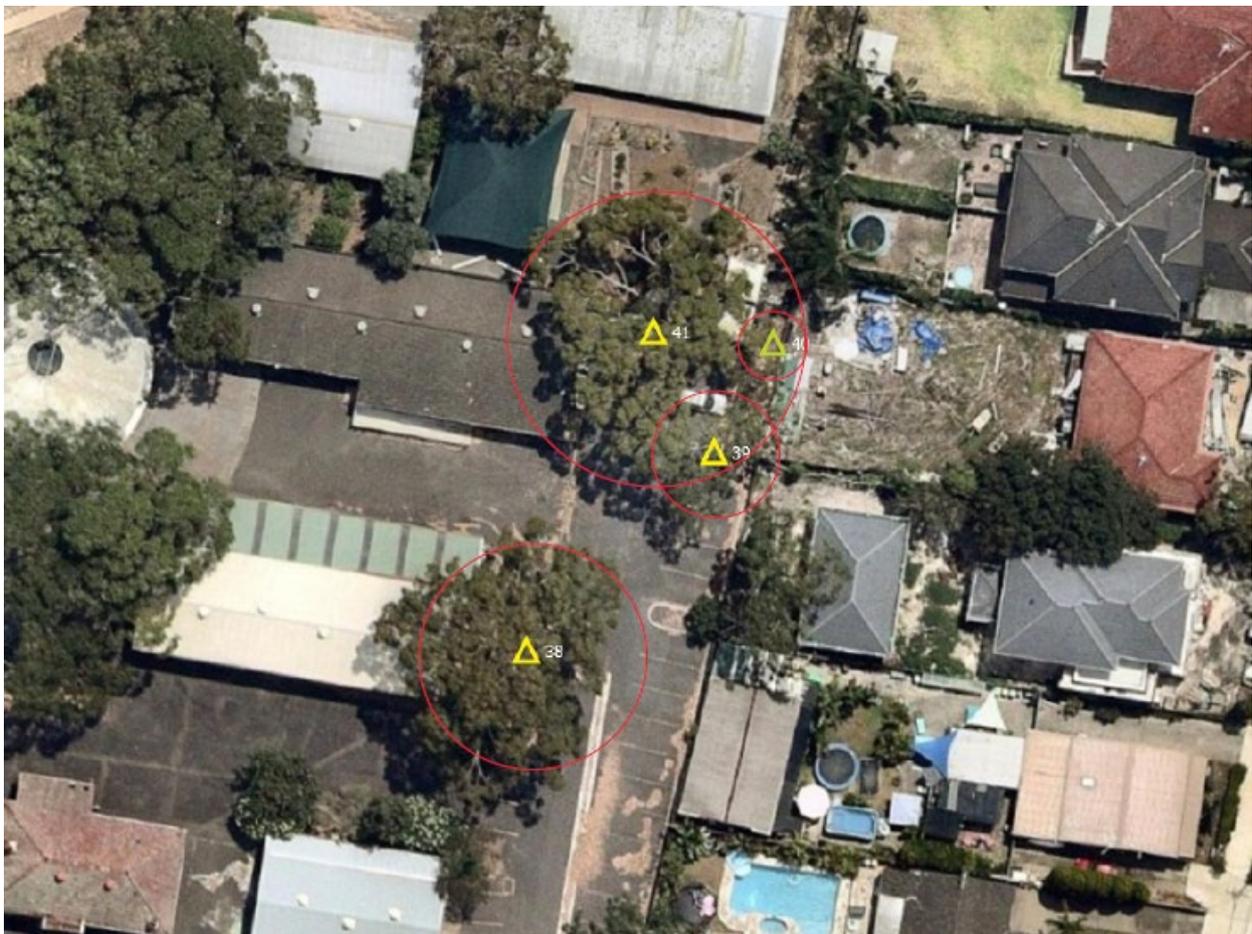
Figure 11. Estimated TPZs, Narrabeen North Public School. (ArborSafe, 18 June 2020).

- 5.3.1 The demountable building is currently proposed to be located in the north-east corner of the car park as per Section 4.5.1. This location would impact the TPZs and SRZs of Trees 39, 40 and 41 via the excavation required to install pad footings for the demountable building, therefore this location is **not** recommended. Recommendations regarding a location that promotes minimal potential for damage to retained trees is discussed in Section 6.

- 6.1.1 The below diagram shows the TPZs of subject trees within this report. The demountable building should be positioned between the two Category A trees, numbered 38 and 41, on the east side of the existing car park to minimise TPZ encroachment and to avoid SRZ encroachment. Distances for this calculation are provided within the Site Assessment Data section of this report. The demountable building and quantity, size and location of pad footings must be definitively located on the plan for review.

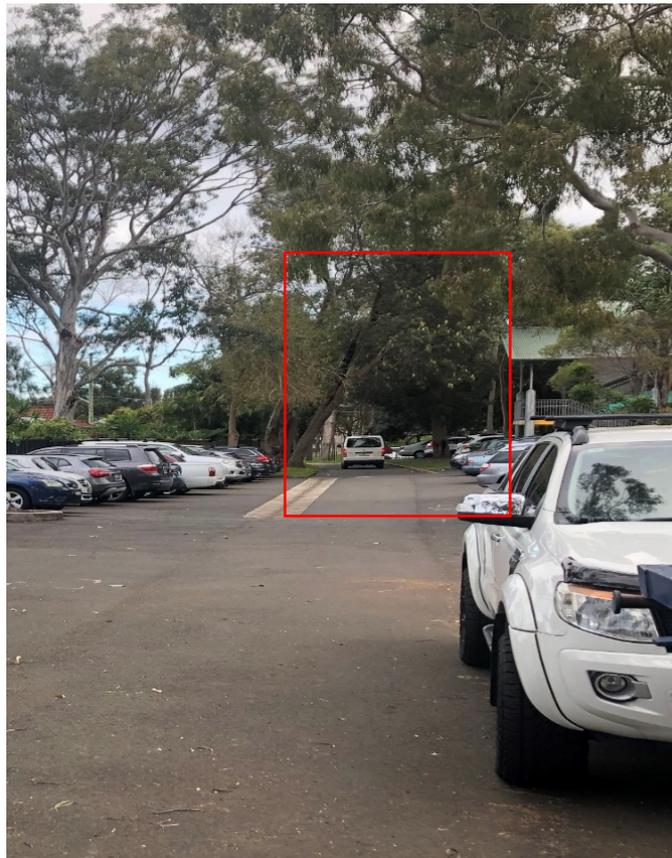
Figure 12. Recommended access point, Narrabeen North Public School. (Justin Herbert, 18 June 2020).

- 6.4.1 Information on site access and vehicle size has not been provided for review. However, it is anticipated that the access point will be the main driveway to the car park as shown in Figure 12.

- 6.4.2 Should pruning for access be required to the site, it must be undertaken in accordance with the Australian Standard AS 4373–2007: *Pruning of Amenity Trees* (Standards Australia, 2007) and undertaken by a suitably qualified arborist (minimum AQF 3 arborist). A pre-inspection in conjunction with the project arborist is likely to avoid unnecessary and poor pruning to retained trees.
