# Geotechnical Assessment

**Project:** New Dwelling  
3A Beach Road, Newport NSW

**Prepared for:**  
Byron & Sophie Rowe

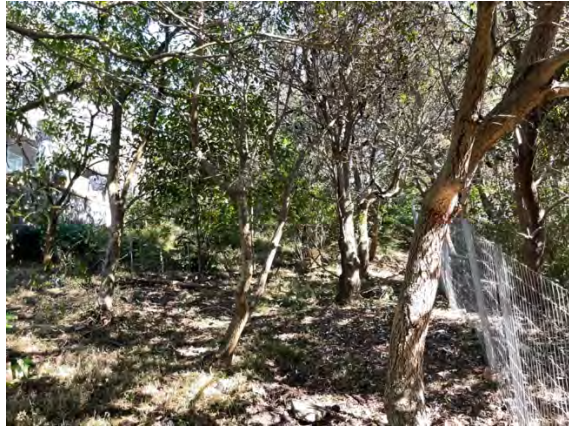
**Photo 1:** View upslope from the eastern end of the block.

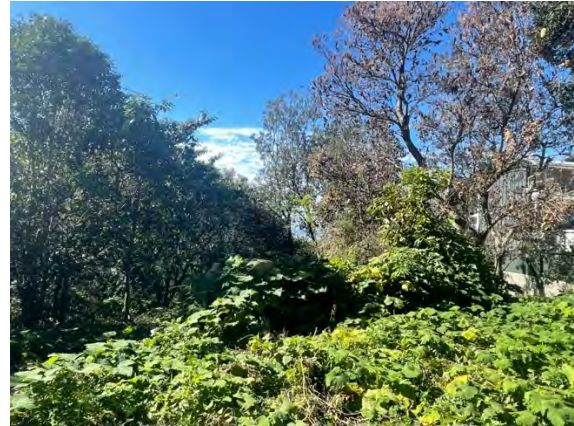
**Photo 2:** Downslope view from driveway
