**REPORT ON GEOTECHNICAL SITE INVESTIGATION**

**CONSTRUCTION OF NEW DEVELOPMENT**

**94-96 PARK STREET AND 4 KUNARI PLACE, MONA VALE, NSW**

**Project No.: 2025-047**

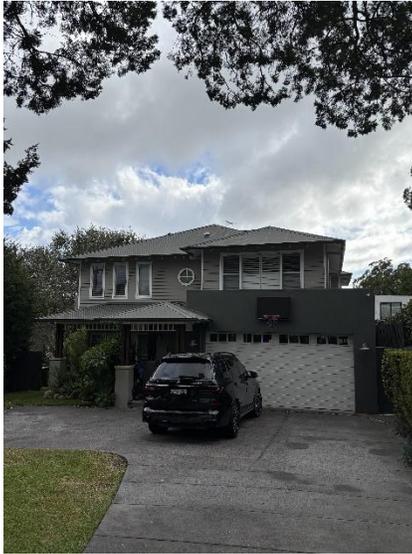
The two-storey rendered dwelling (No. 96 Park Street) is also of new construction and appears to be in good condition, with no signs of cracks or settlement issues observed. The front south end of the property contains a concrete driveway along with a grass lawn near the southwestern boundary. The central portion of the property is occupied by the main structure, which is situated at a slightly lower elevation compared to the adjoining property at No. 94 Park Street. The rear section of the property comprises a grassed lawn and an in-ground swimming pool, both of which appear to be in good condition with no visible signs of structural distress. This property is retained above the level of Kunari Place by a steep vegetated embankment and a timber retaining wall.

*Photograph 2: View of No. 96 Park Street front, facing northeast from Park Street.*

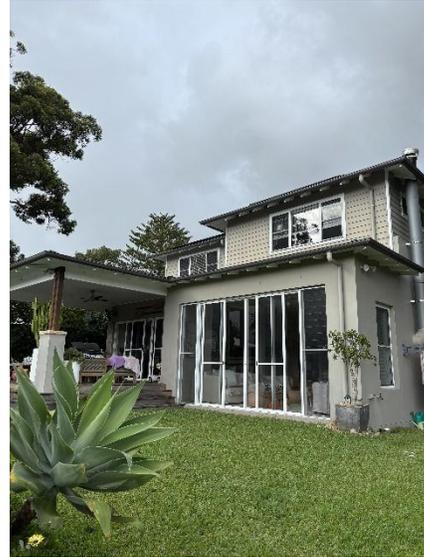
*Photograph 3: View of No. 96 Park Street rear, facing southeast from Park Street*

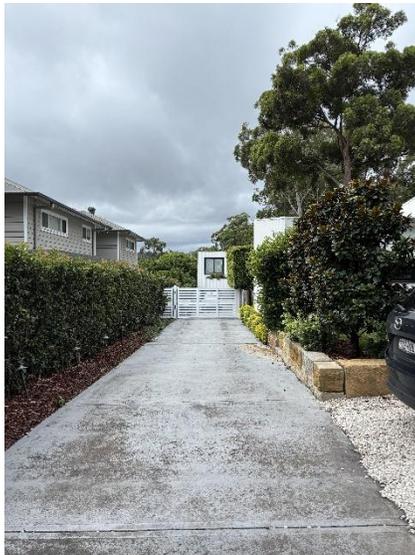
The one storey rendered dwelling (No. 94 Park Street) is estimated to be fairly new. The structure appears to be in good condition, with no signs of notable cracking or differential settlement. The front portion of the site comprises a concrete driveway and a combination of gravel and grassed surfaces towards the southeast. The remainder of the lot is predominantly occupied by the dwelling and a detached garage. A swimming pool and landscaped lawn area are located at the rear of the property.

*Photograph 4: View of No. 94 Park Street front, facing northeast from Park Street*

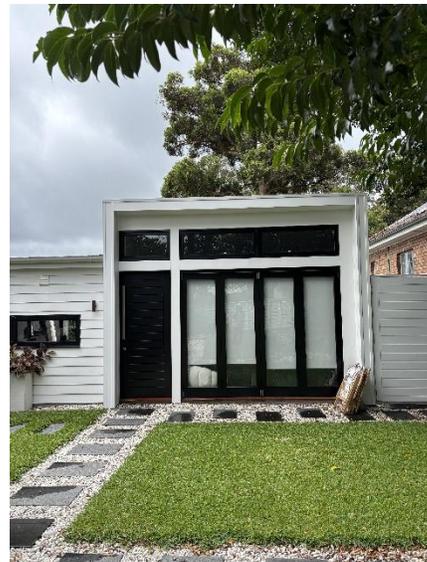
*Photograph 5: View of No. 94a Park Street, facing broadly northeast*

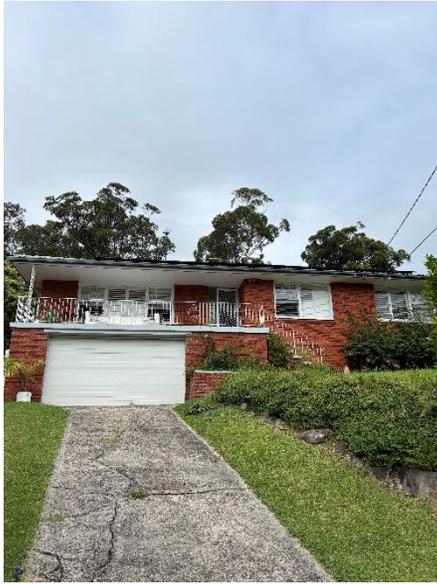
No. 4 Kunari Place contains a one and two storey brick house is estimated to be approximately 80 years old that appears to be in good condition, with no signs of significant cracks or settlement issues observed. The front portion of the property features a concrete driveway exhibiting minor cracking, though no significant cracking was observed. Grass lawns are present on both sides of the driveway. The central part of the property is occupied by the structure, which is generally at a similar elevation to the adjoining properties, with a grassed area extending along the northern boundary. The rear of the site also comprises a gently sloping grass lawn.

*Photograph 6: View of No. 4 Kunari Place front, facing southeast from Kunari Place*

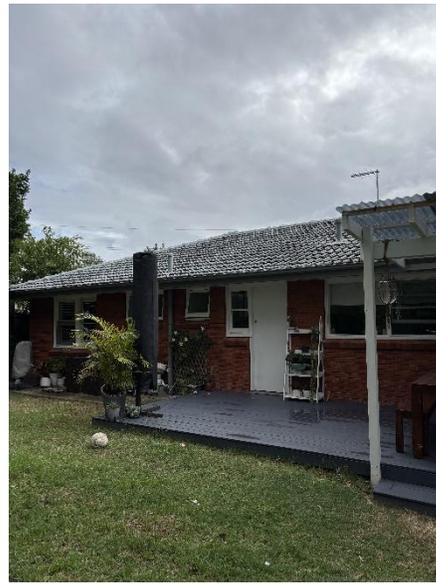
*Photograph 7: View of No. 4 Kunari Place rear, facing northwest from Kunari Place*
