DILAPIDATION REPORT

Re: Brief Report - Dilapidation Report for Gable Carport at 33 Herbert Street, Manly NSW 2095.

Inspection Date: 1/4/09

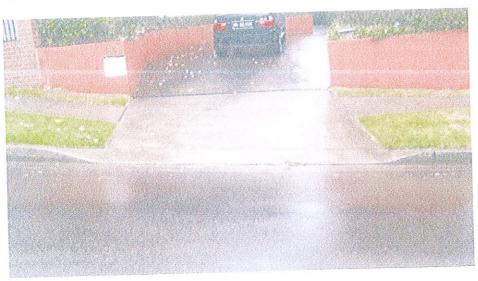
The above Photographs indicate that the existing concrete kerb, gutter, crossing, footpath and bituminous surface have a few small defects due to aging and wear. There is evidence of mostly finite size cracks within a number of these assets and scrapes from tow bars on the crossing surface, as can be seen in the photos taken directly in front of the property of concern.
