Warringah Council Civic Centre Car Park, 36-48 Kingsway, Dee Why

Arborist Report

Prepared for
Warringah Council
12 February 2014

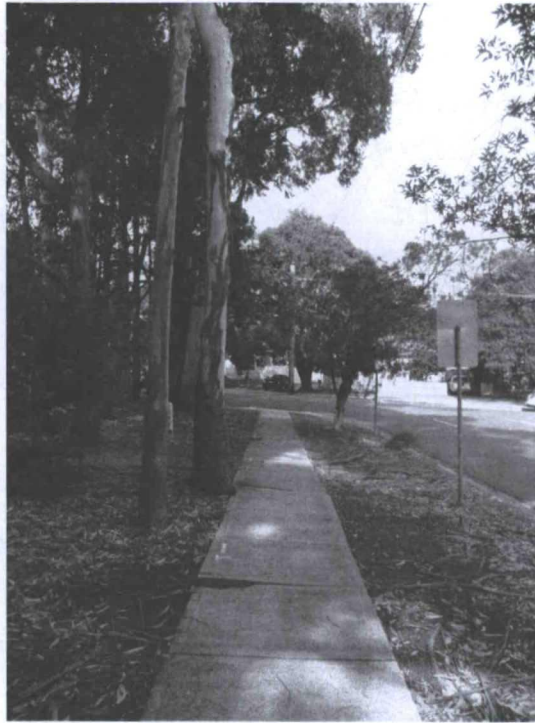
The traditional calculation of SRZ is rendered difficult because most trees growing on shallow sandstone soils have broad root plates which extend across rock surfaces or down into rock fissures. The exposed roots along the Kingsway footpath illustrate this tendency.

Photo 1 – Roots extending from car park across footpath and beneath the road.

Another long-term difficulty associated with retention of these tall-growing trees relates to the extensive root systems which are already extending northwards, beneath the footpath and under the road (see Photo 1). If any of the trees are to be retained, an asphalt footpath with heavily mulched garden beds would be a safer solution, in order to reduce the potential for trip hazards. It should, however be noted that the roots will continue to grow towards and beneath the road, especially after excavation and construction during which the southern portion of the trees' SRZ will have been greatly reduced. As the trees grow, the road surface may be eventually affected.

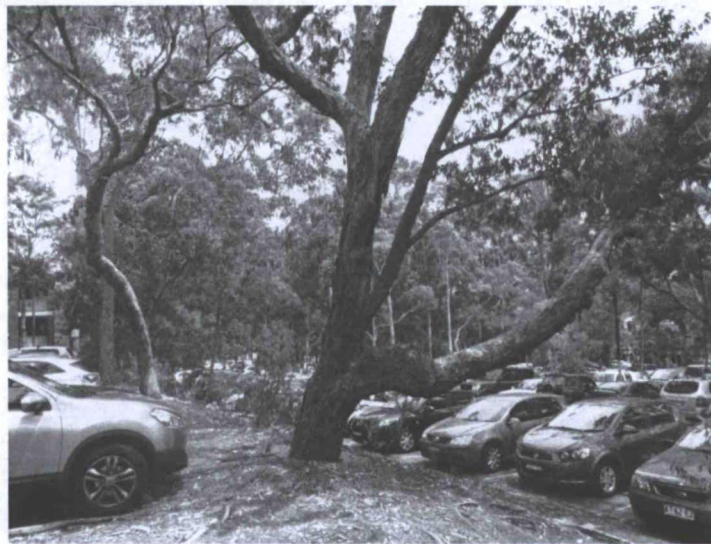
Two specimens of the threatened species *Eucalyptus nicholii* (New England Black Peppermint) (Trees 20 and 30) occur near the proposed building envelope adjacent to Zone 72. These two trees are well outside their known range and they are listed as vulnerable under the *Threatened Species Conservation Act 1995*. The intent of the Act is that these do not require assessments of significance because they are both planted and well outside their range. Both specimens of New England Black Peppermint have poor form and should be removed and replaced with more appropriate species.

Photo 2 – Two specimens of *Eucalyptus nicholii*

Trees 30 and 20, the two New England Black Peppermints should also be removed. The form and growth habit is typical of this species when planted in Sydney. In its natural habitat, with very cold winters and a lower annual rainfall, the growth rates are much slower, with the result that the tree form tends to be more symmetrical and structurally sound, in comparison with planted specimens in Sydney (especially on Hawkesbury Sandstone-derived soil groups). Despite its protected status, the species is listed in many Sydney Basin LGAs as an exempt species, implying that a specimen can be removed without obtaining Council permission.

The exposed roots of Tree 30 are not such a concern as they have obviously been exposed for at least ten years. It is, however, apparent that the root plate is shallow, and that these exposed roots are providing counter-balancing support. There would be potential for failure of the root plate if the surrounding surfaces (especially the sealed areas and garden edging) are disturbed.

Tree 20 has an etiolated, distorted growth habit, possibly because it was growing close to trees which have since been removed. The tree is now isolated and probably has stability problems which would be exacerbated by the proposed development.

Trees 20 and 30, therefore should be removed. Tree 28, a healthy *Eucalyptus botryoides* (Bangalay) with good form could be retained in preference to the two Peppermints.

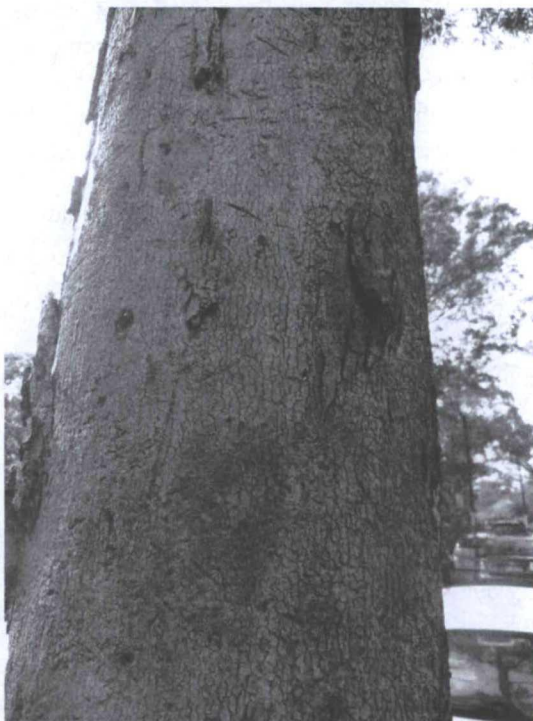
Evidence of use by native fauna include scratches and chew marks on several specimens of *Eucalyptus punctata*. Some trees which are growing close to paved surfaces have created trip hazards.

Photo 5 – Scratches on *Eucalyptus punctata*.

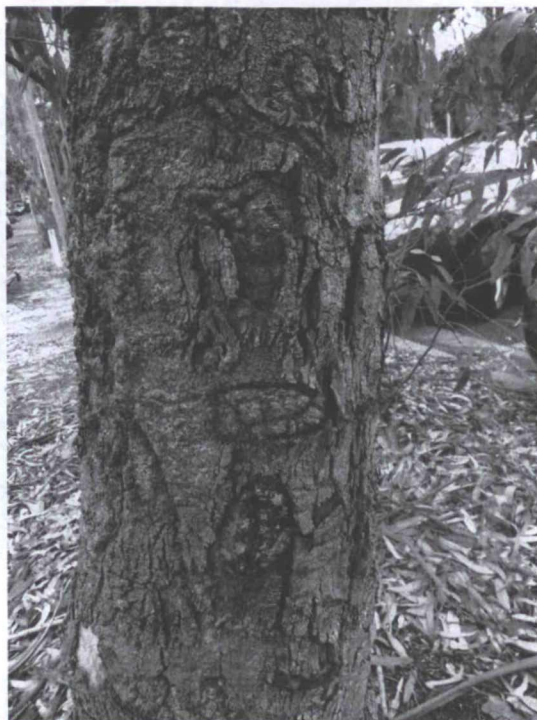
Photo 6 – Chew marks on *Eucalyptus punctata*.

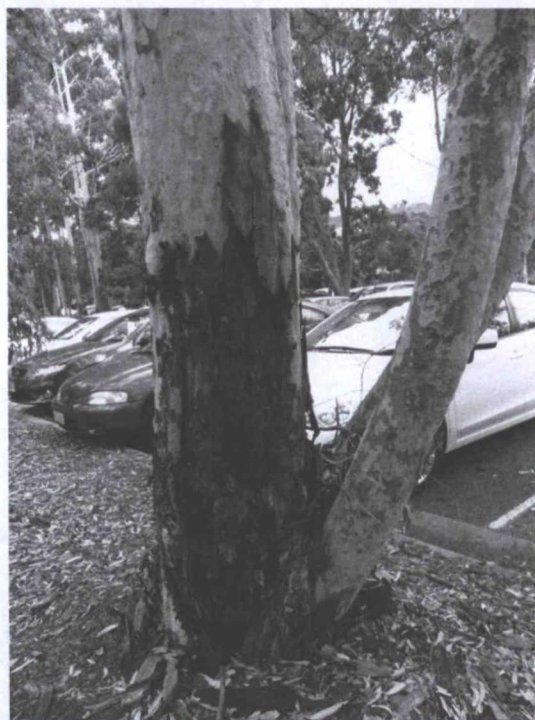
A few older trees display evidence of damage by longicorn beetles.

Photo 7 – Longicorn damage at base of *Angophora costata*.

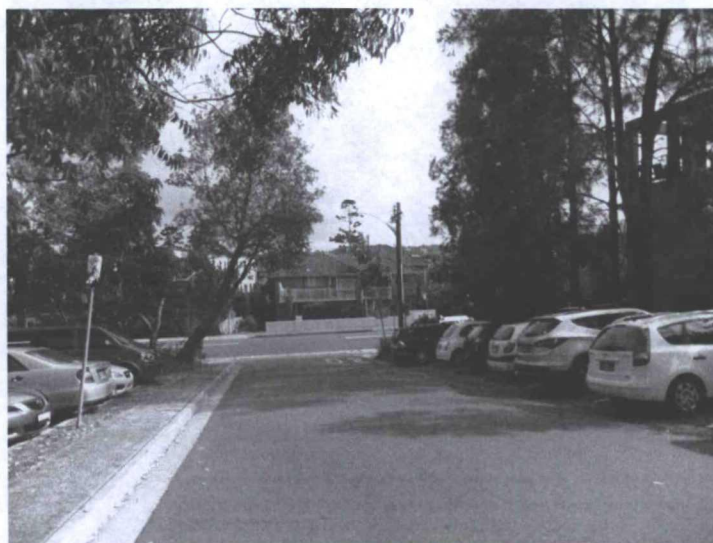
Photo 8 – *Banksia integrifolia* subsp. *integrifolia* leaning away from tree group.

Trees 212, 215 and 217 are *Banksia integrifolia* subsp. *integrifolia* (Coast Banksia). Although this species is indigenous to Warringah LGA, it is apparent that the form of these specimens is inappropriate for their location, in the context of the proposed development. The three individuals have asymmetrical growth which is typical of the species, especially on sandy coastal sites. The specimens on site have co-dominant leaders and biased growth forms which have probably been exacerbated by the crowding from other specimens as well as by accelerated draughts associated with the location at the north-eastern end of the site. It is apparent that Trees 215 and 217 would, if retained, continue to grow and further overhang sections of footpath and road. The trees should either be removed, or heavily pruned, in order to remove overhanging sections of the leaders and laterals. This species has the capability of resprouting after fire and wind damage, therefore pruning would approximate such a loss. It should be noted that such pruning would not comply with Australian Standards (AS 4373 – 2007).
