**Proposed Retaining Wall to Driveway  
114 Whale Beach Road, Whale Beach NSW**

Geotechnical Assessment

Our ref: 6386-G1  
1 April 2021

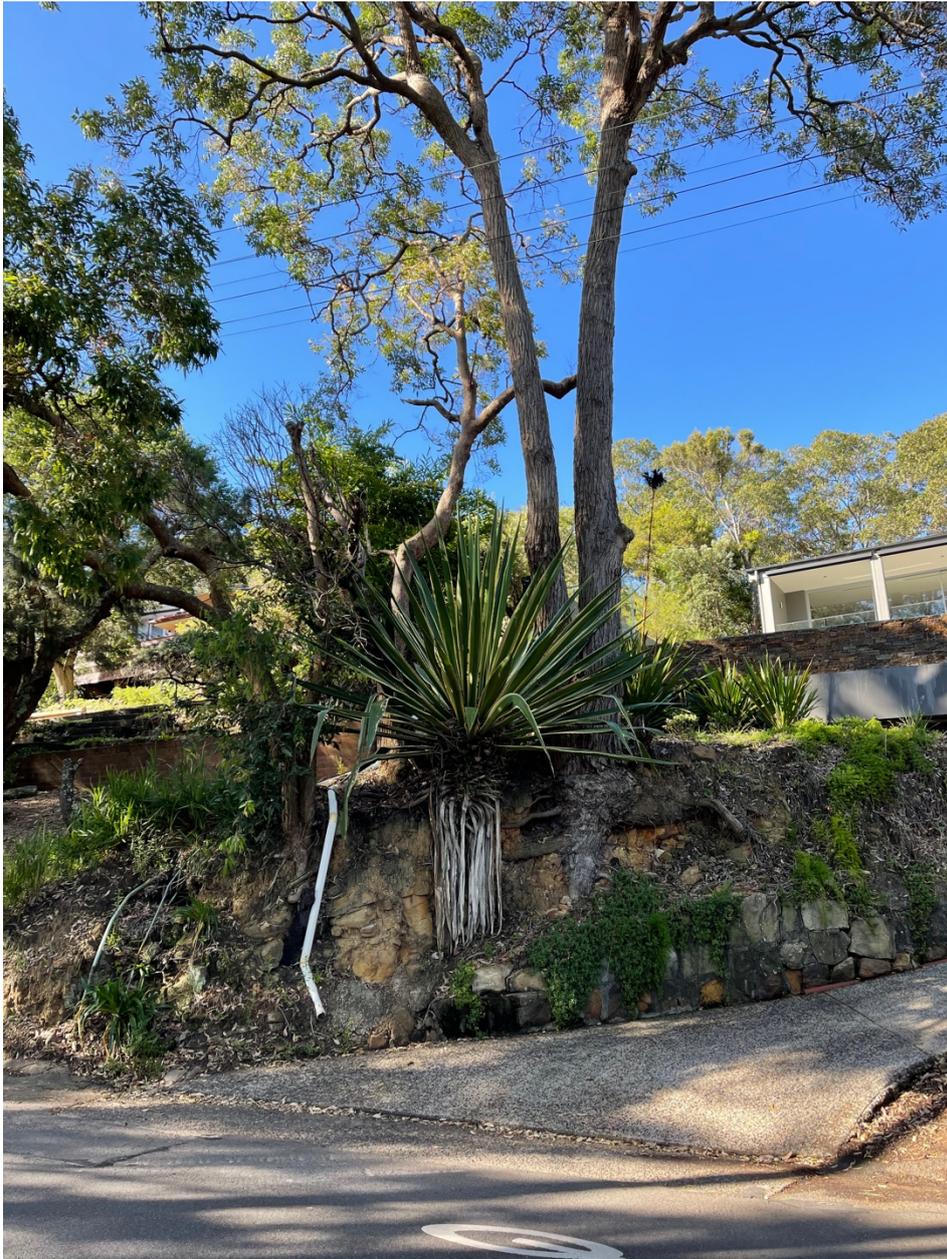
**Photo 1**

View looking south showing driveway entrance in front of site, and subject tree at top of driveway cut

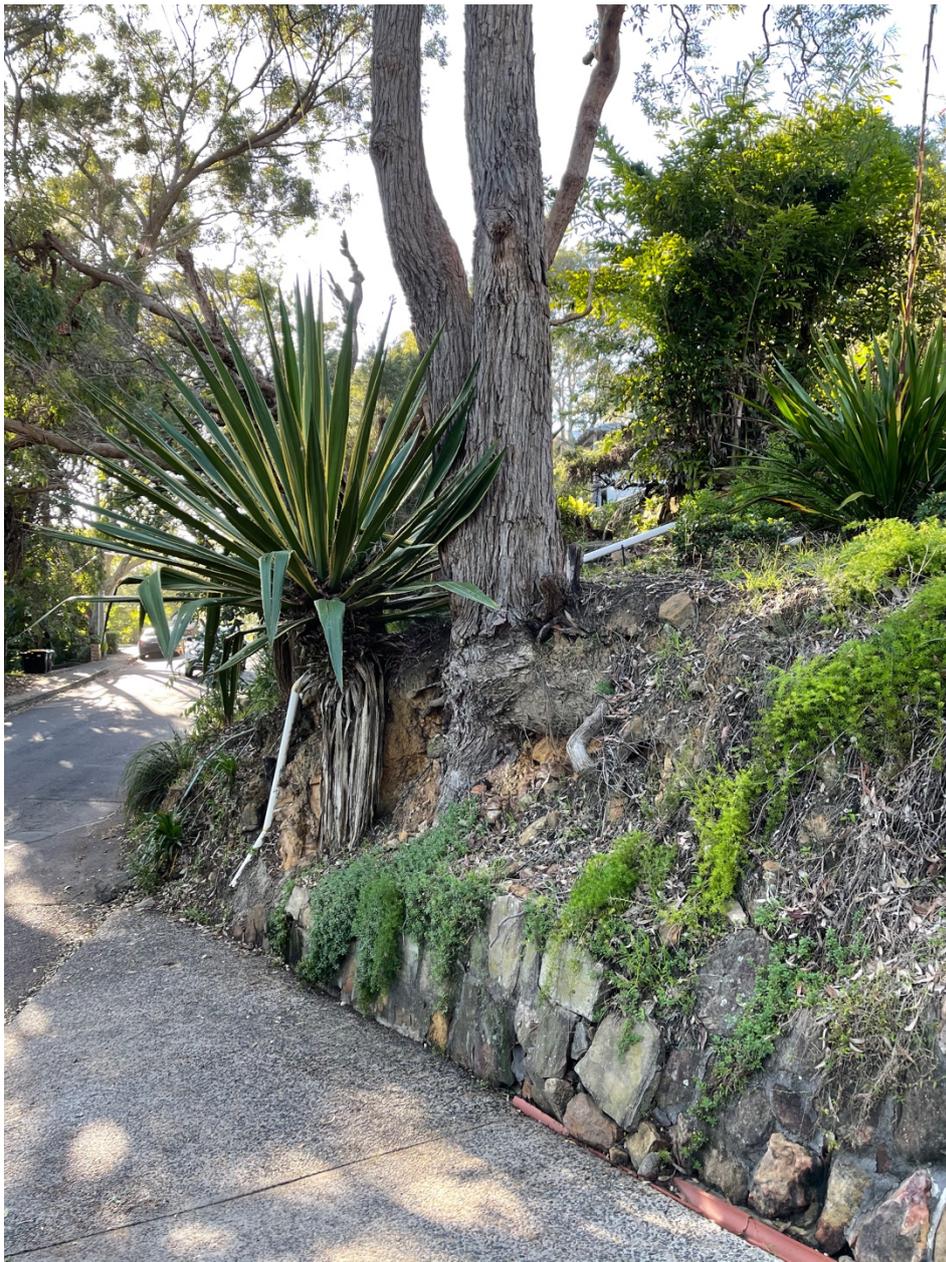
**Photo 2**  
View looking east  
down driveway  
showing tree at top of  
driveway cut

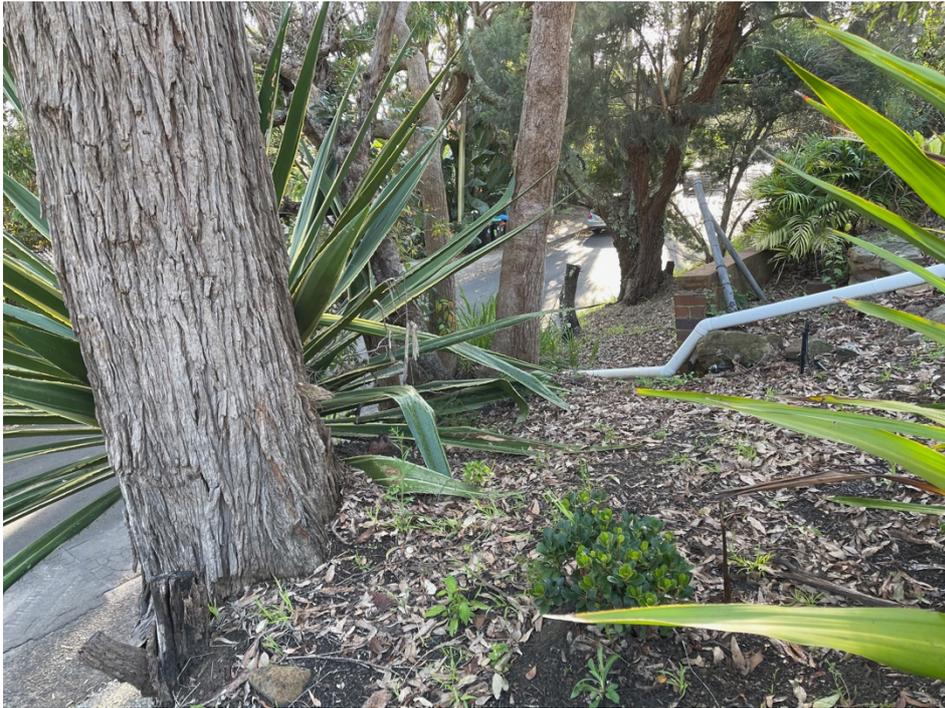
**Photo 3**

View of base of tree taken from top of bank upslope of driveway. Note lean of trunk measured at about 6°

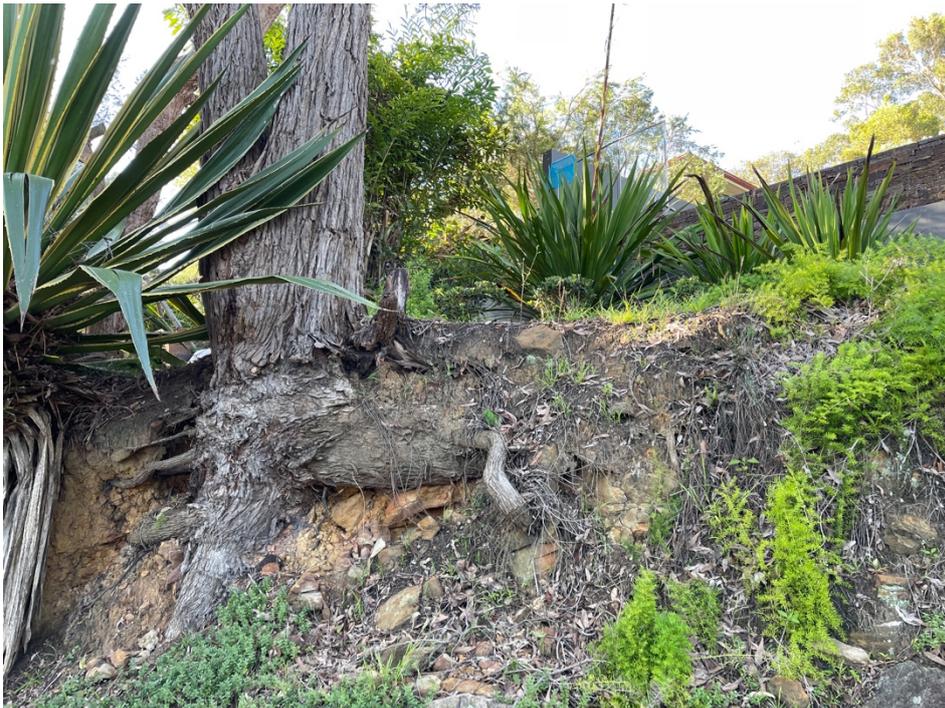
**Photo 4**

The tree roots supporting the subject tree are partly exposed as previously noted, including a significant vertical root down the face of the cut and a series of horizontal roots.

View of driveway cut showing base of tree trunk and exposed roots

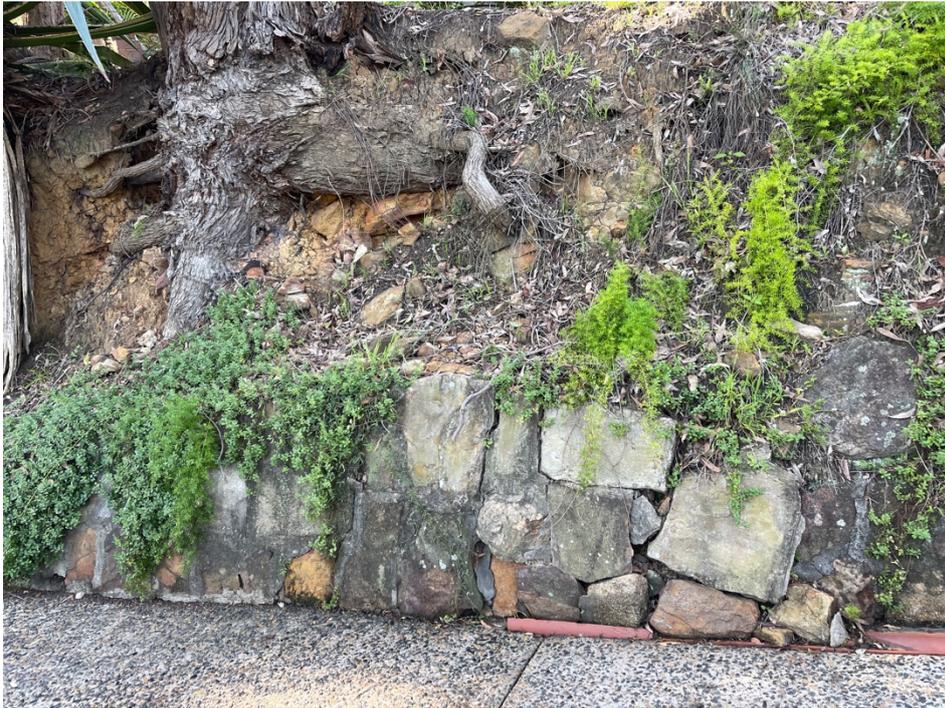
**Photo 5**

View of driveway cut showing base of tree trunk and exposed roots, with sandstone flagging over toe of cut

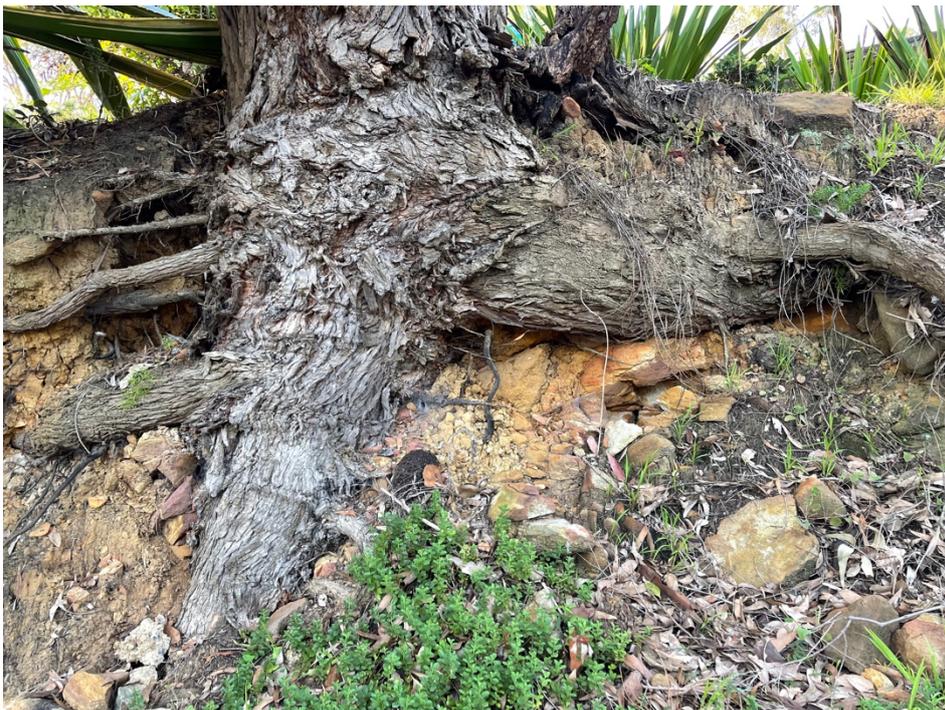
**Photo 6**

Closeup view of base of tree and exposed roots taken from front. Note erosion of soil and rock from base of tree and beneath exposed roots.

We therefore recommend prompt removal of the tree by a licensed and experienced tree removal contractor in accordance with Council and SafeWork NSW requirements.

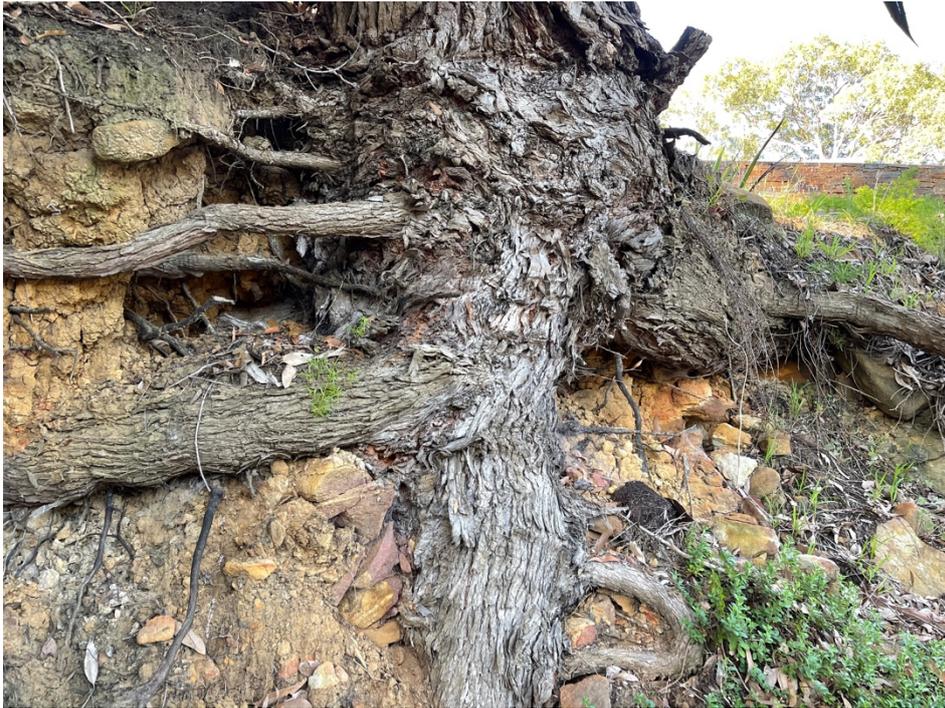
**Photo 7**

Closeup view of base of tree and exposed roots taken from eastern side. Note erosion of soil and rock from base of tree and beneath exposed roots. Erosion measured to extend approx. 400mm beneath outer base of tree trunk.

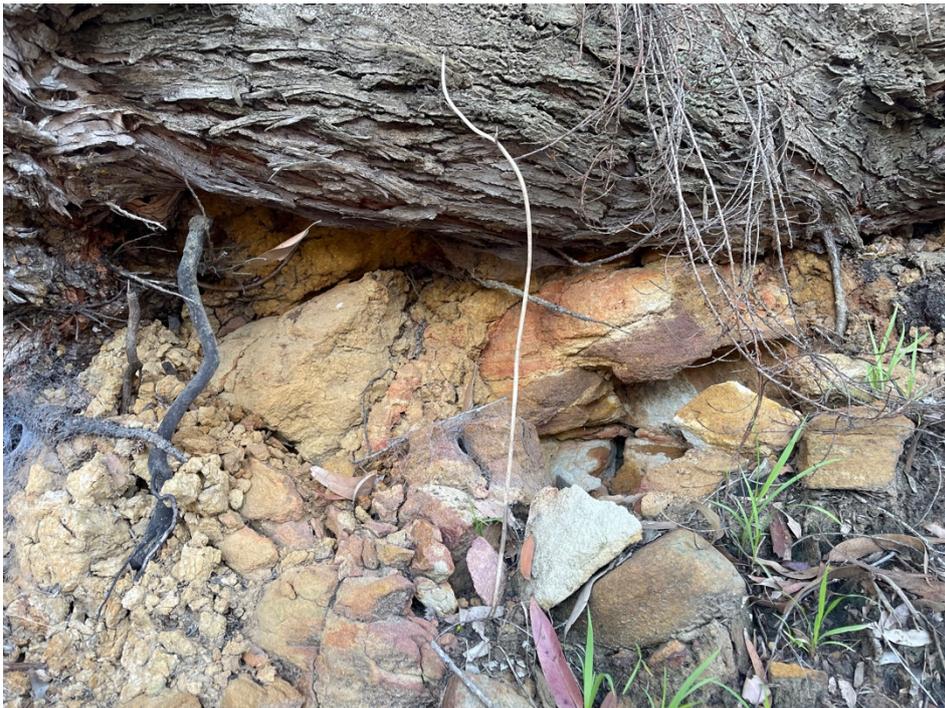
**Photo 8**

Closeup view of eroded soils and rock beneath horizontal root extending west.

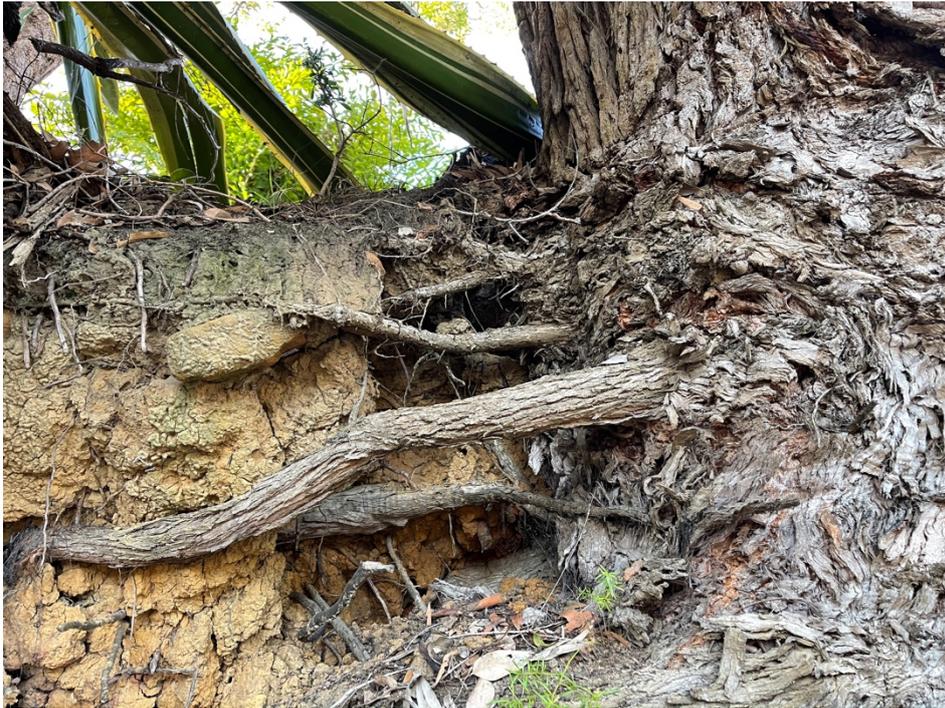
**Photo 9**

Closeup view of eroded soils from eastern side of tree. Note desiccation cracking in clayey soils.

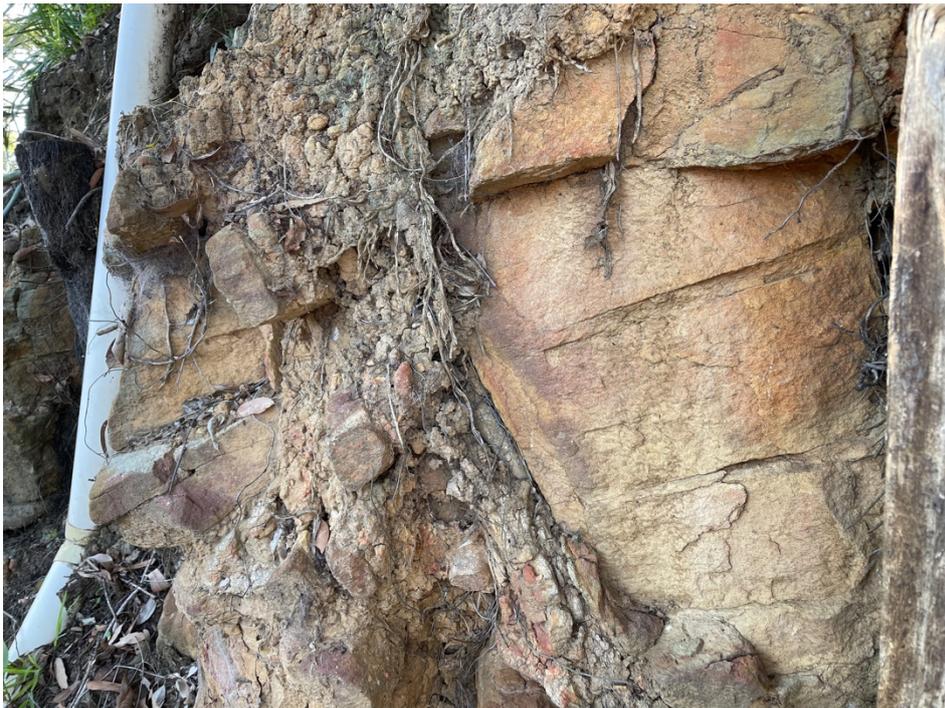
**Photo 10**

View of exposed sandstone in cut to east of tree. Note bedding dipping to the east, and presence of sub-vertical inclined joint infilled with soil and tree root.

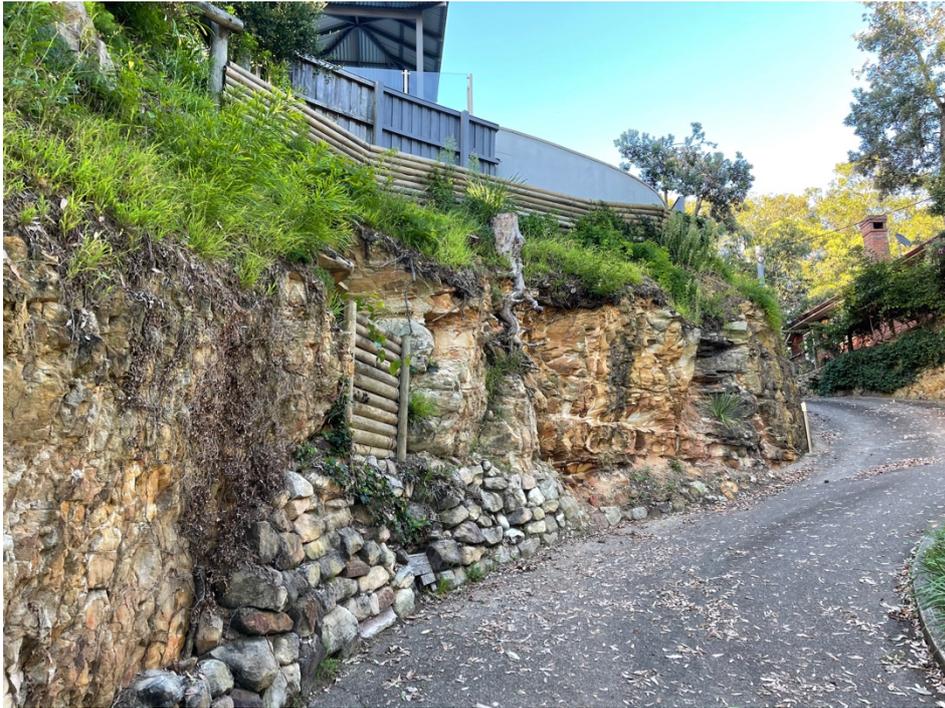
For comparison, a driveway cut in sandstone bedrock was observed to the east of the Site adjacent to the driveway up to Nº 110 and 112 Whale Beach Road (see Photos 11 and 12). The remnant trunk of a tree was observed at the top of this cut, with an exposed vertical tree root down the face of the cut, in a very similar arrangement to the tree in question.

**Photo 11**  
View of driveway cut for № 110 & 112 Whale Beach Road to the east, showing remnant tree at top of slope.

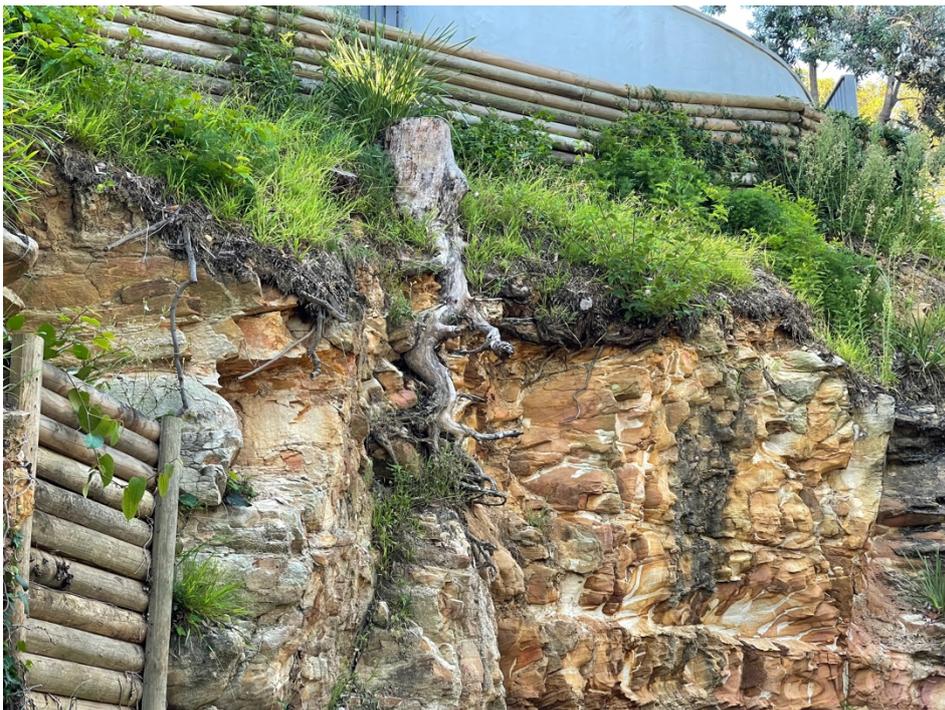
**Photo 12**  
Closeup view of remnant tree in Photo 11. Note vertical exposed remnant roots.
