**GEOTECHNICAL INVESTIGATION REPORT**

PROPOSED NEW DWELLING  
38 HILLTOP CRESCENT, FAIRLIGHT NSW

PREPARED FOR BALGOWLAH BUILDING PTY LTD  
REPORT ID: G23045FAI-R01F REV 2

**Date:** 5<sup>th</sup> August 2025

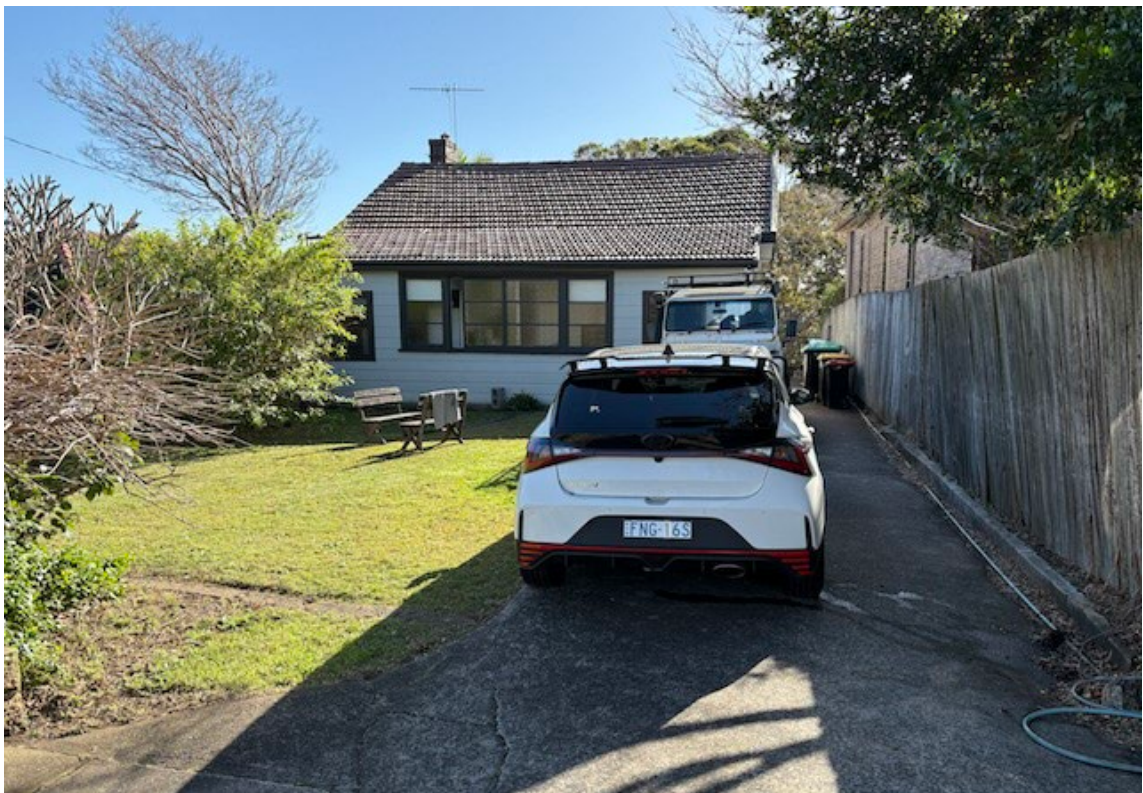
**Plate 1:** Front of site viewed to the north.

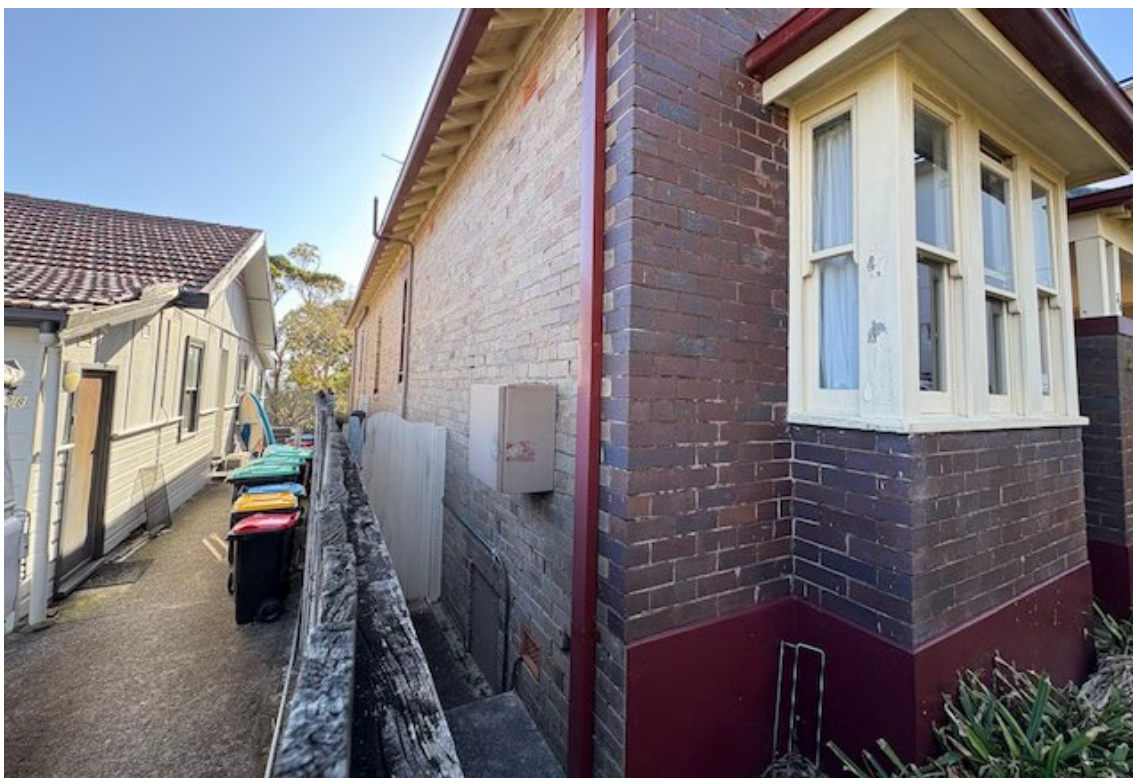
**Plate 2:** Eastern site boundary viewed to north.

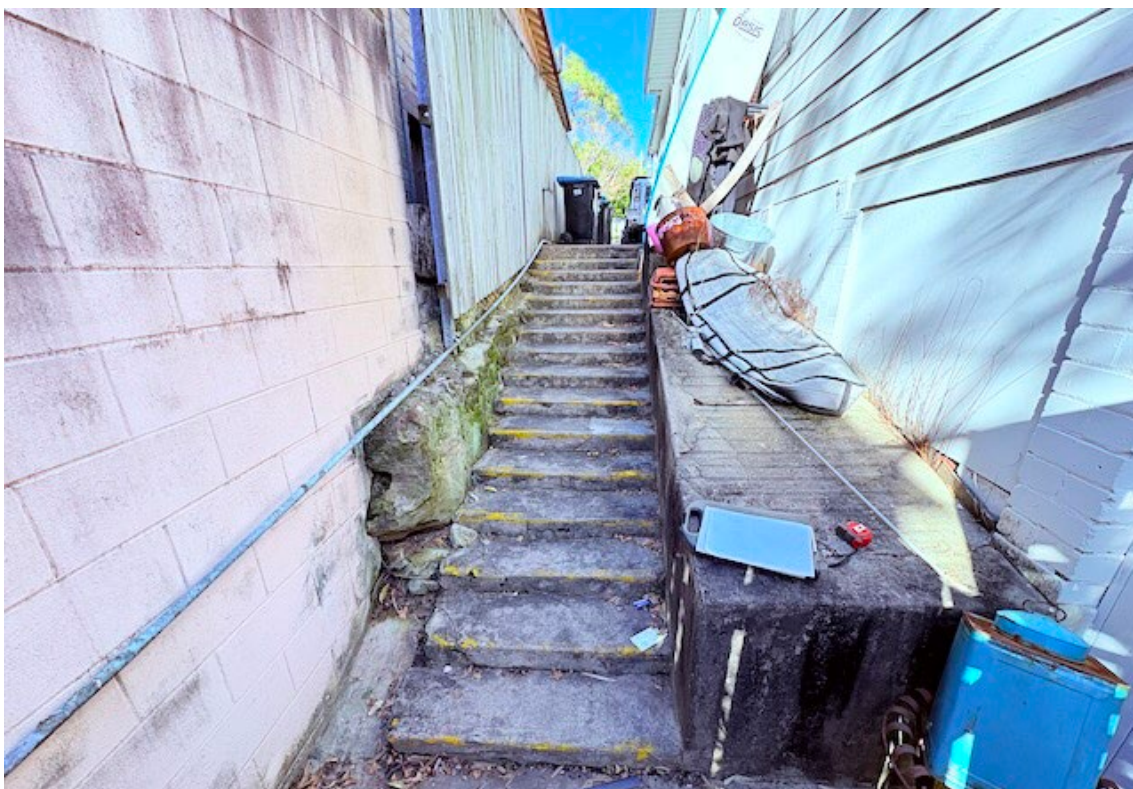
**Plate 3:** Sandstone outcrop along eastern site boundary.

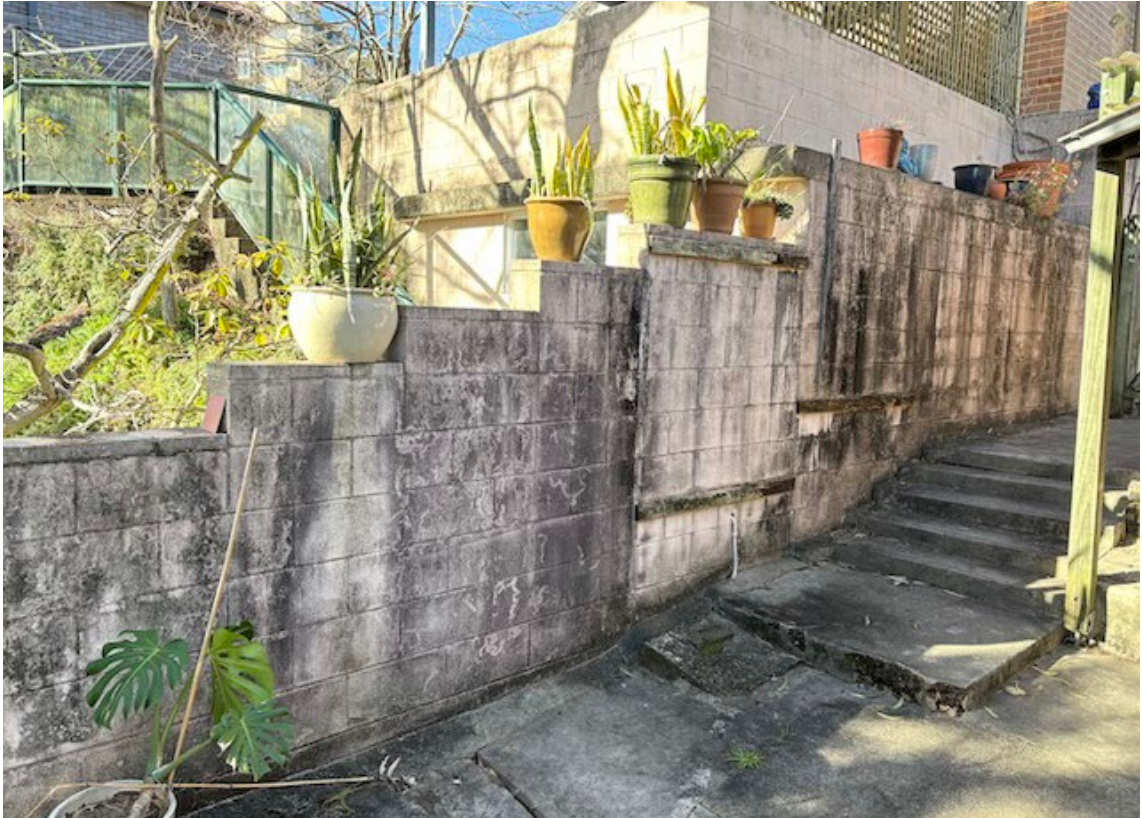
**Plate 4:** Eastern site boundary with concrete block wall boundary fence.

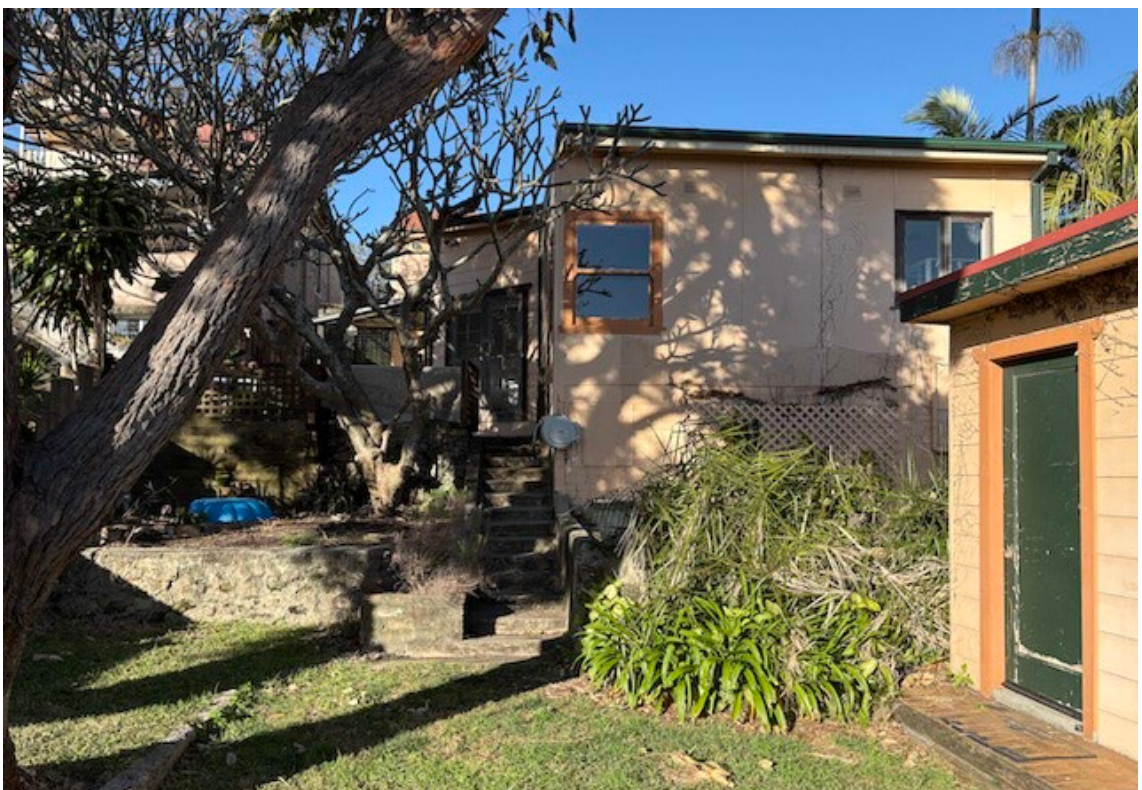
**Plate 5:** Rear yard viewed to the south.

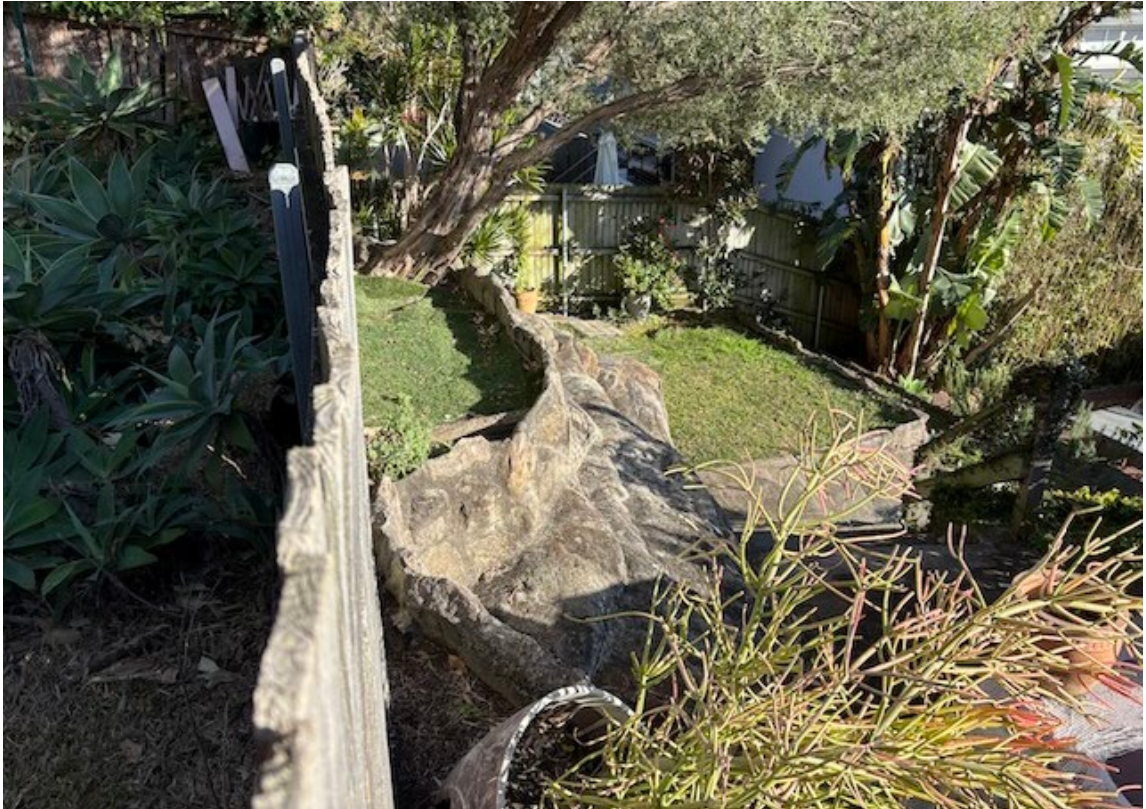
**Plate 6:** Sandstone outcrop downslope of rear, northern site boundary.

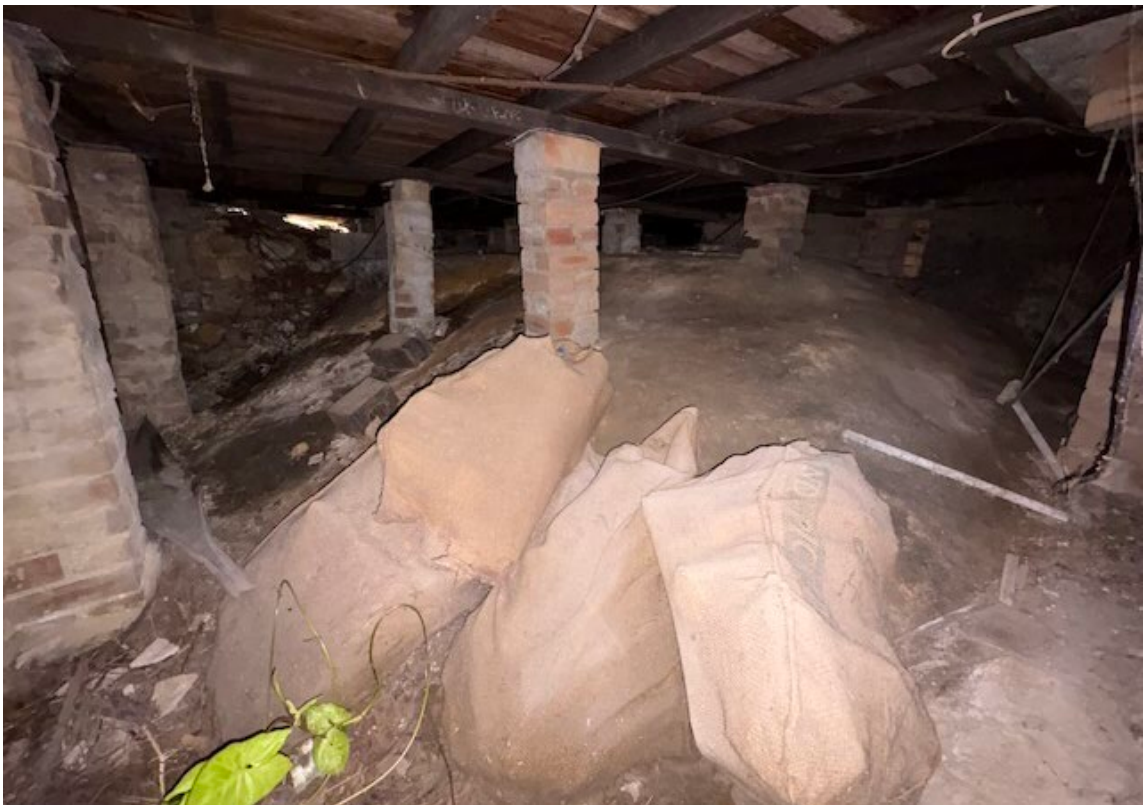
**Plate 7:** brick pier footings into natural slope below existing dwelling.

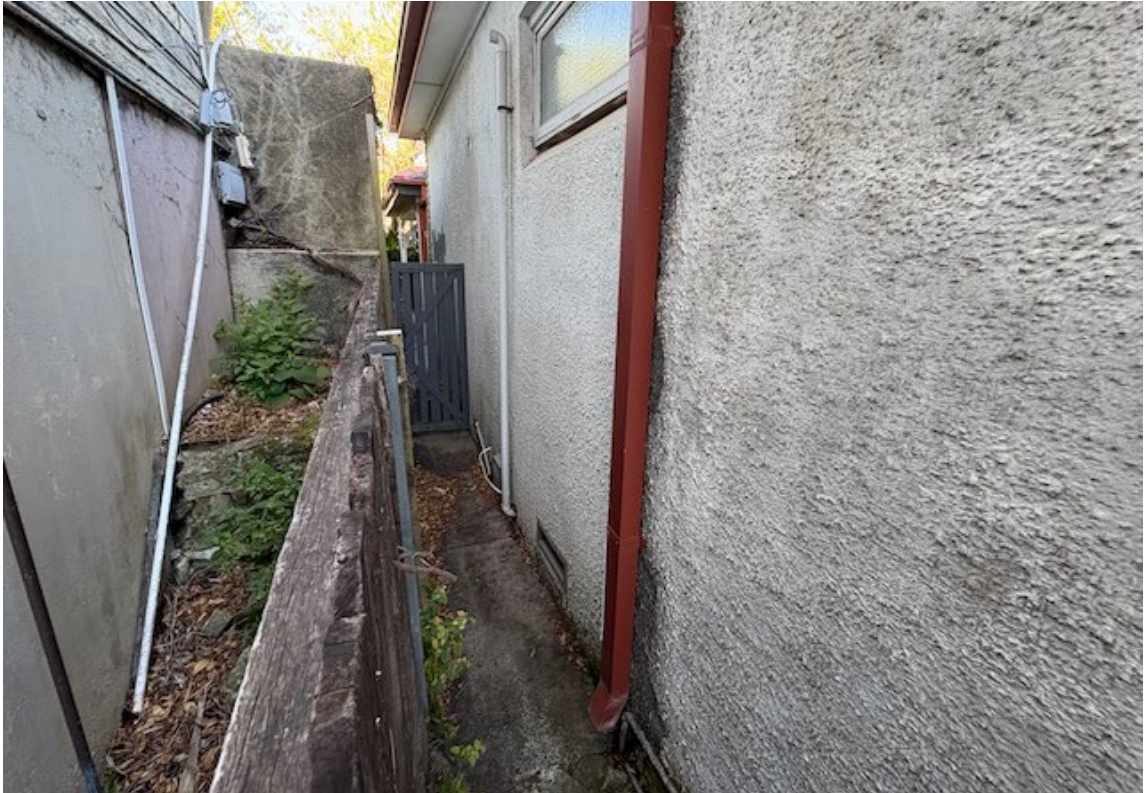
**Plate 8:** Retained slope, front southwest corner of existing dwelling.

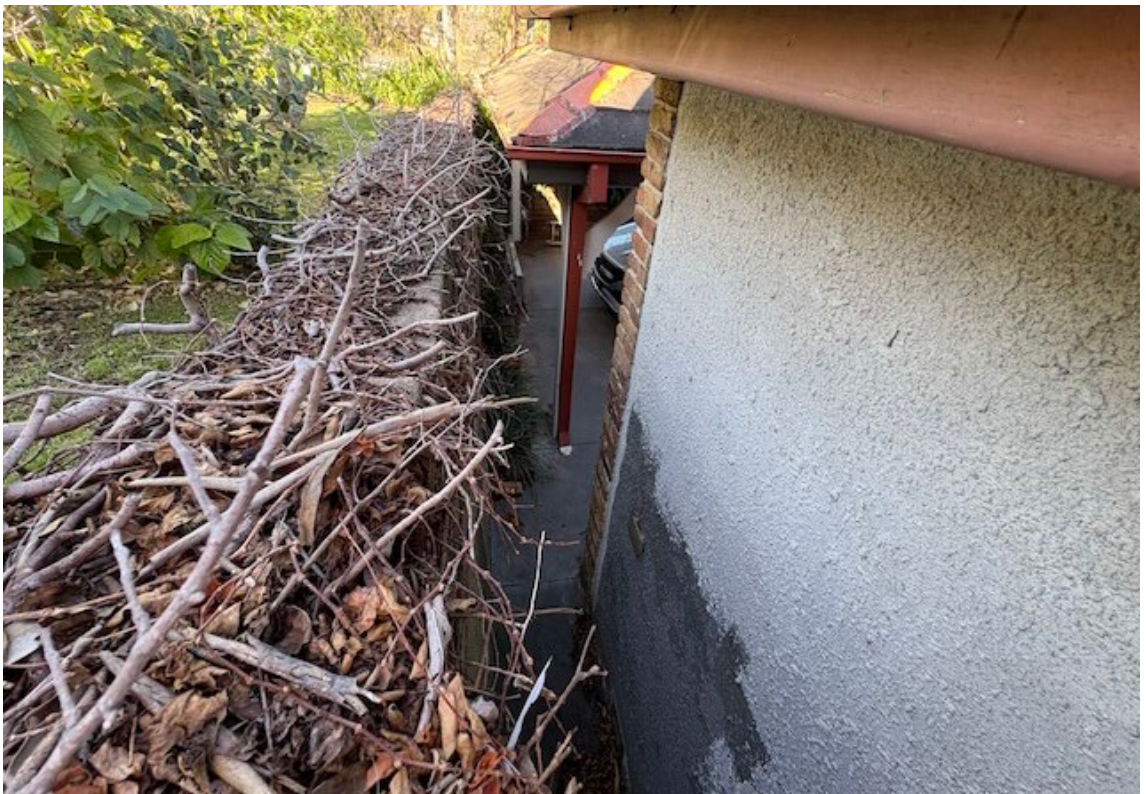
**Plate 9:** Concrete retaining wall along front southwest corner of site.

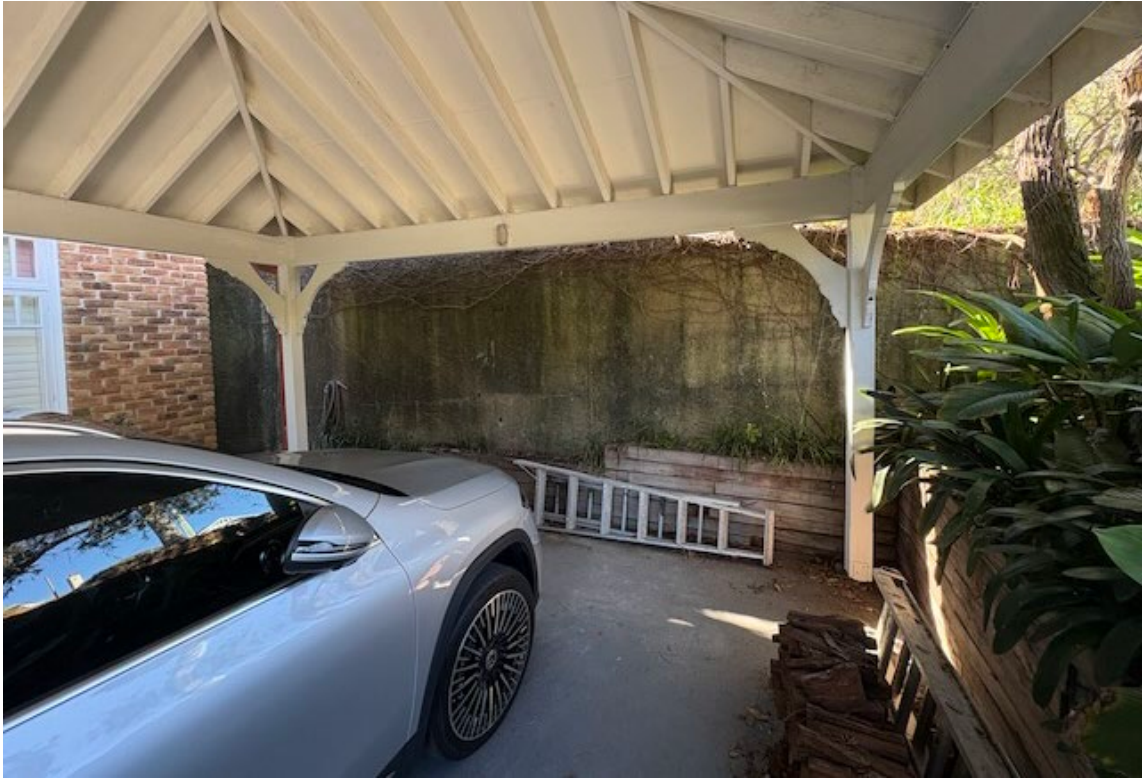
**Plate 10:** Concrete retaining wall along front southwest boundary with No.40.
