Geotechnical Assessment

Project: Alterations & Additions
4 Kunari Place, Mona Vale NSW

Ref: AG 24539
2 December 2024

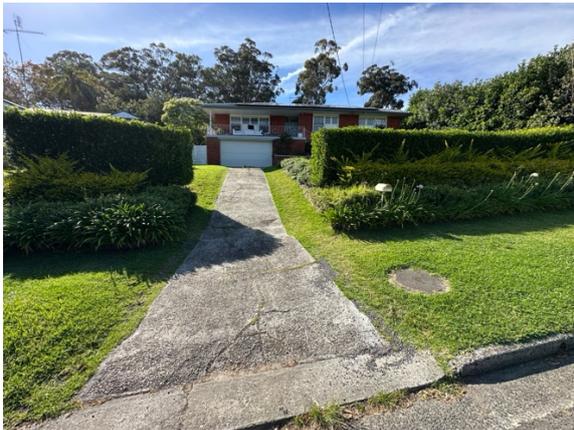
Photo 1: Frontage of the dwelling facing south-east.

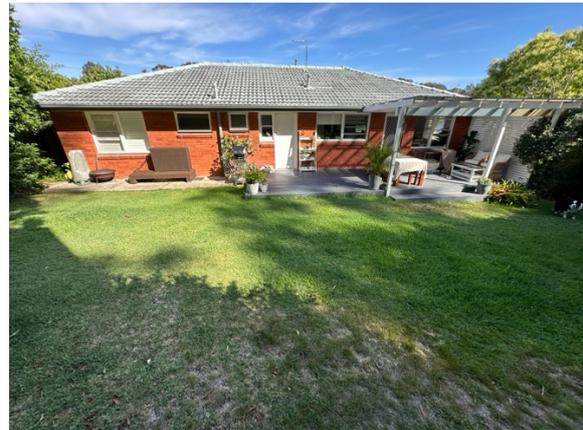
Photo 2: Rear of the dwelling facing north-west.

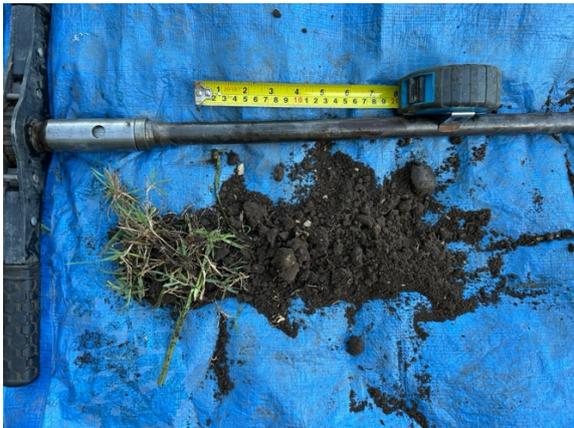
Photo 3: Subsurface soil profile seen in BH1.

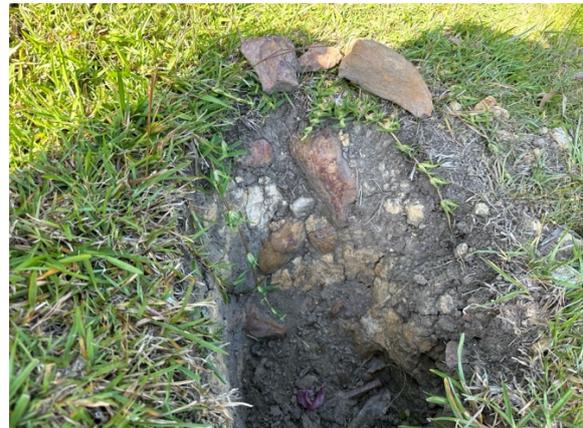
Photo 4: Iron rich sandstone material in soil profile.
