**Project No.:** 2025-133

Jenna & Richard Mair 9 Roosevelt Avenue Allambie Heights NSW 2100

## Preliminary Landslip Assessment for 9 Roosevelt Avenue, Allambie Heights, NSW

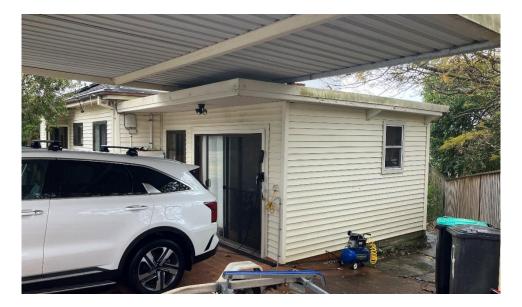
The site dwelling is situated broadly in the middle of the site and comprises a single storey timber residence supported on brick piers. The structure is anticipated to be of approximately 50 years construction age. The dwelling appeared to be in good condition with no signs of excessive settlement or cracking to indicate any impending geotechnical concern. Photograph 1 below provides a view of the site at the time of inspection.

Photograph 1: view of the site dwelling
