DILAPIDATION REPORT

Bubalo Street, Warriewood

Prepared by: Rezoning Pty Ltd t/as Effective Building & Consultancy

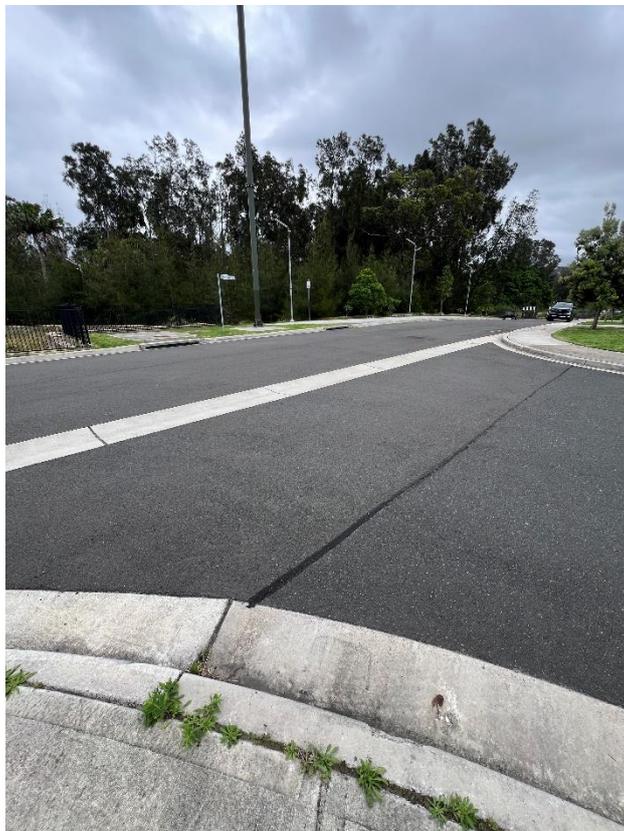
Figure 2 – General condition of the road.

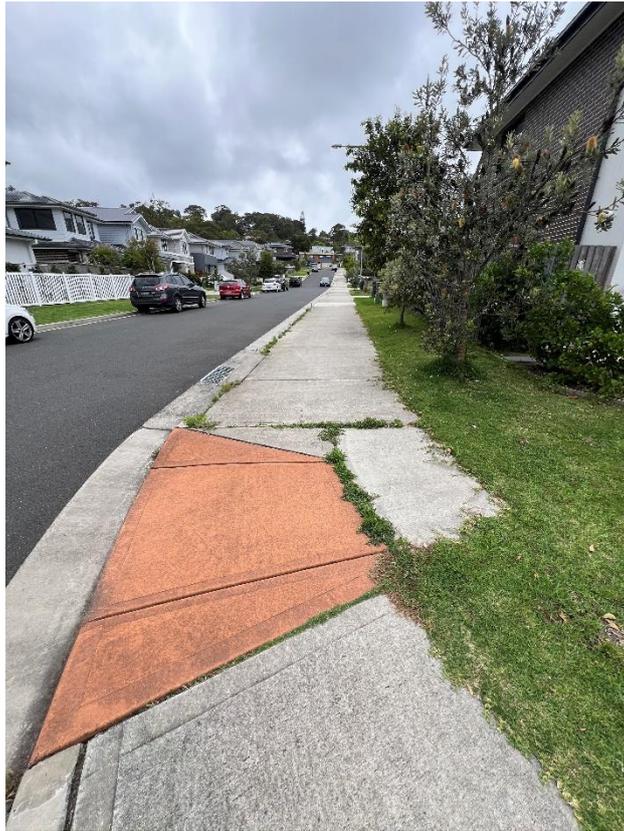
Figure 5 – General condition of the footpath.

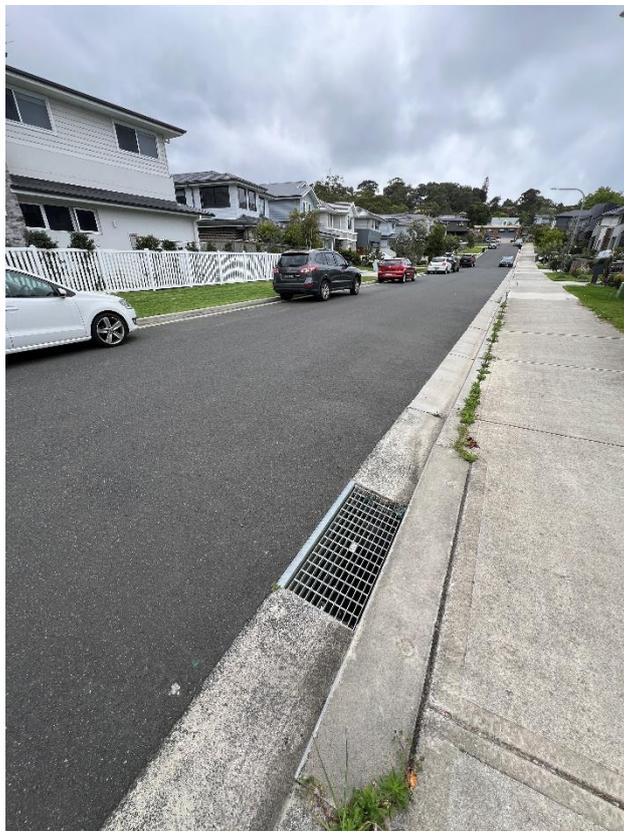
Figure 6 – General condition of the road/pit.

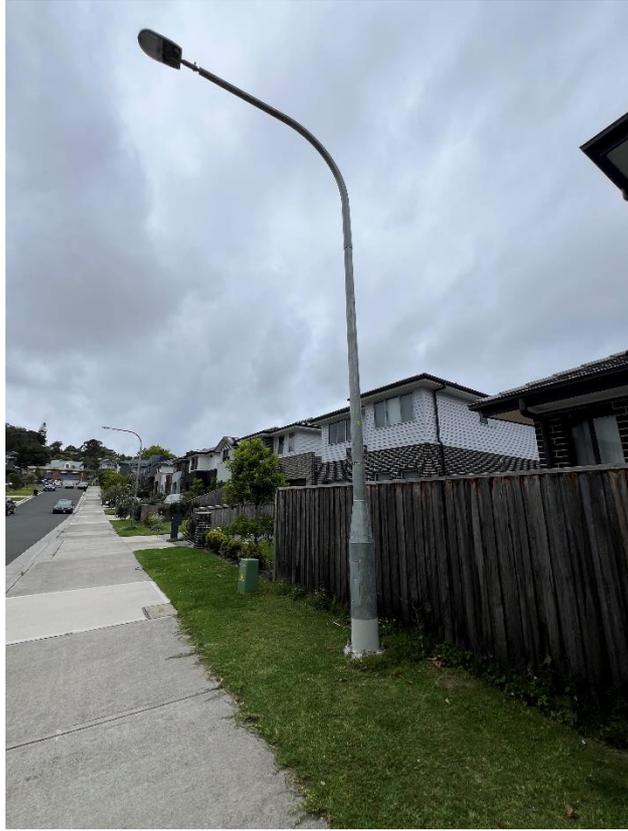
Figure 7 – General condition of the street light.

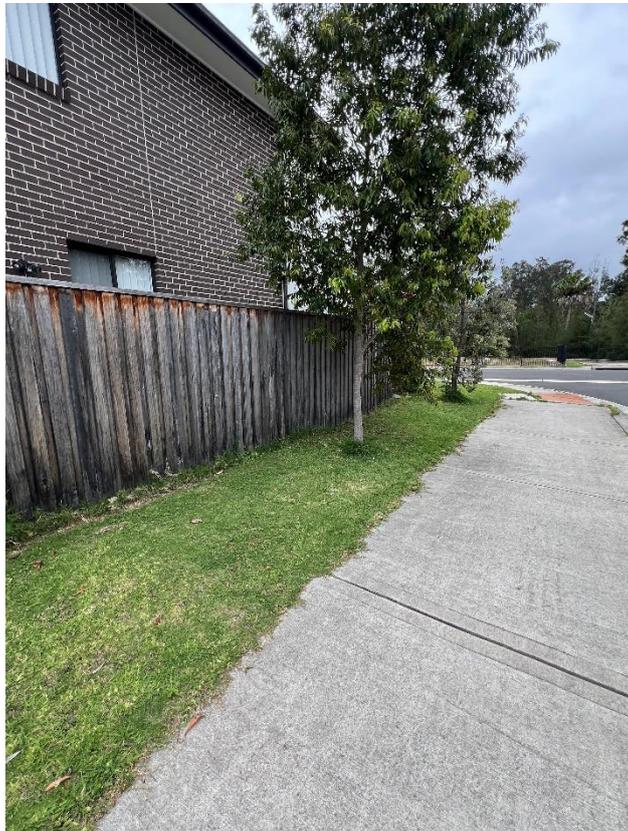
Figure 8 – General condition of the nature strip/tree.

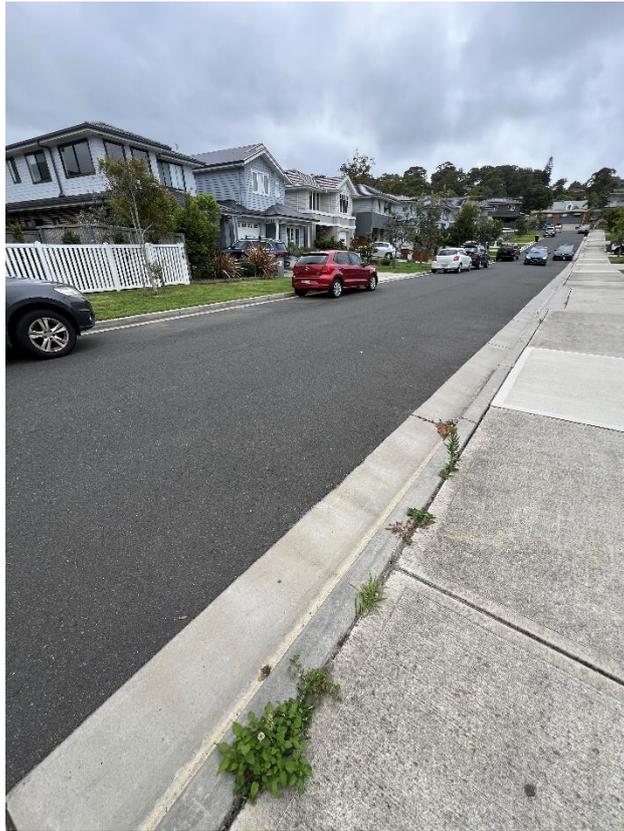
Figure 9 – General condition of the road/kerb.

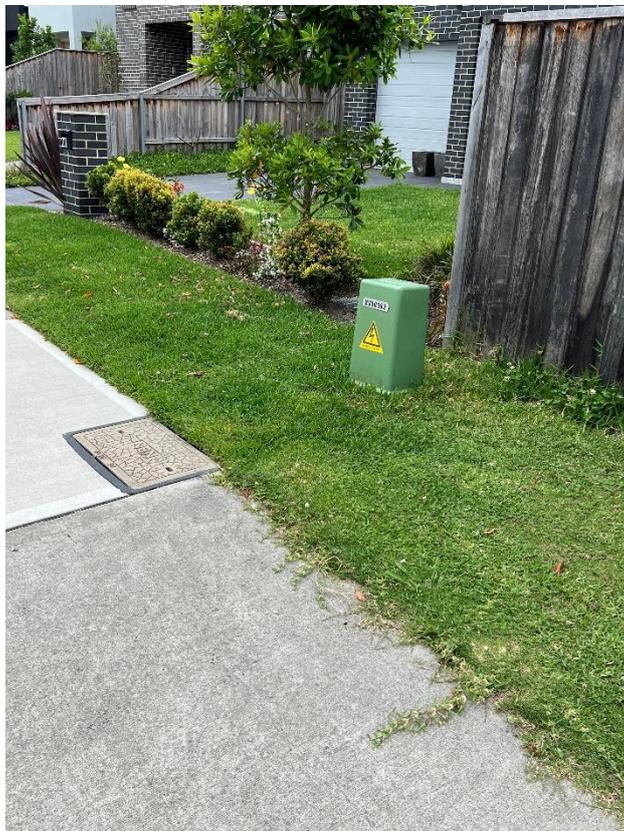
Figure 10 – General condition of the nature strip/transformer box.

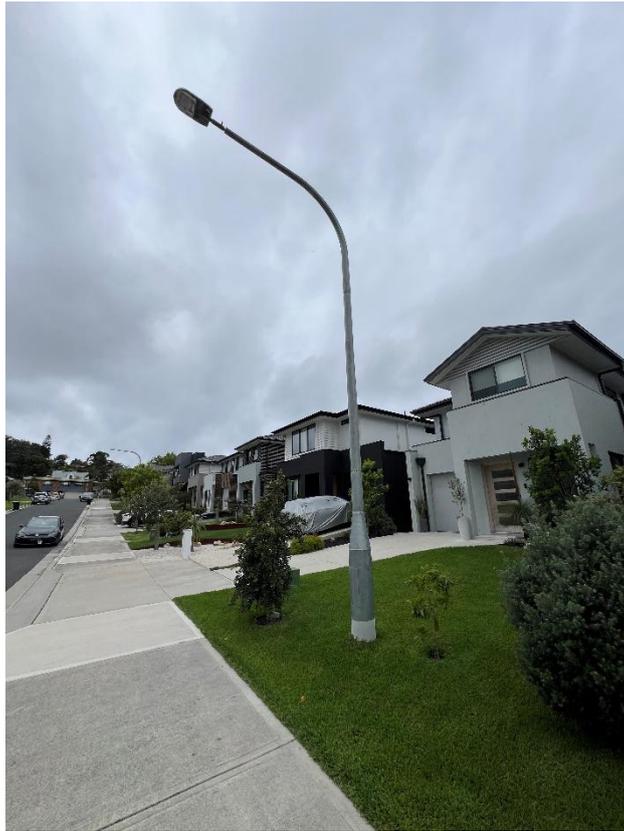
Figure 19 – General condition of the street light.

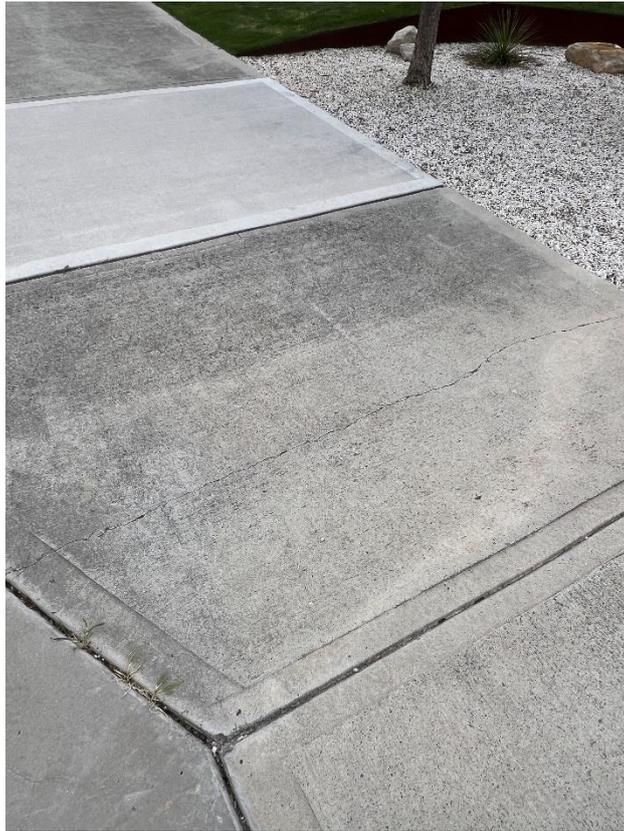
Figure 25 – Crack is evident to the footpath.

The council assets were found to be in a fair condition with evidence of crack to the footpath, pit, kerb, and layback.

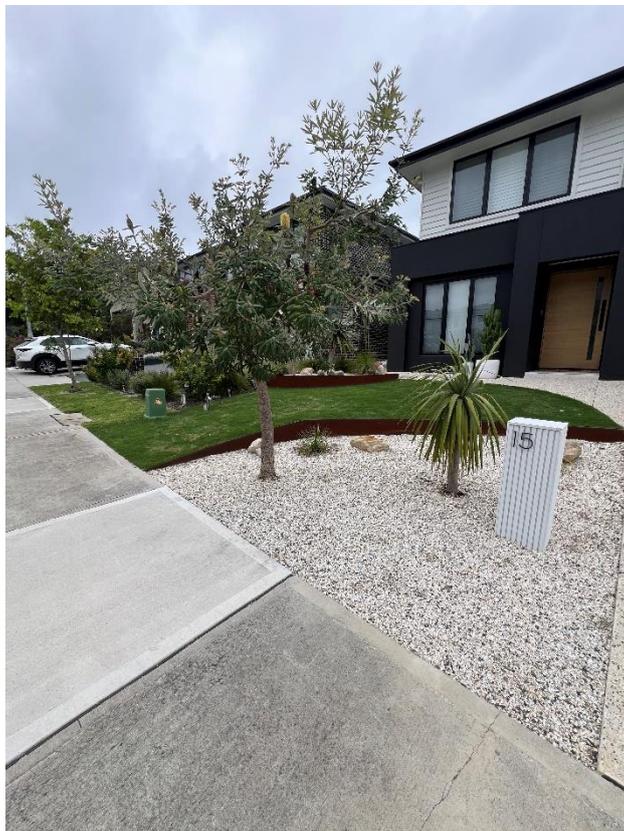
Figure 26 – General condition of the landscaping.

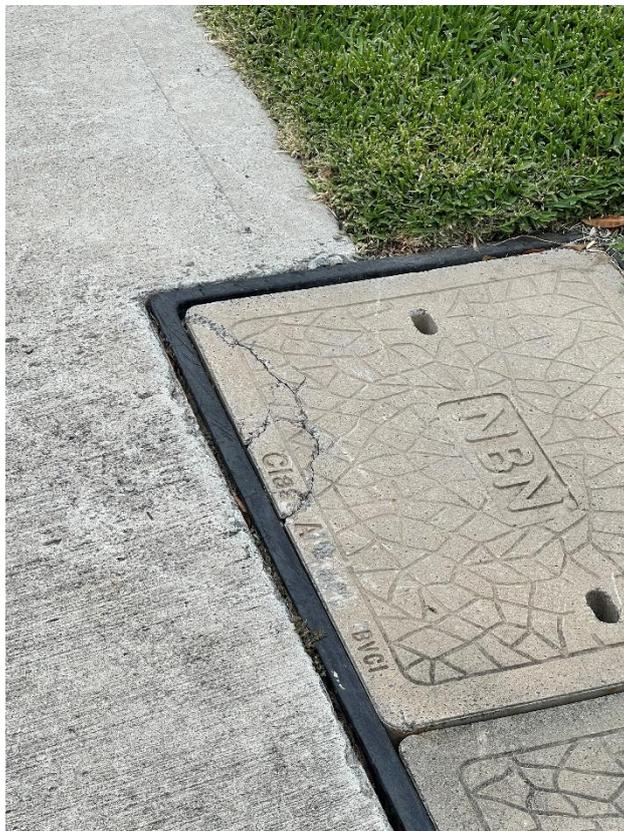
Figure 30 – Crack is evident to the pit.

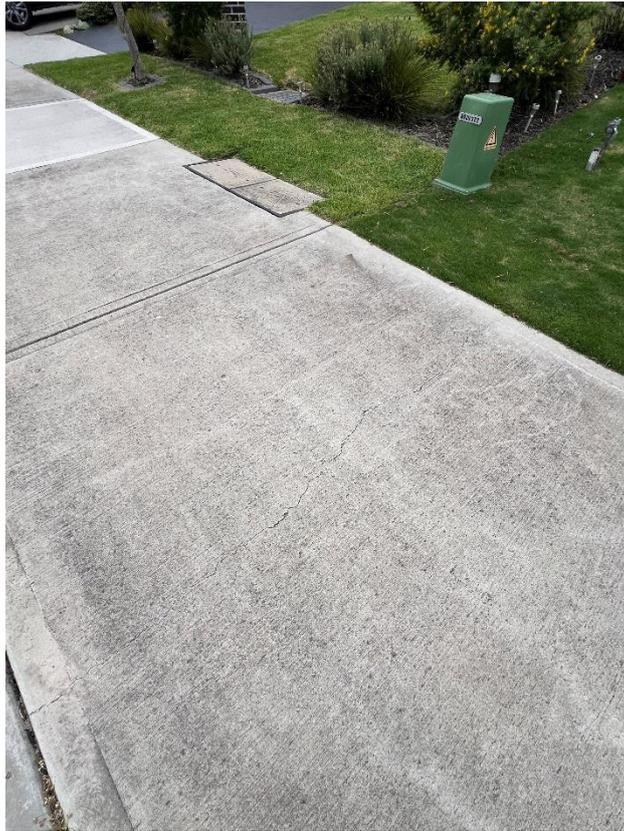
Figure 31 – Crack is evident to the footpath.

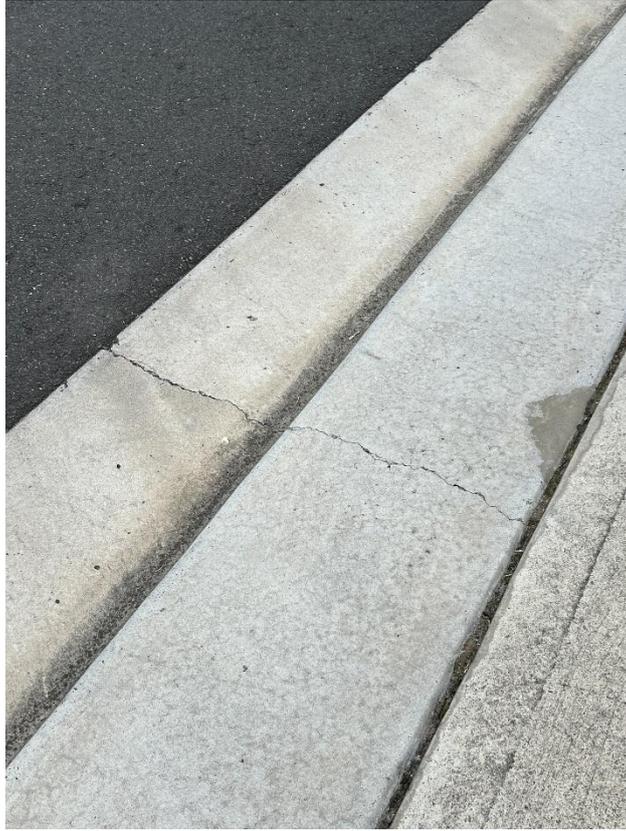
Figure 53 – Crack is evident to the layback.

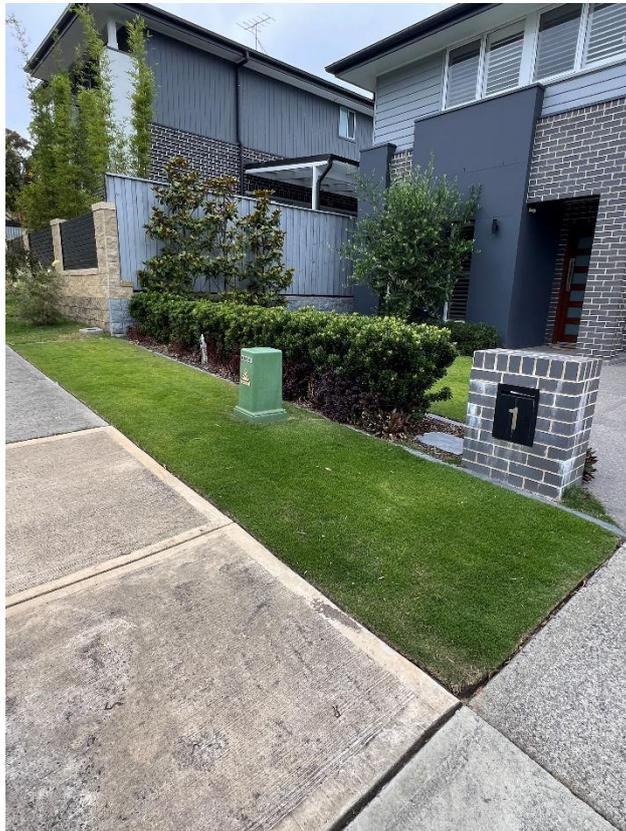
Figure 54 – General condition of the nature strip/transformer box.

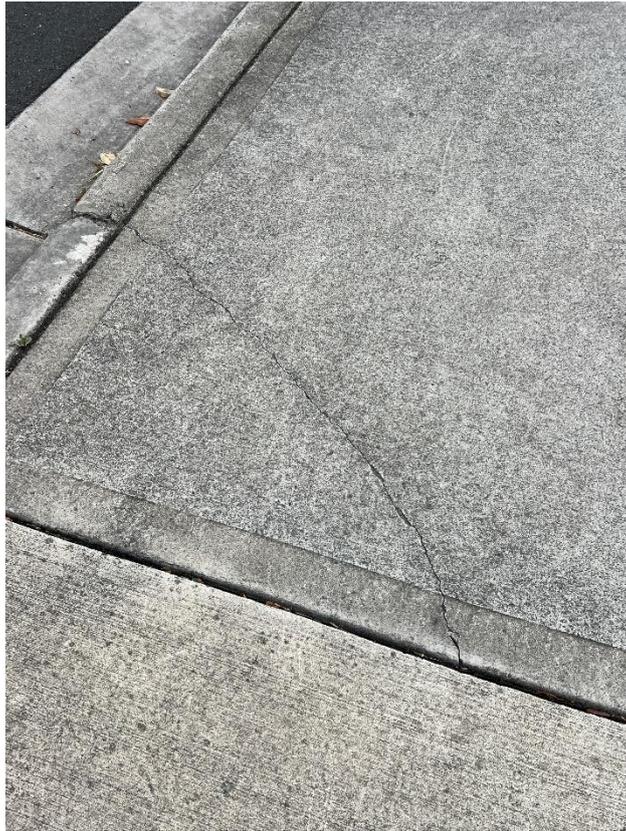
Figure 65 – Crack is evident to the footpath.

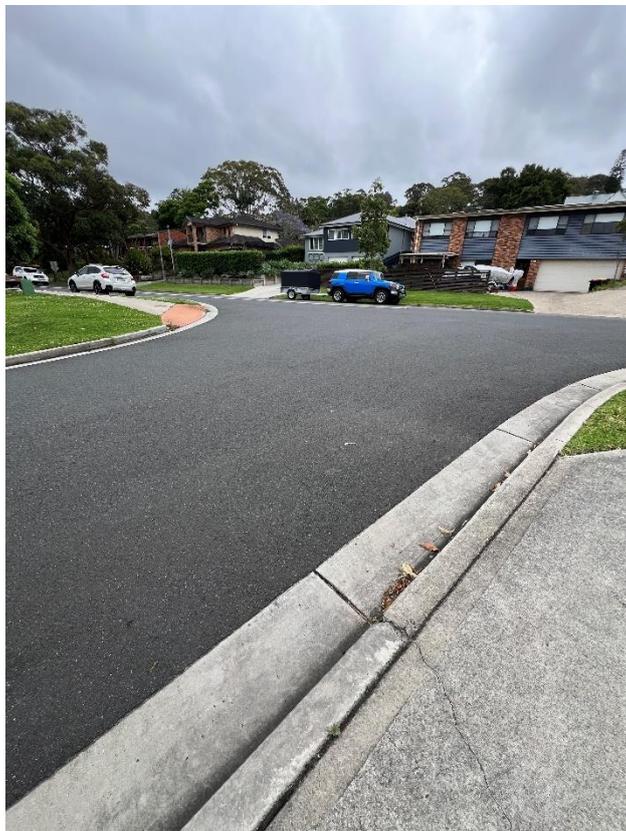
Figure 66 – Crack is evident to the footpath.

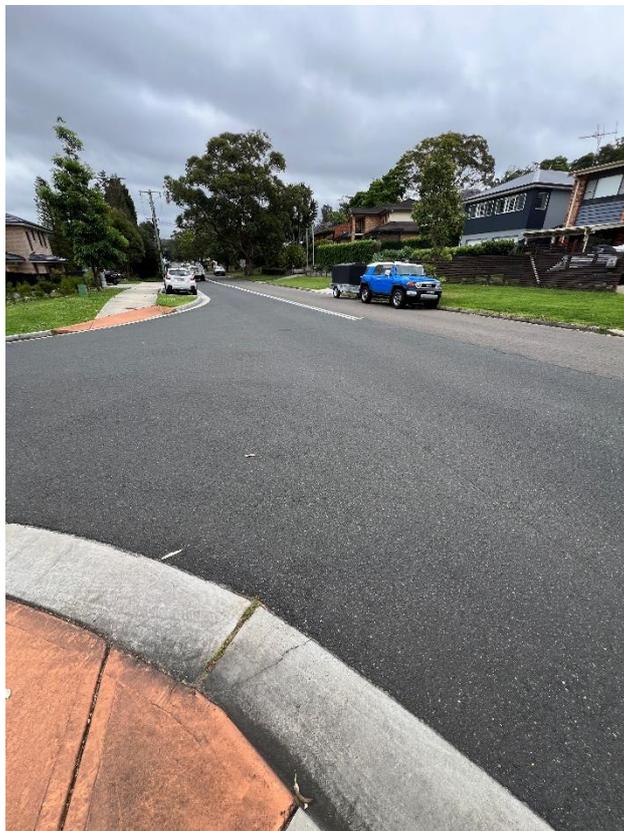
Figure 74 - Crack is evident to the layback.

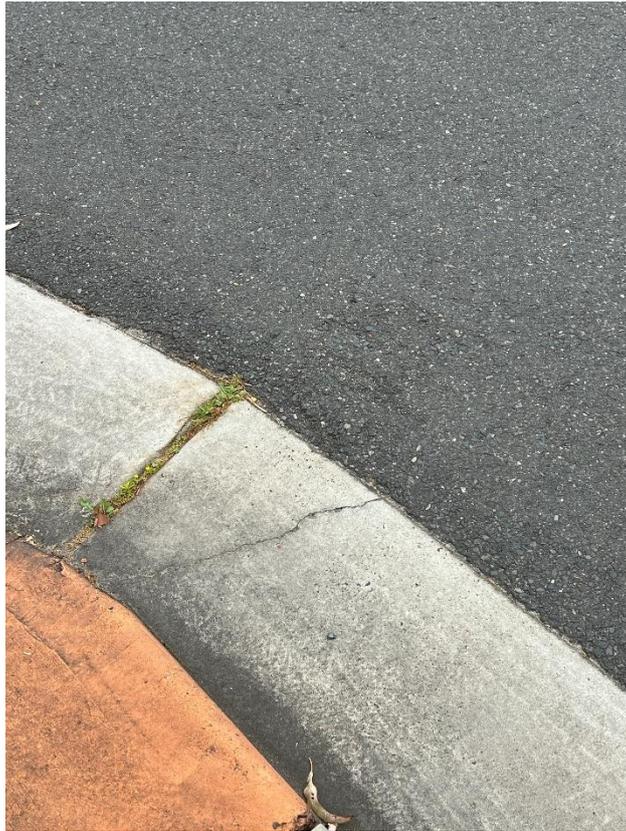
Figure 75 – Crack is evident to the layback.

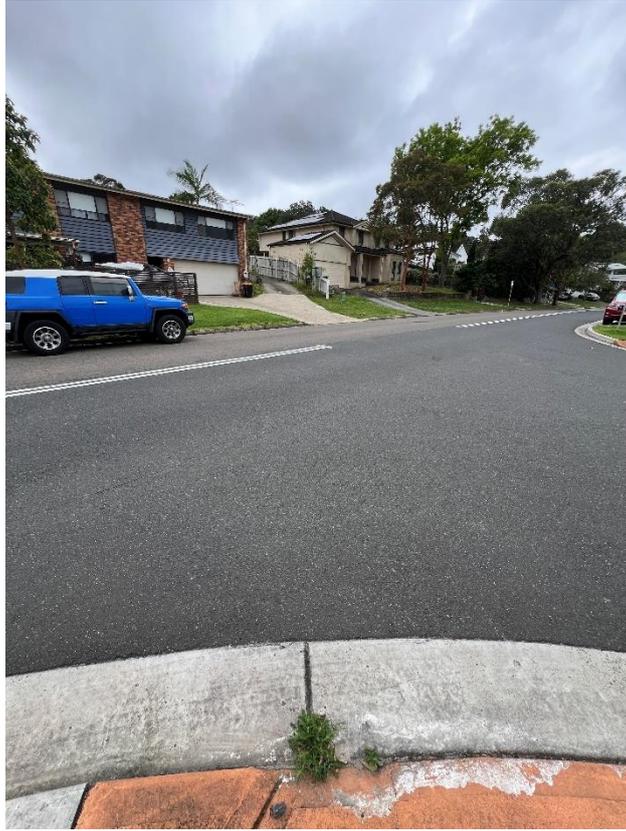
Figure 80 – Crack is evident to the layback.

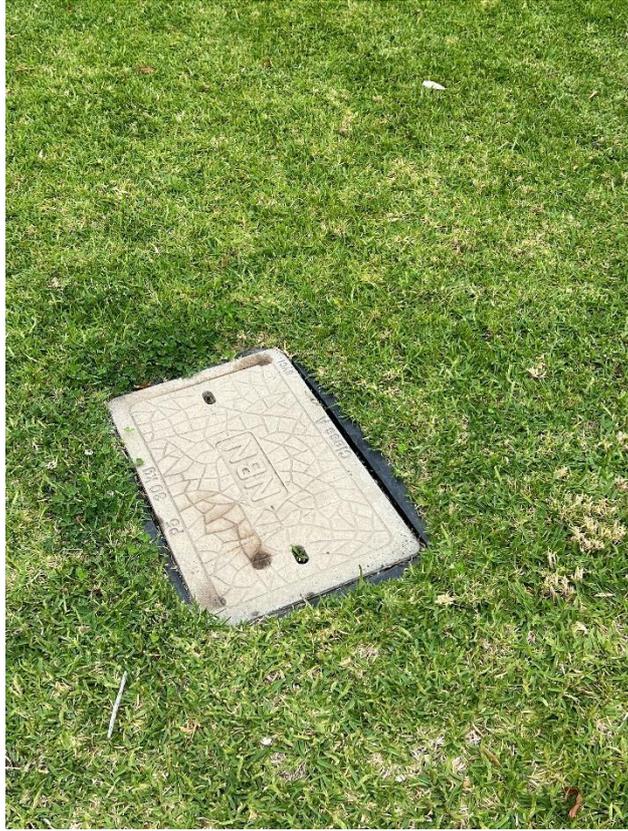
Figure 97 – General condition of the pit.

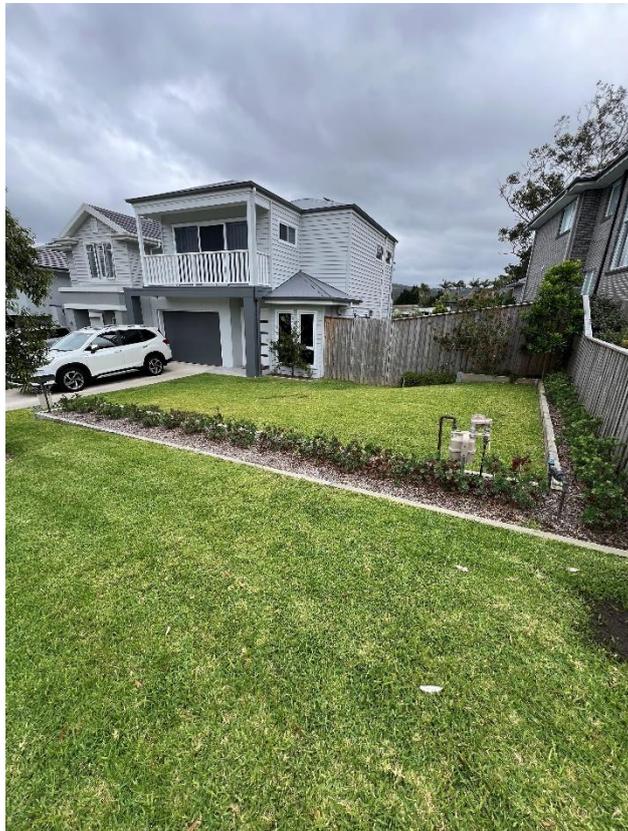
Figure 98 – General condition of the landscaping.

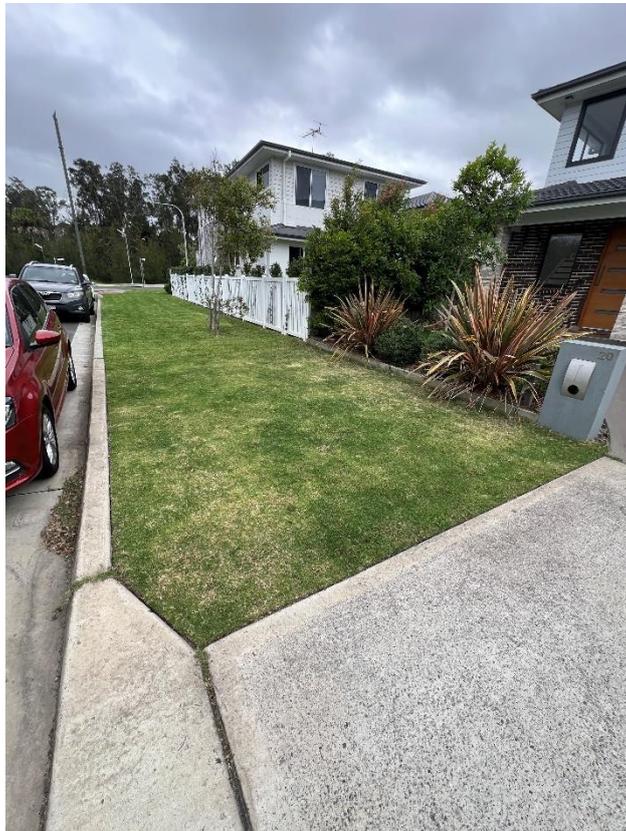
Figure 121 – Crack is evident to the layback.
