## **REPORT ON GEOTECHNICAL SITE INVESTIGATION**

### **ALTERATIONS AND ADDITIONS**

**1126 BARRENJOEY ROAD, PALM BEACH, NSW**

**Project No.: 2025-044**

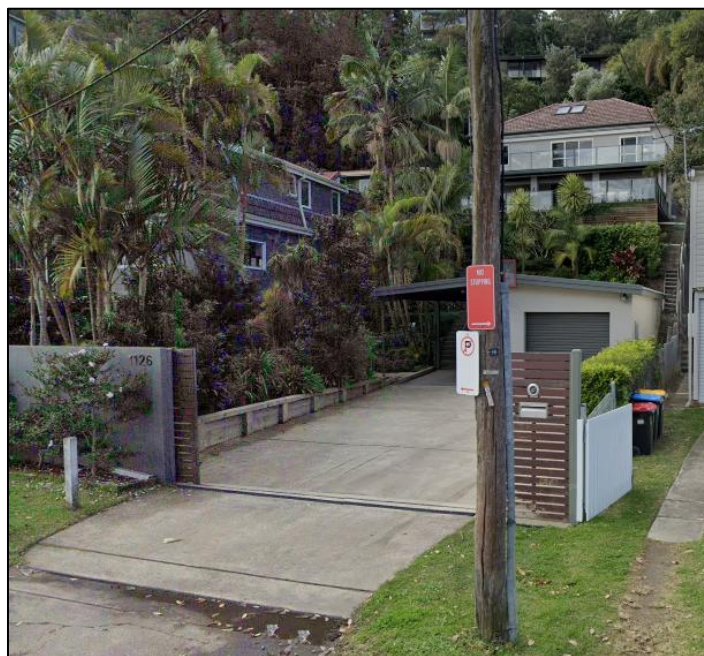
*Photograph-2: View of the front of the site from Barrenjoey Road.*

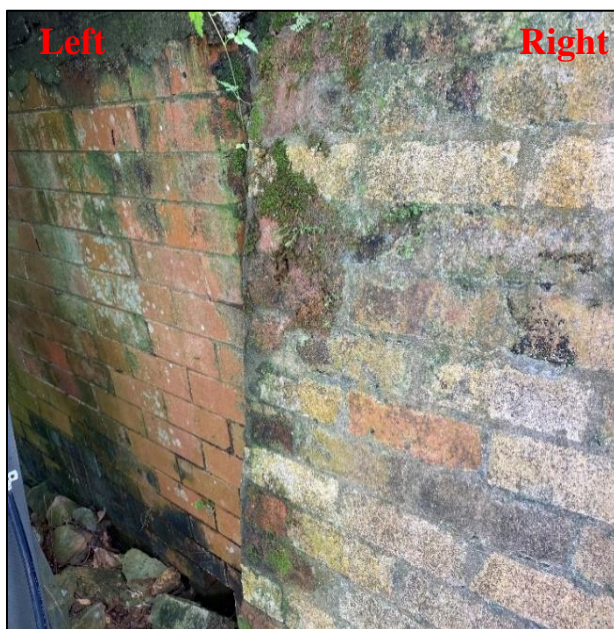
During the investigation two portions of this wall were observed to be rotated beyond vertical (Photograph-3). The portion of the wall supporting the water-tank and slab (Photograph-3 [left]) appears to be under rotating due excessive load from the tank structure and inadequate construction. The portion of the wall directly south (Photograph-3 [right]) was either formed with a defined slope or experiencing foundational failure from circular slip. A concrete staircase leads up the north side of the main dwelling and provides access to the existing veranda.

*Photograph-3: View of brick retaining wall failing.*

The existing brick retaining walls below the veranda and supporting the existing concrete slab and tank appear to be failing. As such they will need additional support or replacement, especially if structures are proposed to be supported upslope. Any excavation will require care to ensure it does not impact the existing dwelling or its footings therefore further assessment is recommended following demolition of the veranda and initial site mark out.

5.2.3. Retaining Structures:					
Required	New retaining structures will be required to remediate failing existing structures				
Types	Concrete block and steel reinforced retaining wall.				
Parameters for calculating pressures acting on retaining walls for the materials likely to be retained:					
Material	Unit Weight (kN/m³)	Long Term (Drained)	Earth Pressure Coefficients		Passive Earth Pressure
			Active (Ka)	At Rest (K0)	Coefficient *
Fill	18	ϕ' = 28°	0.35	0.52	N/A
Residual Clay Soils (Stiff)	20	ϕ' = 30°	0.33	0.47	3.25
VLS -LS bedrock	22	ϕ' = 38°	0.10	0.20	200kPa

The new spa is anticipated to be founded on a concrete slab, however the existing slab supporting the water tank appears itself supported by a failing brick retaining wall. Therefore, further investigation into this structure is required following deck removal and it is expected that a new support/retaining wall will be required with a new foundation system constructed to support the spa.

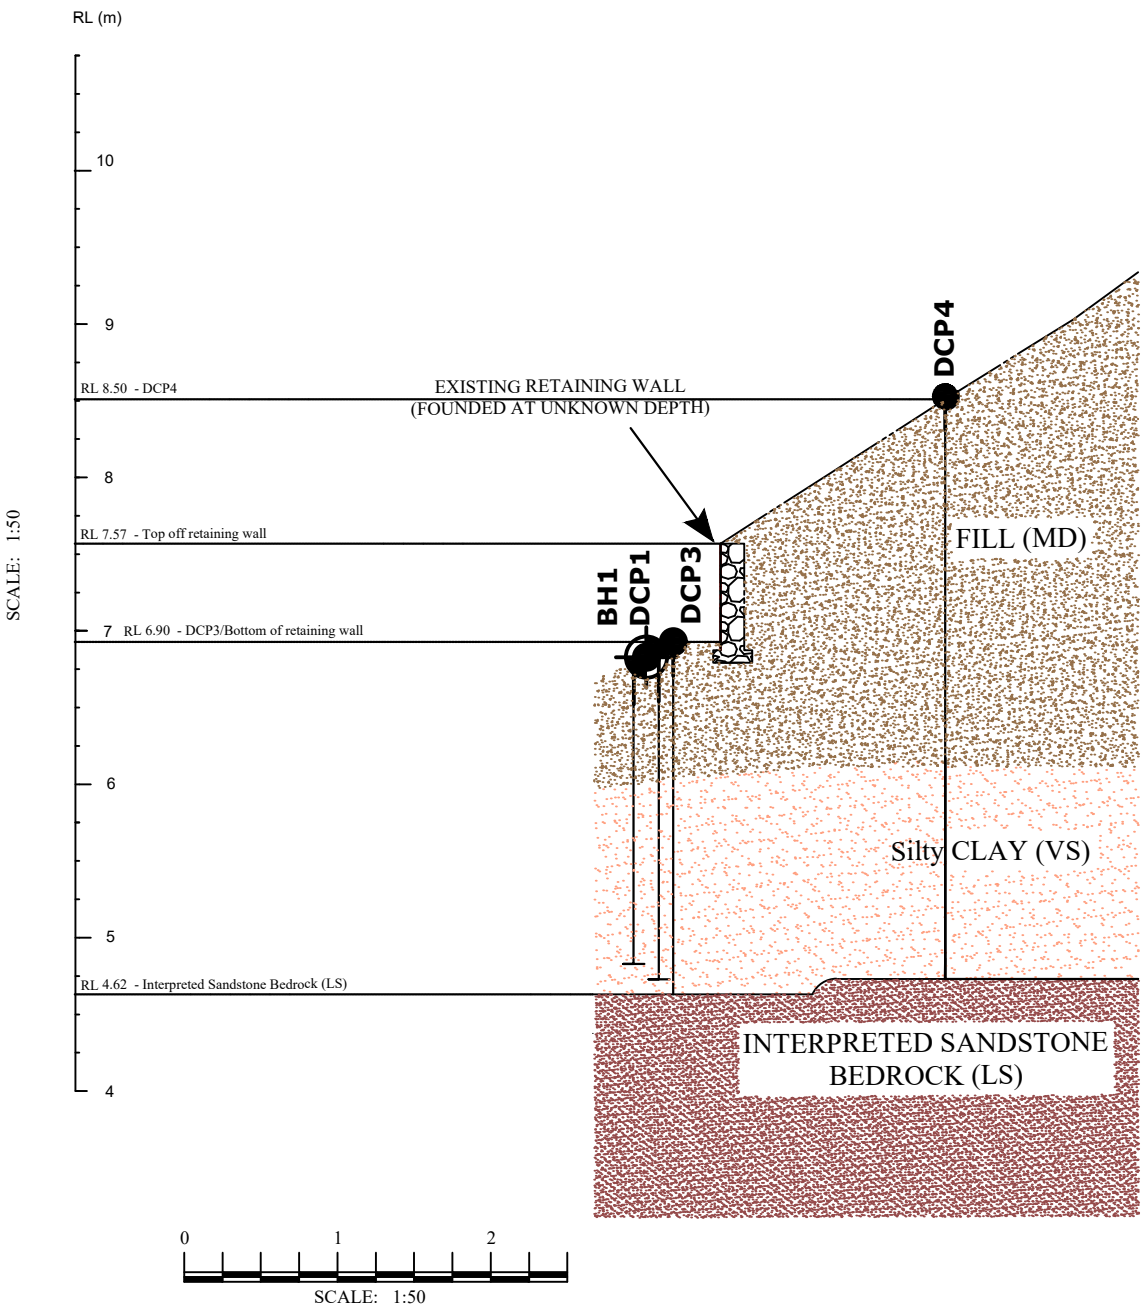
SECTION A: FIGURE 2

The site investigation identified the presence of a variable layer of fill, generally overlaying silty clays, which extended to a maximum depth of 2.00m in BH1, before intersecting interpreted sandstone bedrock of at least very low strength. Additionally, DCP testing throughout the site confirmed the variability of the fill behind the existing retaining wall as well as identified the existence of rock at varying depths 2.30m, 3.50m, and 2.70m from ground level (DCP3, DCP4, DCP5).
