REPORT ON GEOTECHNICAL SITE INVESTIGATION

PROPOSED NEW GARAGE

119 HUDSON PARADE, CLAREVILLE, NSW

Project No.: 2025-086

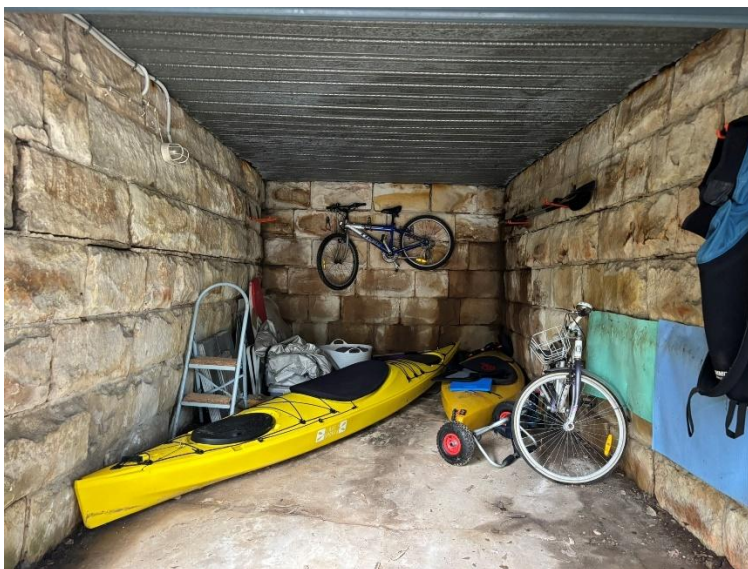
The front portion of the site at No. 119 Hudson Parade, Clareville, comprises a concrete driveway and a sandstone block staircase adjacent to a detached garage structure that currently provides access to the property. The garage is estimated to be approximately 100 years old and is excavated into the slope, with external retaining walls constructed from sandstone blockwork, while the roof is of more recent concrete construction. The remaining front area consists primarily of gardens and vegetated surfaces supported by the retaining wall along the boundary, with pedestrian access to the dwelling and rear portion of the site provided via a stone-paved pathway. The garage walls exhibit signs of bowing and structural distortion (refer to Photograph 2), and the retaining wall along the front west boundary also appears to show evidence of cracking.

Photograph 2: View of existing garage, facing southeast from Hudson Parade

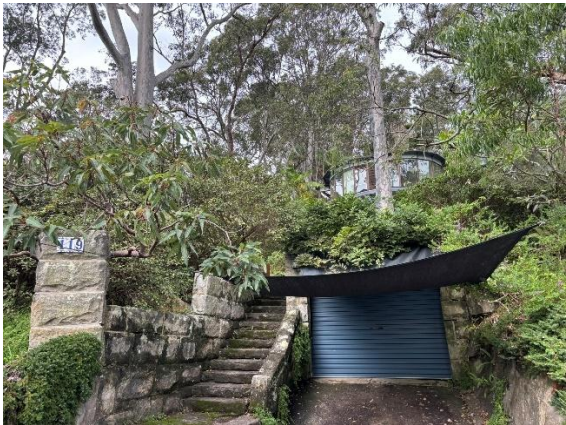
Photograph 3: View of No. 119 Hudson Parade front, facing east from Hudson Parade.

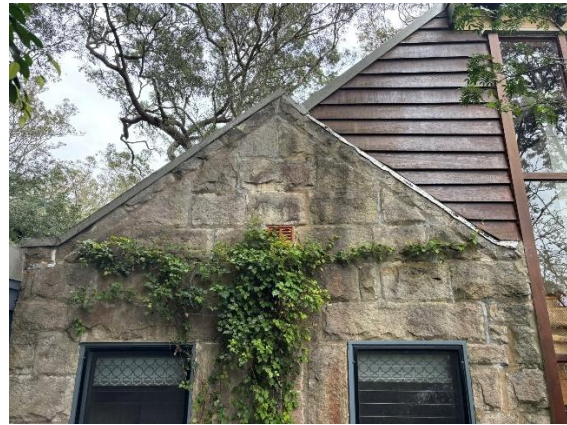
Photograph 4: View of the addition to the old structure, facing west

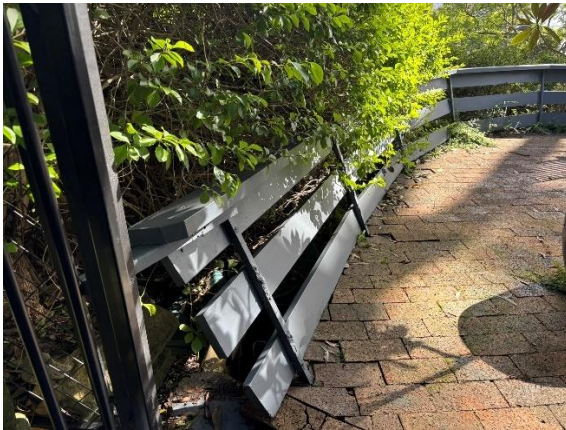
The one and two storey sandstone masonry dwelling is located at centre of the site with a brick paved front terrace. Observations suggest that the front portion of the structure is a timber-framed extension to the original rear section, which is approximately 100 years old. The terrace is elevated approximately 3.5 m above the front gardens and is retained by a sandstone block retaining wall. At the time of inspection, the main structure appeared to be in good condition with no evident signs of differential settlement or structural cracking. However, the terrace showed minor cracking and indications of localized settlement, likely associated with the rotation of the supporting retaining wall (Photograph 5).

Photograph 5: View of the terrace retaining wall showing signs of rotation, facing northwest

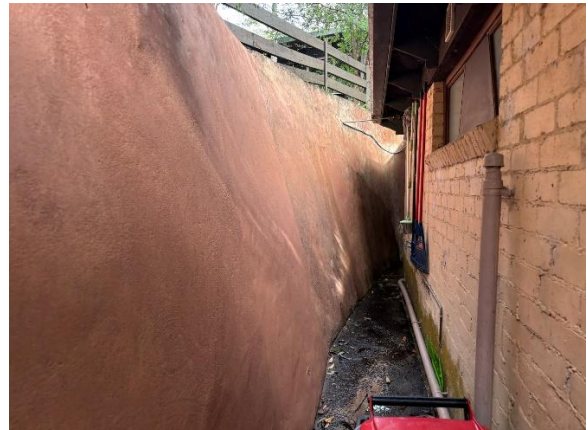
A rendered retaining wall ≤ 3.0 m high is positioned to the immediate rear of the main structure. The retaining wall has been constructed on an approximate and variable 1:4 near-vertical batter and appears likely to be of shotcrete construction. While weep holes are positioned near the base of the retaining wall, no formal drainage system was noted at the rear of the dwelling. There was no indication of anchoring within the wall.

Photograph 6: View of the retaining wall at the rear, facing south

Voids adjacent to the proposed garage, particularly near the existing retaining wall at the rear east of the excavation, should be backfilled with granular material, preferably clean crushed sandstone, placed in controlled layers. This material is recommended for its favourable drainage characteristics and compaction properties, which are essential for limiting long-term settlement and maintaining ground stability in the vicinity of the retaining wall and proposed structure.

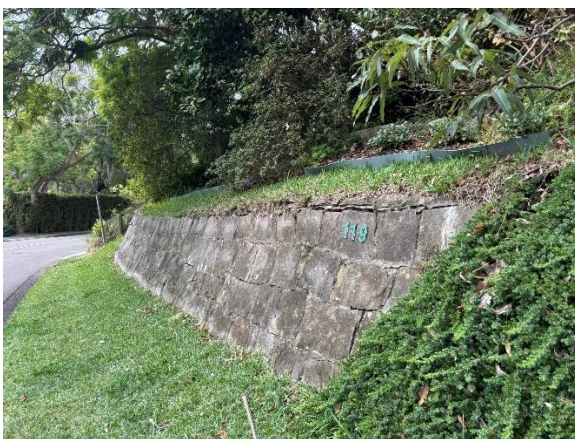
Photograph 7: View of the retaining wall at front boundary, facing east from Hudson Parade

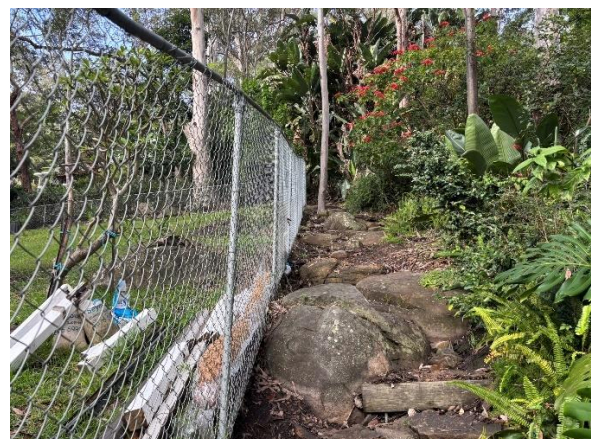
Photograph 8: View of the boulders in the Public Pathway, facing southeast
