## ARBORICULTURAL IMPACT ASSESSMENT REPORT

Site Address: 231-233 McCarrs Creek Road,  
CHURCH POINT, NSW, 2105

Inspection Dates: 22<sup>nd</sup> October 2024

Report Date: 14<sup>th</sup> April 2025

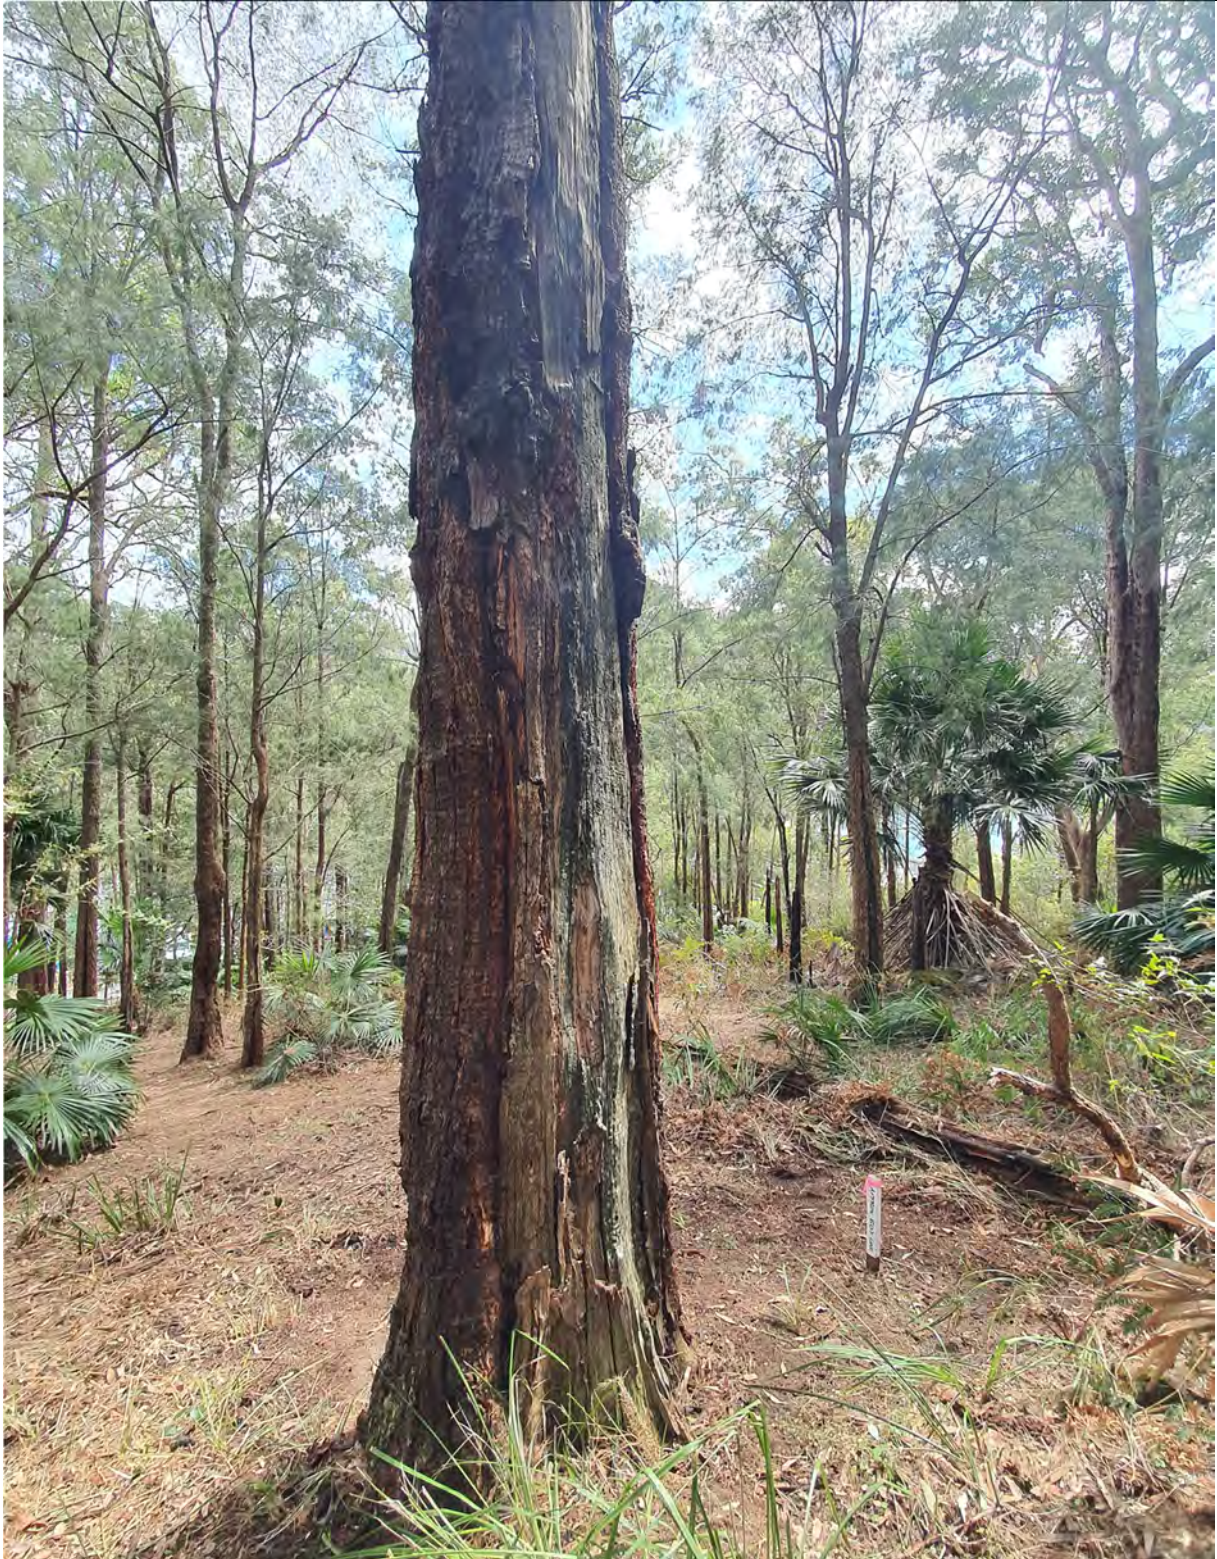
*Image 4: A view from the South-Eastern Boundary looking Northwest. Tree 10 [centre] with extensive cambium dieback visible.*

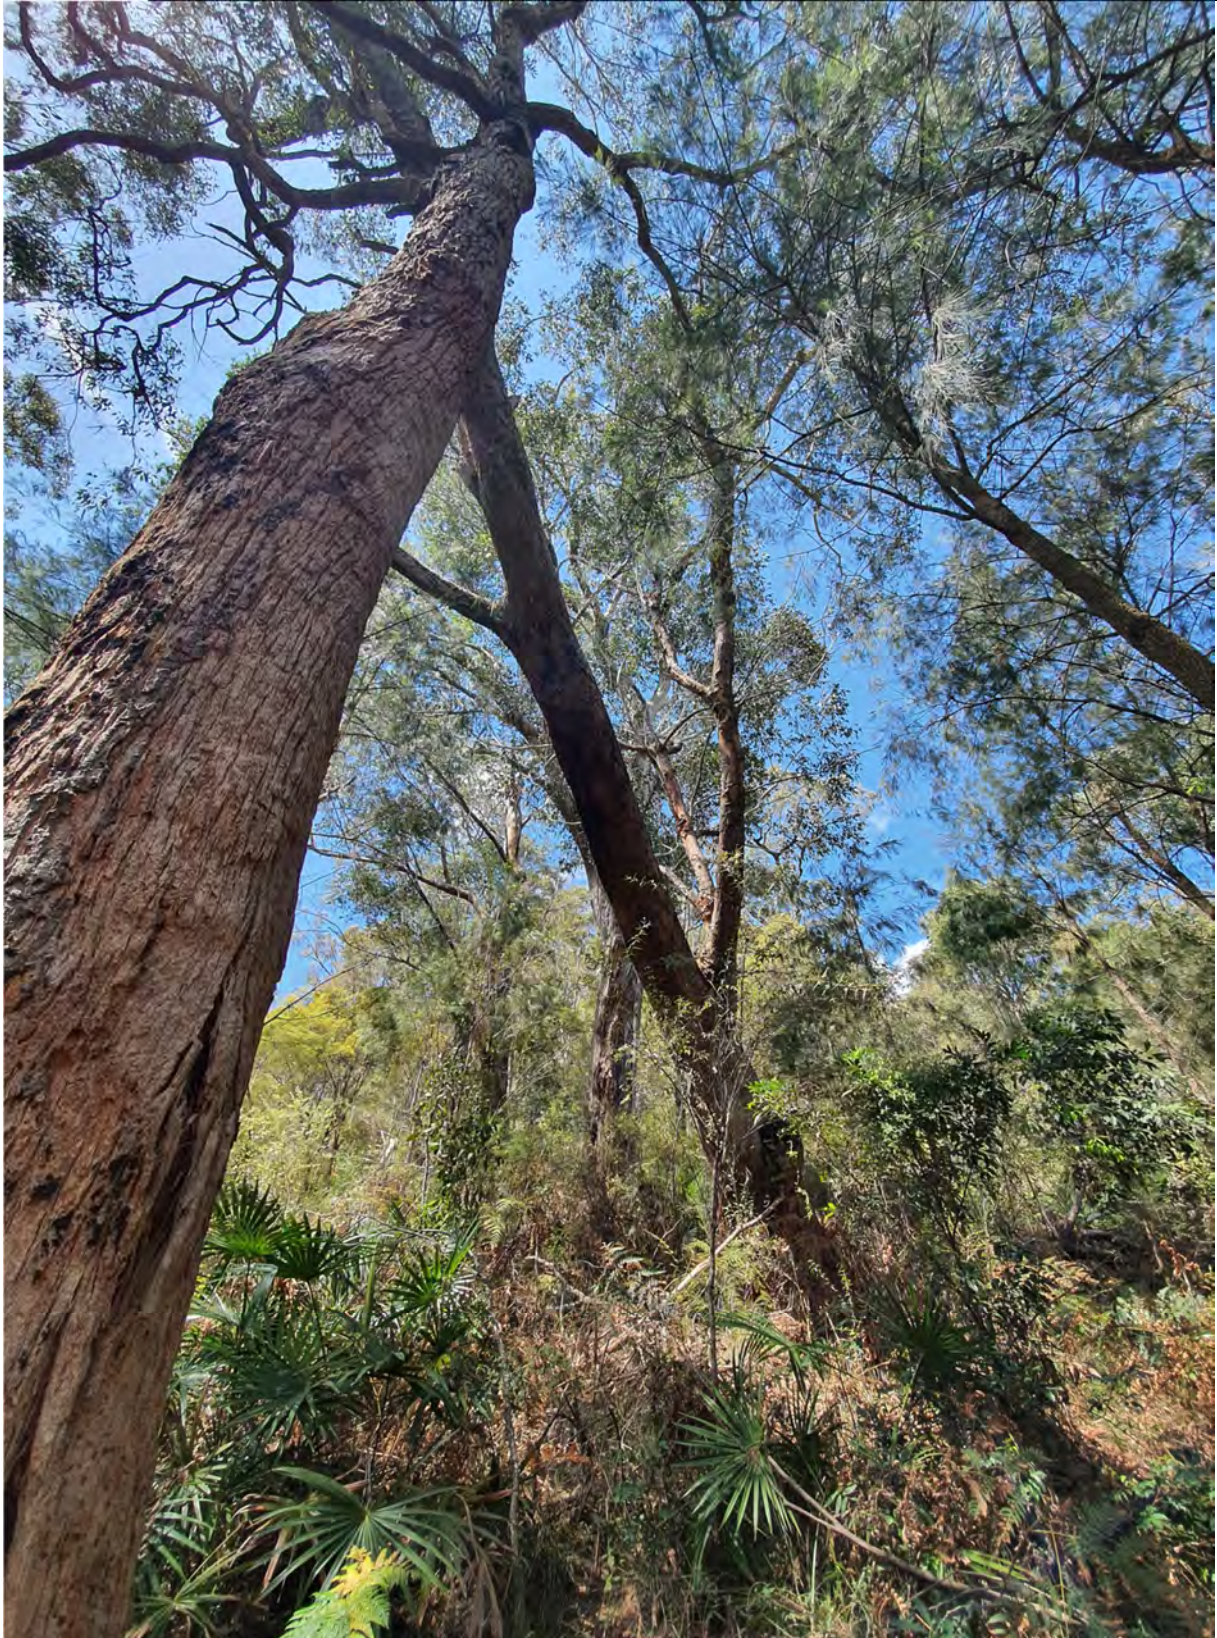
3.4.6 The neighbouring Tree 12 (Blackbutt) is a large remnant tree within the National Park. It presented with a critical lean of 25° above horizontal towards the development site.

*Image 5: The critical lean of Tree 12 before Hazard reduction burning.*

5.2.2 It is recommended that the removal of T12 (Blackbutt) occurs irrespective of development. This tree is located on adjoining land & the removal of this tree is *subject to discussions* with the relevant landowner & council.

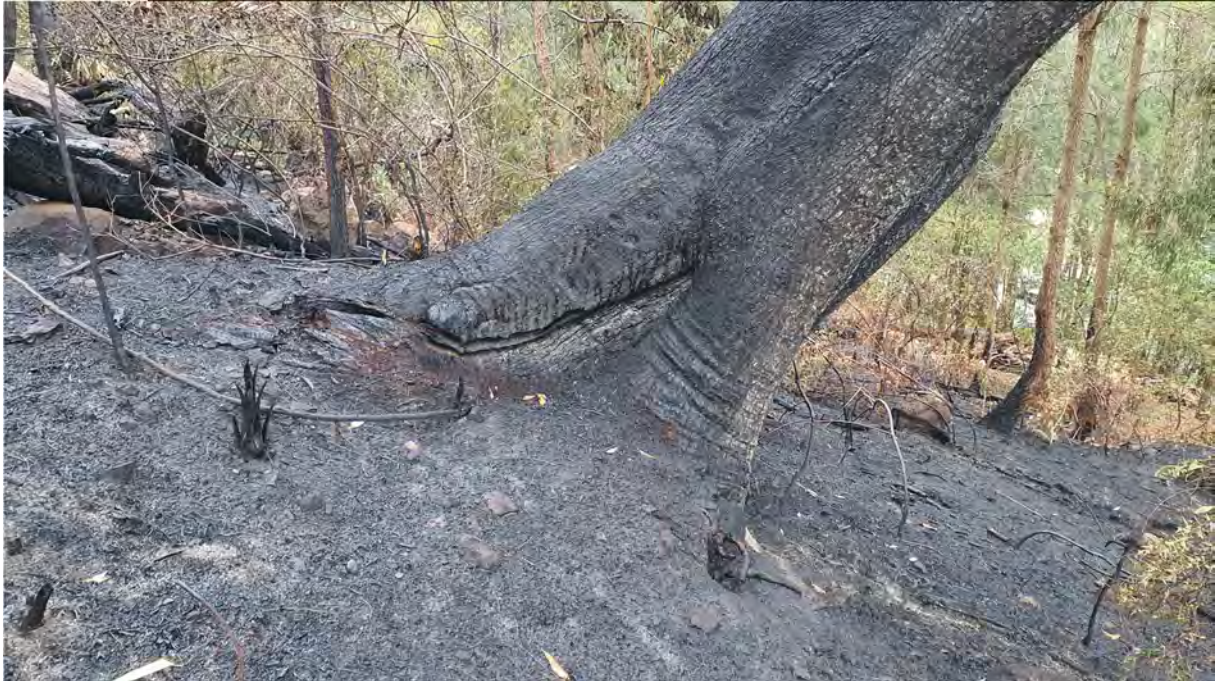
Subsequent assessment of the tree following the hazard reduction burn has revealed this tree is growing atop a natural sandstone rock scarp & appears to be in a state of active failure due to signs of soil & bark separation.

This tree was observed in a state of active failure & poses a high risk of collapse, impacting the development site.

*Image 6: Tree 12 as seen following the Hazard Reduction burn. Cambium and soil separation was noted indicating this tree is at a high risk of failure in the near future.*

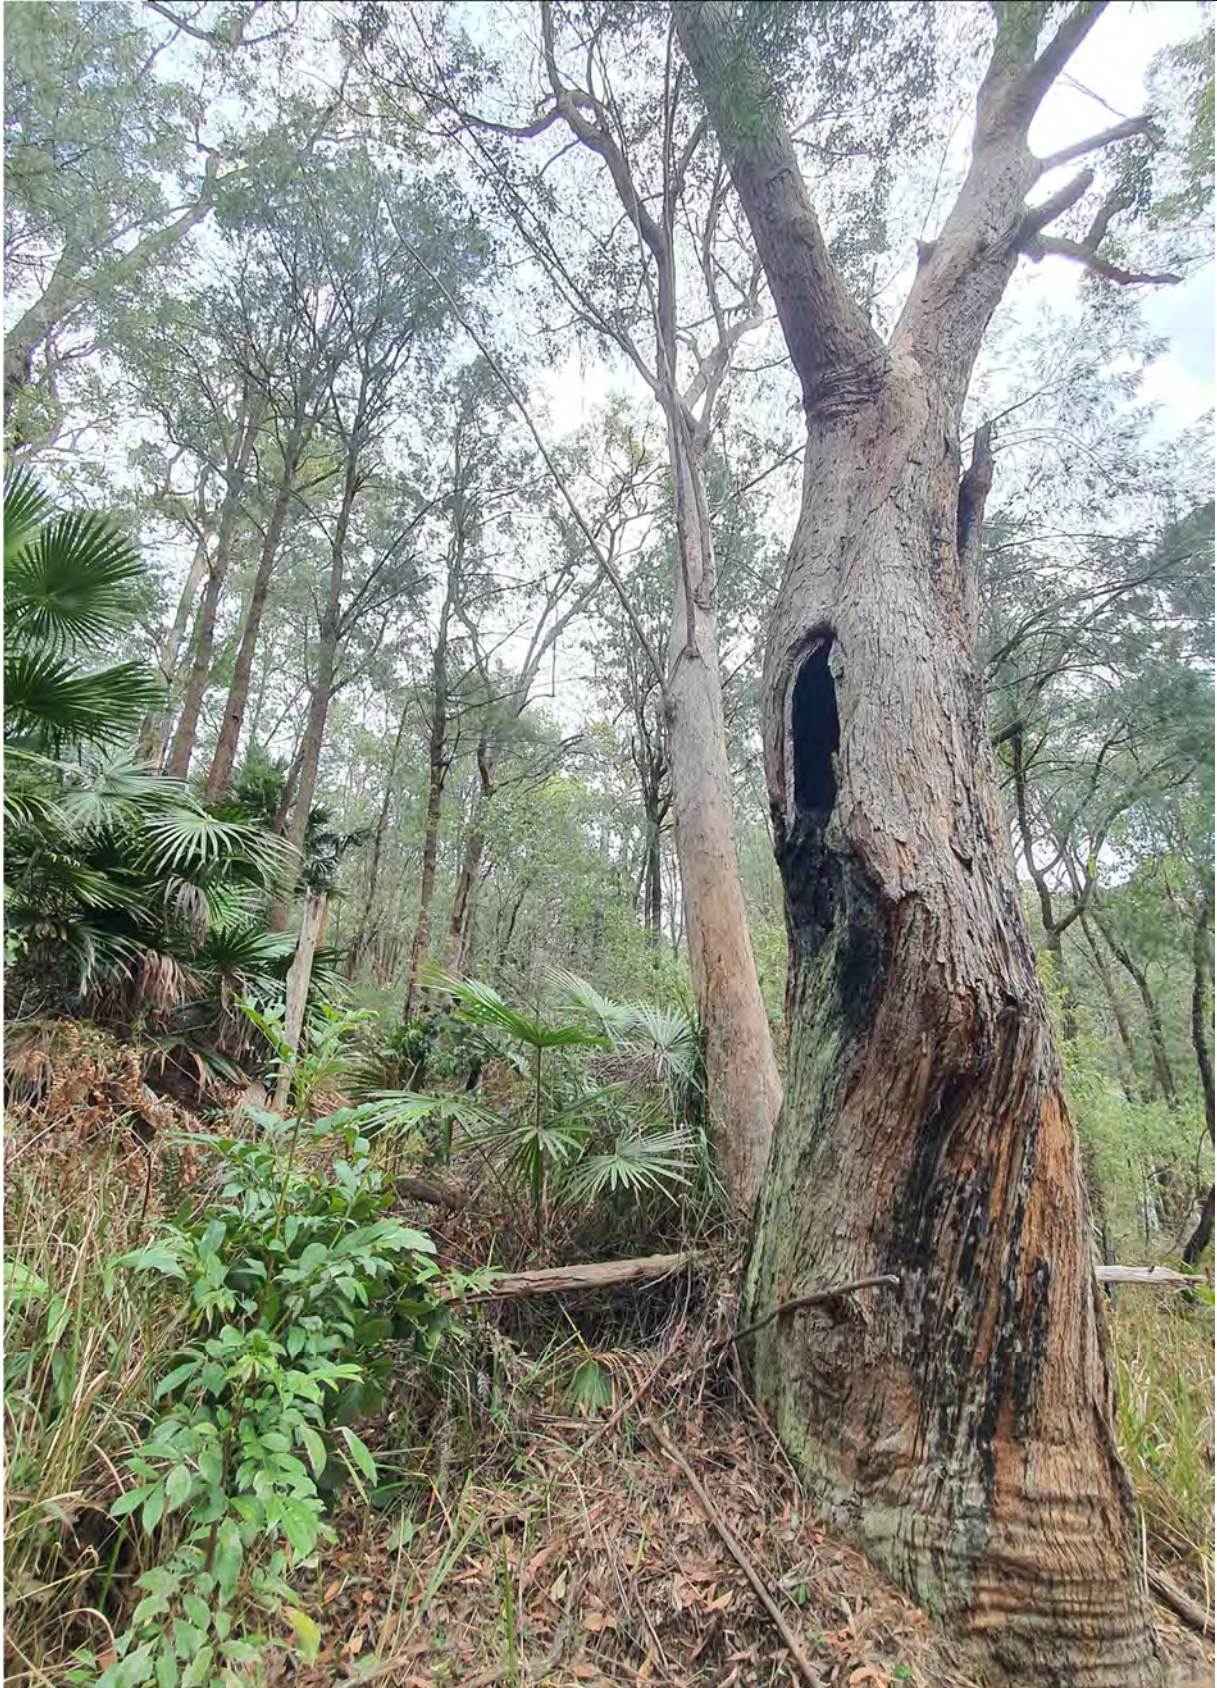
*Image 8: Tree 21 [right] with previous fire damage formed hollow.*
