Project name	2025_03_27_TotalSurveyingSolutions_22SuffolkAveCollaroy
Project date	27/03/2025
Job End Date	27/03/2025

Pipe Asset ID	SPI06733	US MH	SPP00202
Suburb	Collaroy	DS MH	SPP0002
Address/Location	22 Suffolk Avenue	Dia/Height [mm]	300
Inspected Length [m]	31.4	Material	Concrete reinforced

Section Inspection - 27/03/2025 - SPI06733

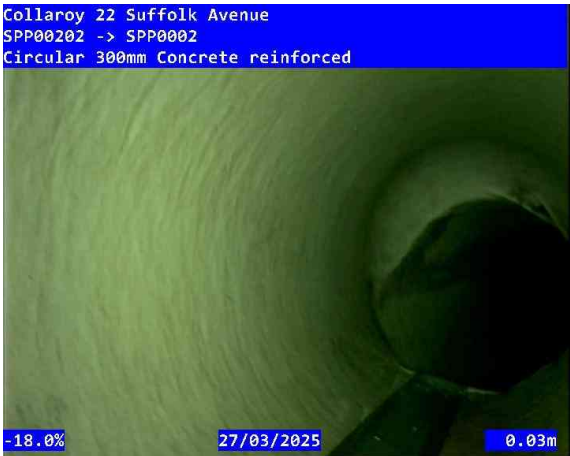
1, 00:00:47, 0.00  
Point repair, injected sealing material, length: 1000mm from 12 o'clock to 12 o'clock

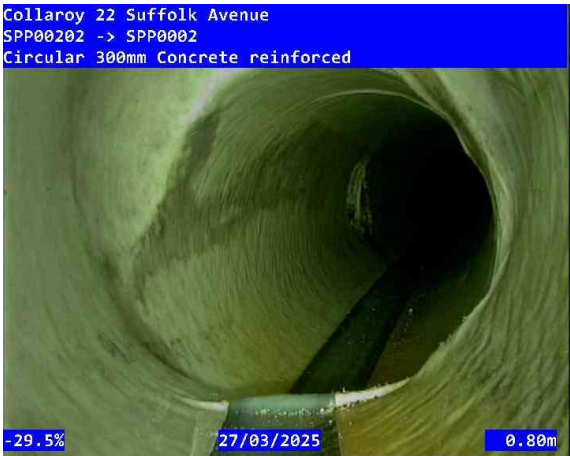
2, 00:02:24, 0.80  
Horizontal deformation, change in diameter: 20% at 5 o'clock

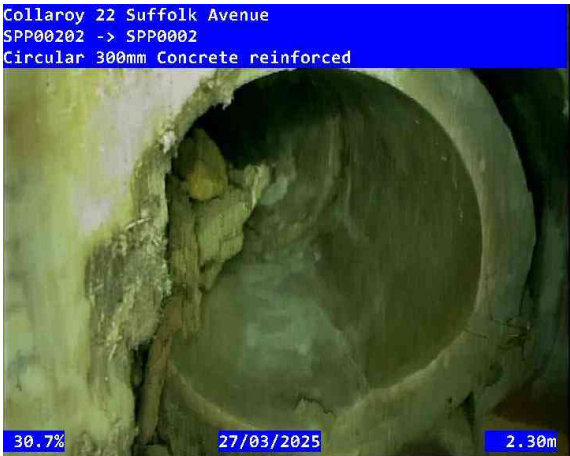
3, 00:03:28, 2.30  
Connection, lined, connection appears to be open,  
Height/Diameter (mm): 150 at 9 o'clock / Possible Pit  
SPP19823

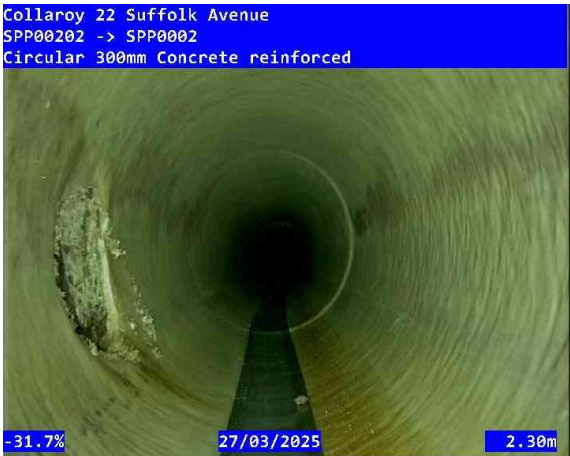
4, 00:03:28, 2.30  
Connection, lined, connection appears to be open,  
Height/Diameter (mm): 150 at 9 o'clock / Possible Pit  
SPP19823

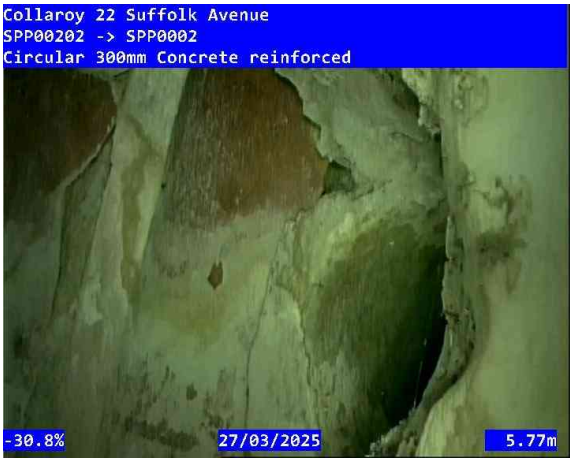
5, 00:04:45, 5.75  
Connection, lined, connection appears to be open,  
Height/Diameter (mm): 150 at 1 o'clock / Possible pit  
SPP19824

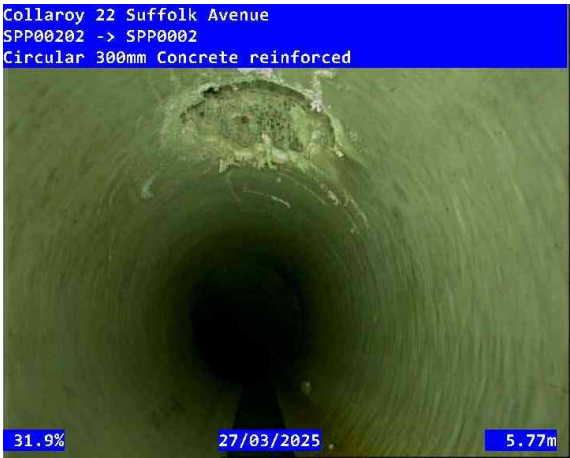
6, 00:04:45, 5.75  
Connection, lined, connection appears to be open,  
Height/Diameter (mm): 150 at 1 o'clock / Possible pit  
SPP19824

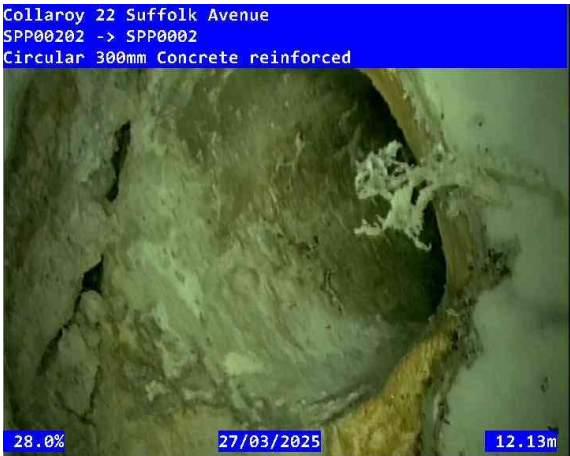
7, 00:06:21, 12.10  
Connection, unlined, connection appears to be open,  
Height/Diameter (mm): 150 at 12 o'clock

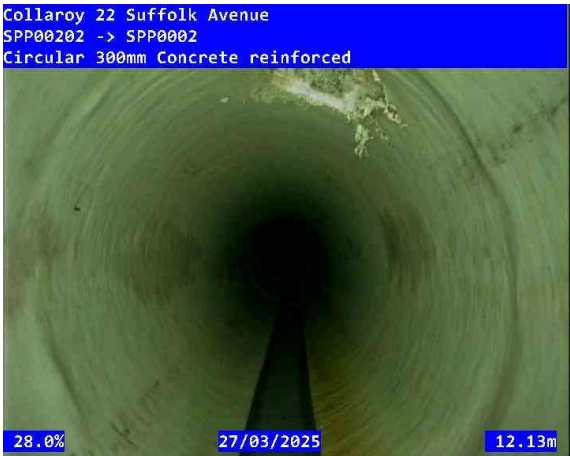
8, 00:06:21, 12.10  
Connection, unlined, connection appears to be open,  
Height/Diameter (mm): 150 at 12 o'clock

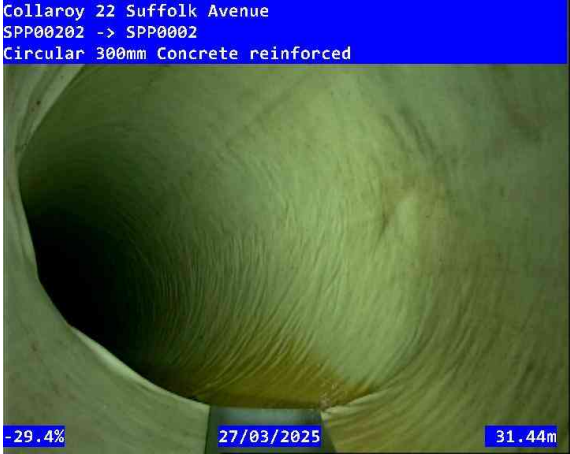
9, 00:10:52, 31.44  
Inspection (survey) abandoned, obstruction / Pipe is to steep for  
CCTV Crawler

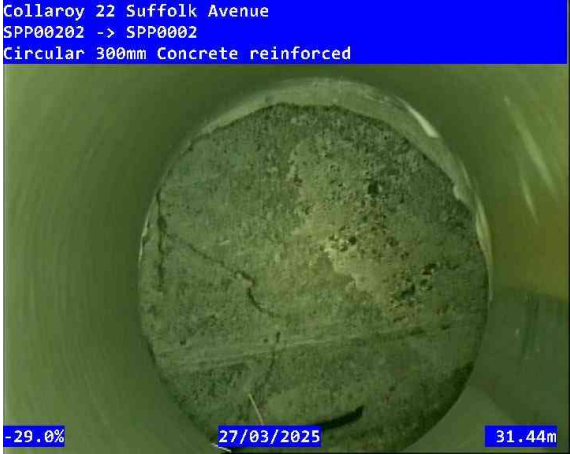
10, 00:10:52, 31.44  
Inspection (survey) abandoned, obstruction / Pipe is to steep for  
CCTV Crawler
