# Geotechnical Assessment

**Project:** New Dwellings  
33 Undercliff Road, Freshwater NSW

**Ref:** AG 24530  
29 November 2024

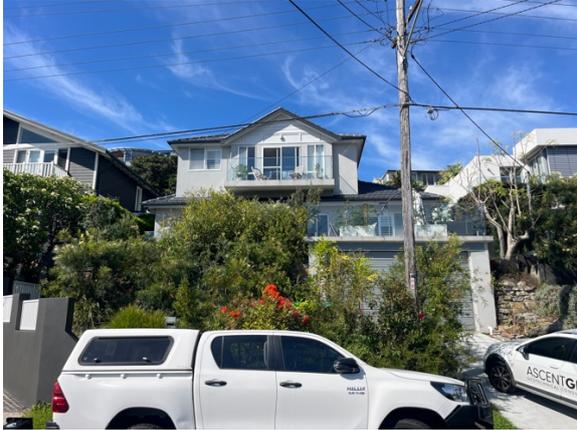
**Photo 1:** Residence frontage

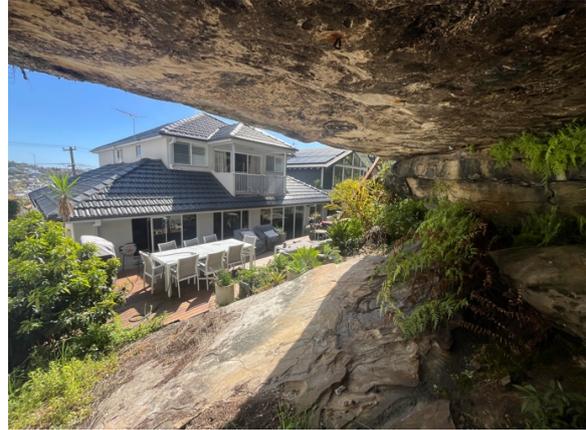
**Photo 2:** Residence rear

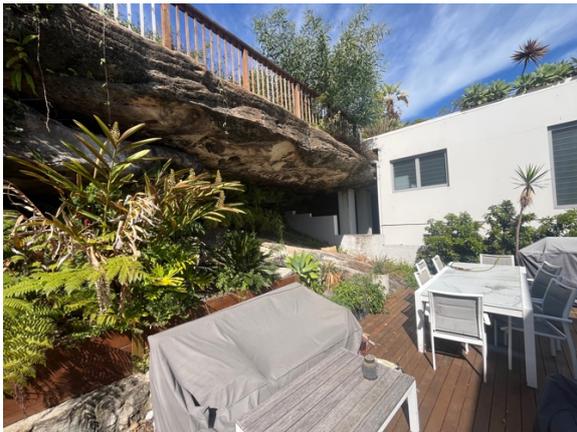
The sandstone escarpment in the rear yard of the site is ~4m high and extends into adjoining properties to the east and west. The escarpment is undercut on the western side of the block. The undercut is ~6m deep at its maximum depth, the overburden is ~0.8m thick. The overburden is a massive bed, with no significant horizontal defects. There are fine but persistent vertical joints within the overburden spaced ~4-5m apart, these joints are visible on the face and underside of the overburden but could not be identified on the top side of the overburden. The undercut section of rock extends into the adjoining property to the west where it has been supported by two concrete columns that are in good condition. There is a fine vertical joint within the overburden located on, or just outside, the western boundary of the subject site. The eastern portion of the escarpment contains 'blocky' jointing and sections of the bedrock are partially detached from the underlying competent rock, no fully detached blocks were identified. A complete assessment of the escarpment within the subject site was partially obscured by vegetation and the existing timber staircase.

**Photo 3:** Undercut sandstone escarpment in the rear yard.

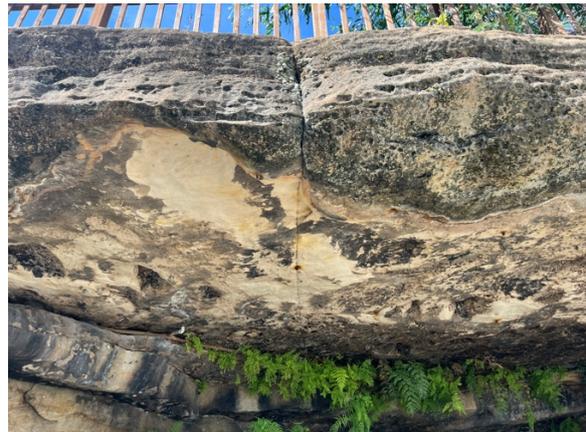
**Photo 4:** Example of fine vertical jointing in the over hanging bedrock

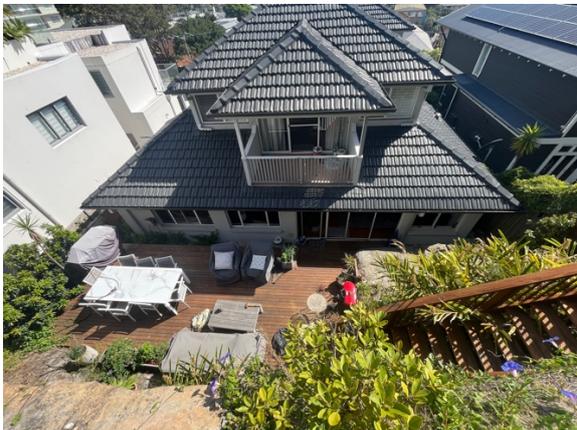
**Photo 5:** Rear of the residence

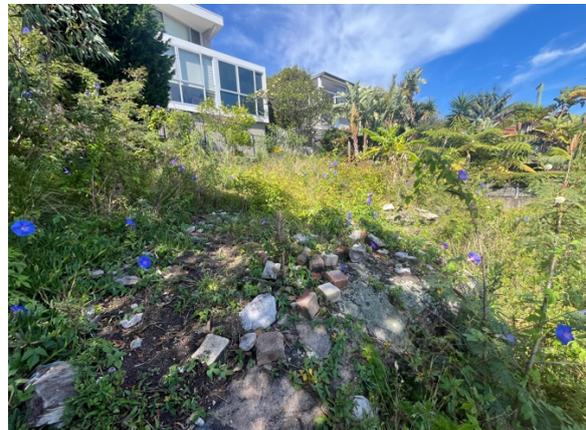
Normal seepage was observed through bedding defects in the escarpment. Materials on the slope above the escarpment are rocky fill materials. Bedrock is outcropping and generally shallow in area at the rear of the site above the escarpment. Sandstone bedrock is also outcropping at the south-eastern corner of the house, in a subfloor space under the north-western side of the house and in areas near the street frontage.

**Photo 6:** Area above the escarpment, looking towards rear boundary.
