REPORT ON GEOTECHNICAL SITE INVESTIGATION

PROPOSED ALTERATIONS AND ADDITIONS

48 THE SERPENTINE, BILGOLA BEACH, NSW

Project No.: 2019-065

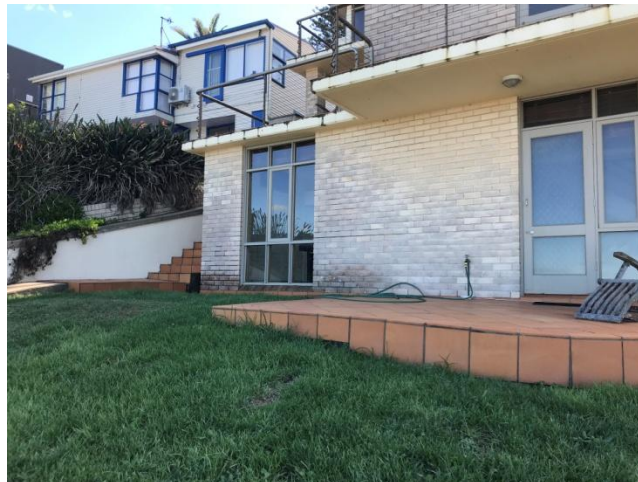
Photograph 2: View of the rear of the existing residence

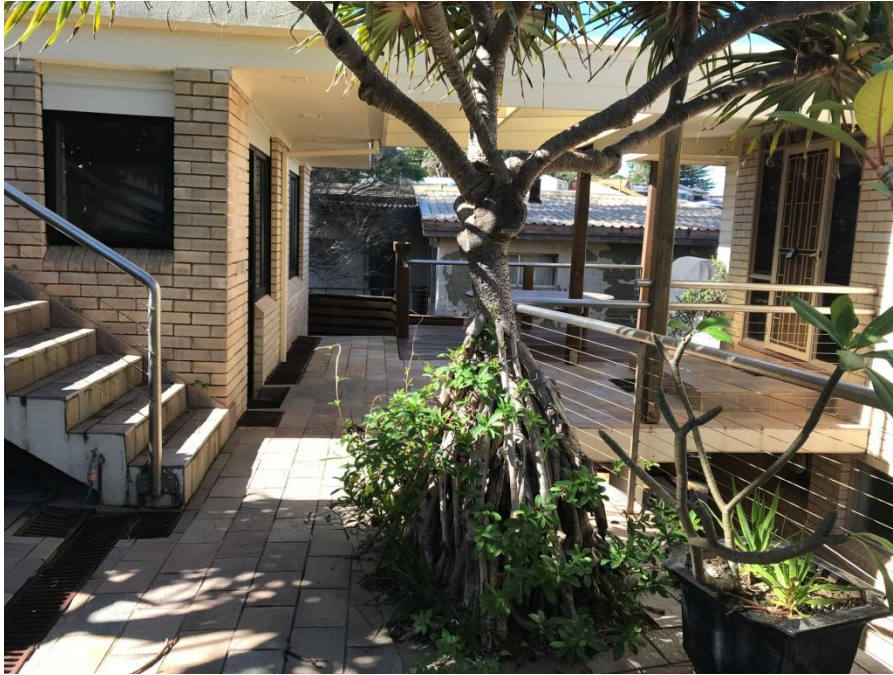
Photograph 3: View of the rumpus rooms (left) and main entrance of site property from the upper patio level.

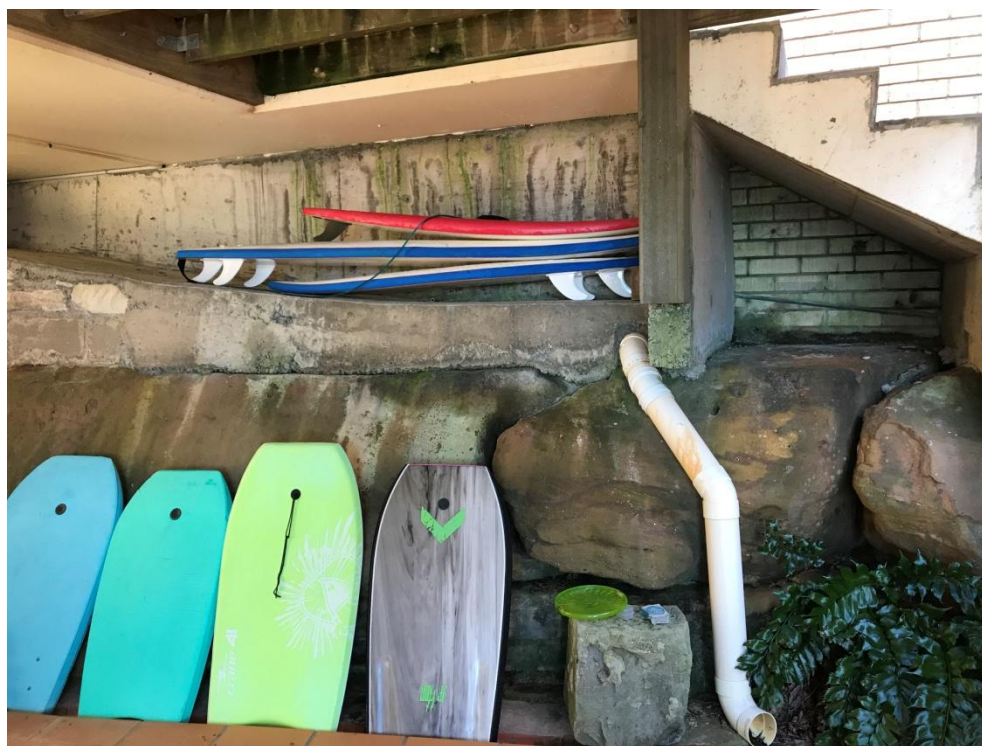
The southern wall of the rumpus room can be seen extending to the top of the bedrock exposure. The exposure comprised medium strength sandstone with sub-horizontal defects and was also visible in outcrop within the neighbouring property to the east.

Photograph 4: View of the bedrock expose observed from the lower patio level.

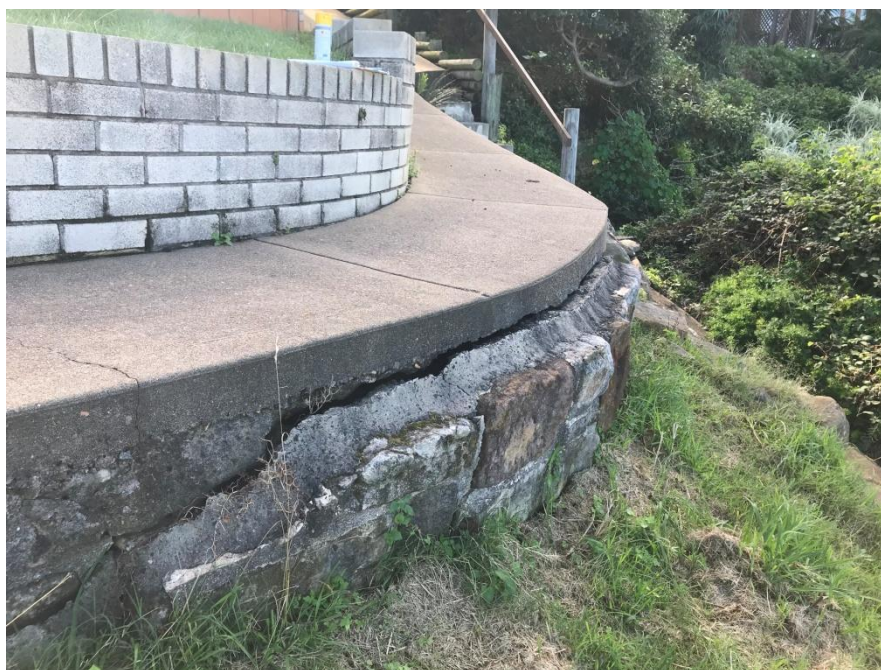
At the rear of the property a grassed area/patio with access pathway is supported by mortared/dry stone sandstone block and brickwork retaining walls. The retaining walls are typically less than 1m in height and (particularly the mortared sandstone wall), displayed signs of distress and is shown in Photograph 5.

Photograph 5: View of the mortared sandstone retaining wall in the rear of the property.

The site investigation did not identify any signs of previous or impending major, deep seated landslip instability within the site and there were no landslip hazards identified within the neighbouring properties. An existing retaining wall within the rear of the property was showing signs of distress and would be expected to continue to rotate however it is not considered a landslip hazard.
