Arboricultural Impact Assessment

**Prepared for Construct by Design
Site Address: 27 Bellevue Avenue Avalon**

3rd September 2020, 25th February 2021 Revision C

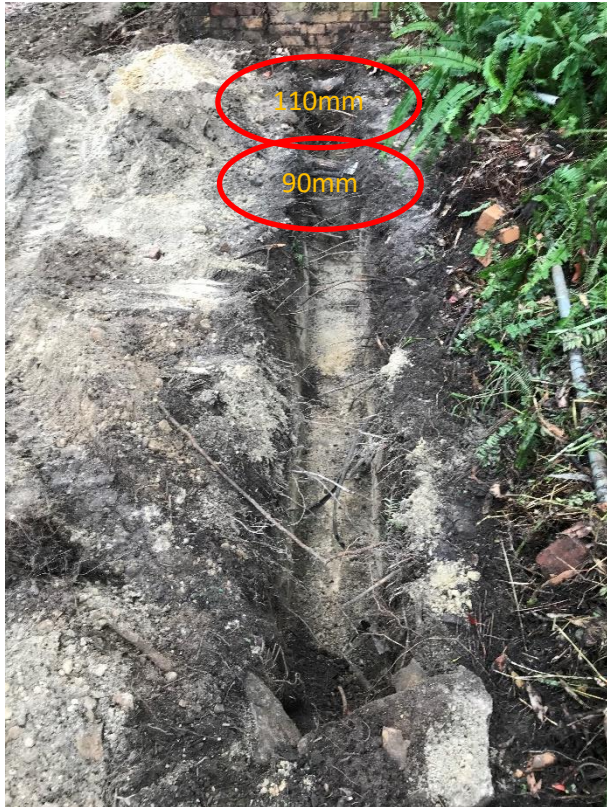
Of the remaining 37 trees, trees 37, 42 and 43 are in the neighbouring property of 29 Bellevue Avenue Avalon. There is no impact projected for trees 42 and 43. The encroachment as calculated from AS 4970-2007 to tree 37 is 18%. To provide an indication of the potential tree roots severed for this development a trench 700mm deep was excavated beside tree 37. Three tree roots 40mm, 90mm and 110mm were located. See section 6.2 for a plan of excavation. Because of the size of these tree roots the impact if these were to be removed is closer to 10% compared to the calculated 18% incursion. The hardy nature of this tree species is well known and was shown to be one of the top performing trees planted in Hong Kong during forest rehabilitation programs (Corlett, 1999). Proposed works within the TPZ of tree 37 comply with AS 4970-2009. See figures 2 and 3 below.

Figure 3 Trench looking west 2 tree roots

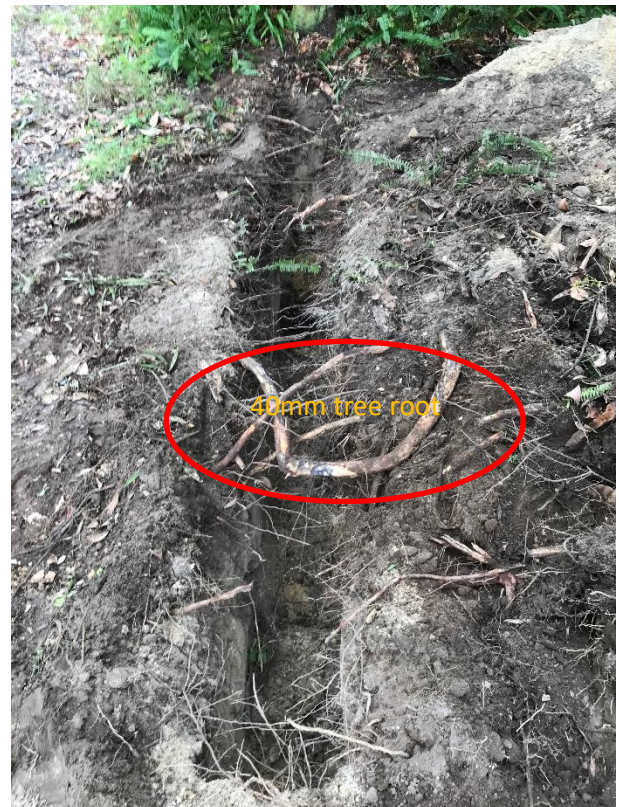
Figure 2 40mm tree root located within trench

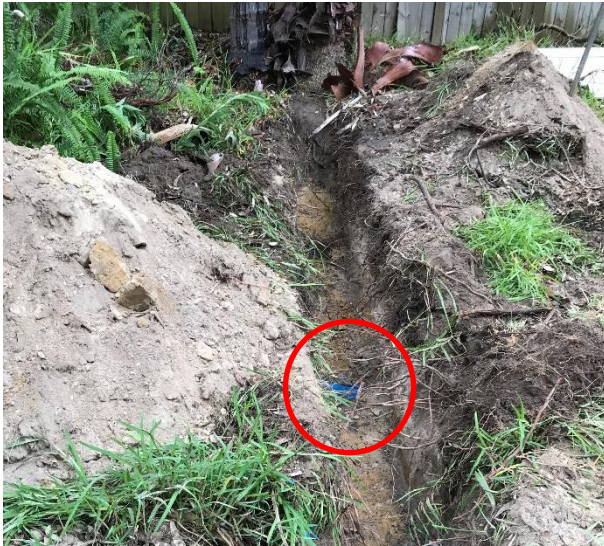
The proposed new driveway/crossover is at a similar level to the existing driveway and hence will have a minimal impact. The proposed driveway on the property to the north of the tree occupies approximately 10% of the TPZ. A tree root survey was conducted to determine the impact of the proposed driveway as it curved around the TPZ. One tree root 110mm root was identified. See figure 4 below. To install the driveway in this location it would involve severing this tree root. The projected impact to the TPZ is less than 10%.

Figure 4 Tree roots 110 & 120mm found 4 metres from tree 21

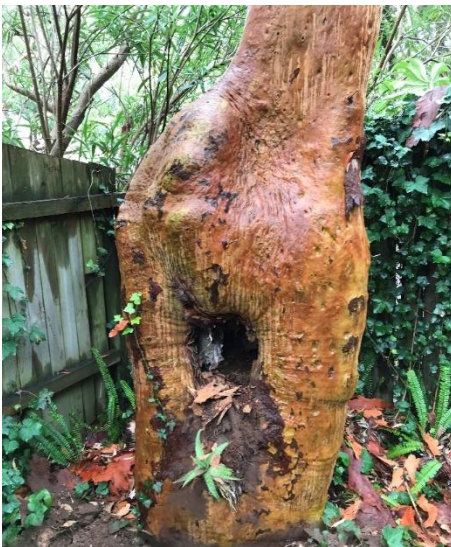
Tree 16 is experiencing dieback; the tree has a significantly large hollow trunk with decay. The significant swelling of the trunk often indicates extensive internal decay. See figure 5 below.

Figure 5 Tree 16 hollow and decay

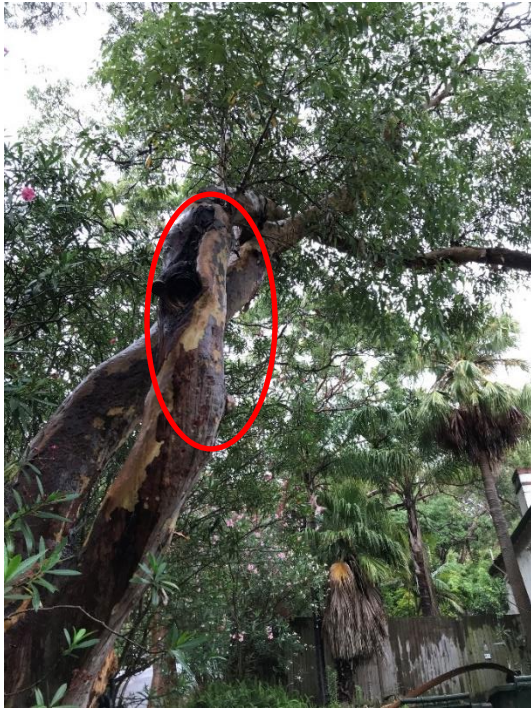
Tree 22 has a large bracket fungus in one of the trunks of the tree, swelling is evident. Pruning would reduce the risk; however, the resulting tree would be severely unbalanced and would be prone to limb drop due to its weakened structure shown in figure 8. This tree should be removed irrespective of the proposed development. The tree may be of very high landscape use, however this irrelevant as the tree is of very low retention value due to this risk. The SULE rating for the tree was revised during the second assessment from <5 years to a hazard rating with no ULE (Useful Life Expectancy) remaining. See figures 6, 7 and 8 below.

Figure 7 Tree 22 Bracket fungus (*Phellinus* sp.)

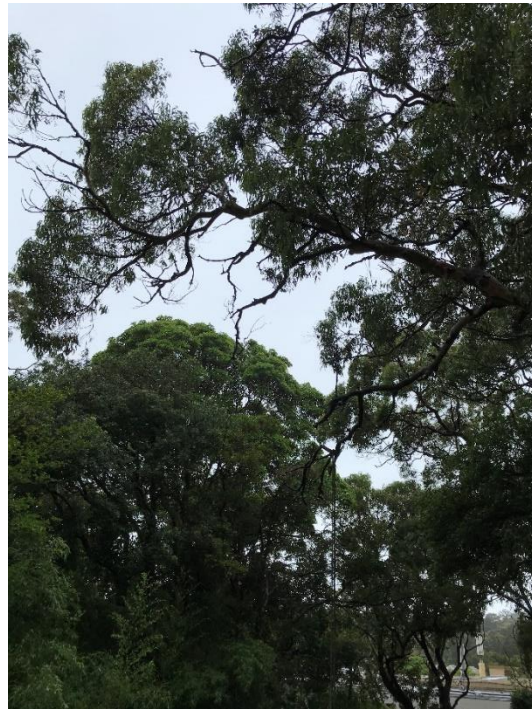
Figure 6 Significant dieback on tree 22

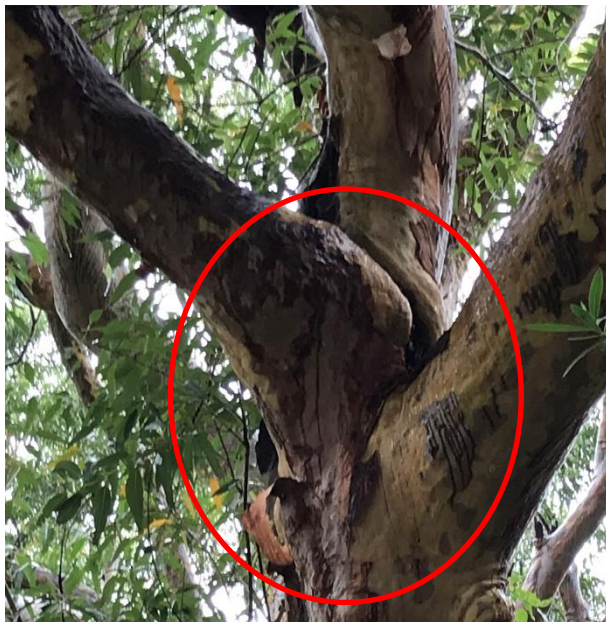
Figure 8 Weakened branch structure, rubbing branches.

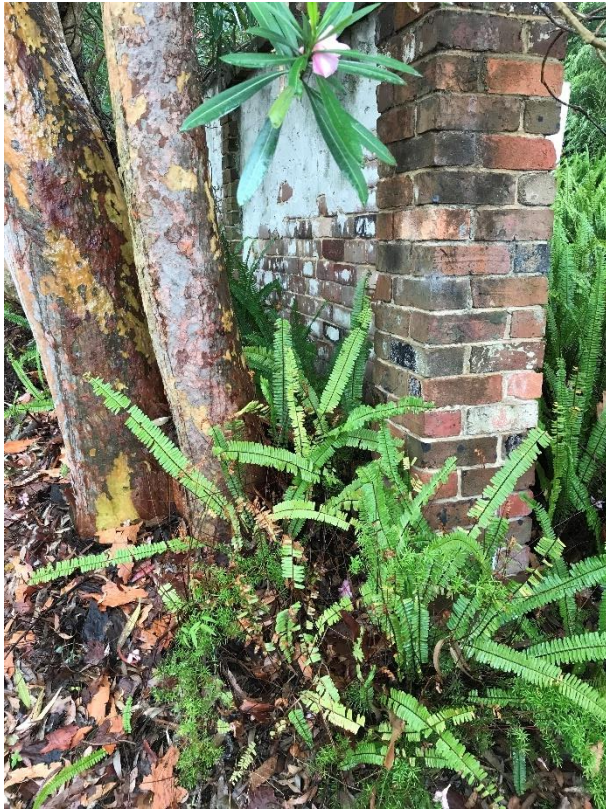
Figure 9 Masonry wall beside tree 29

An existing masonry wall is located on the boundary beside trees 27, 28 and 29. A tree root survey was conducted to determine extent of root growth, particularly from tree 29. The trench was excavated beyond the wall to the west. No tree roots of significance were located. The masonry wall is acting as a tree root barrier and preventing tree roots from trees 27, 28 and 29 entering the property of 27 Bellevue Pde Avalon. Any proposed works inside of the existing masonry wall will not affect trees 27, 28 and 29. See figures 9, 10 and 11 below.

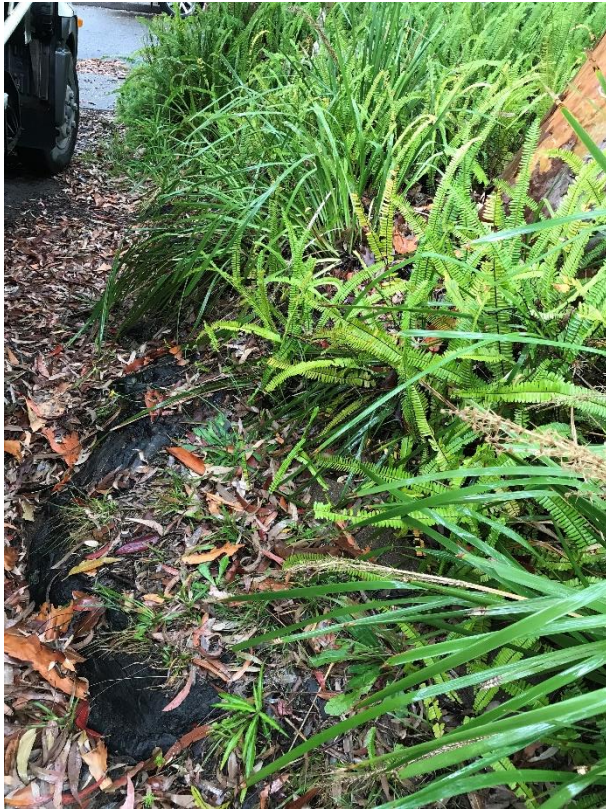
Tree 31 appears to be in fair health; however, the exposed root system looks to have been severed many years prior for the existing lower driveway entry. The structural root system is decaying, and the tree is prone to whole tree failure. Sydney Red Gums that fail in strong winds often have decay of anchor roots. This tree is structurally unsound and should be removed. Moore (2014) identified that a decaying lateral root system was present in most trees assessed subject to windthrow. See figures 12 and 13 below.

Figure 13 Decaying tree roots within the SRZ

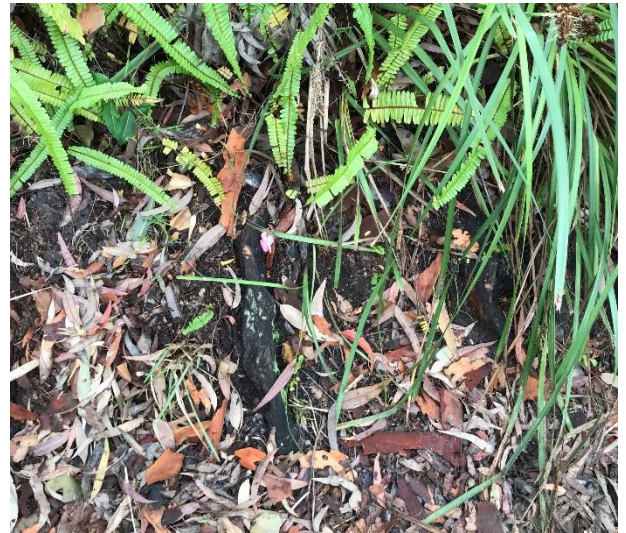
Figure 12 Decaying tree roots from tree 31

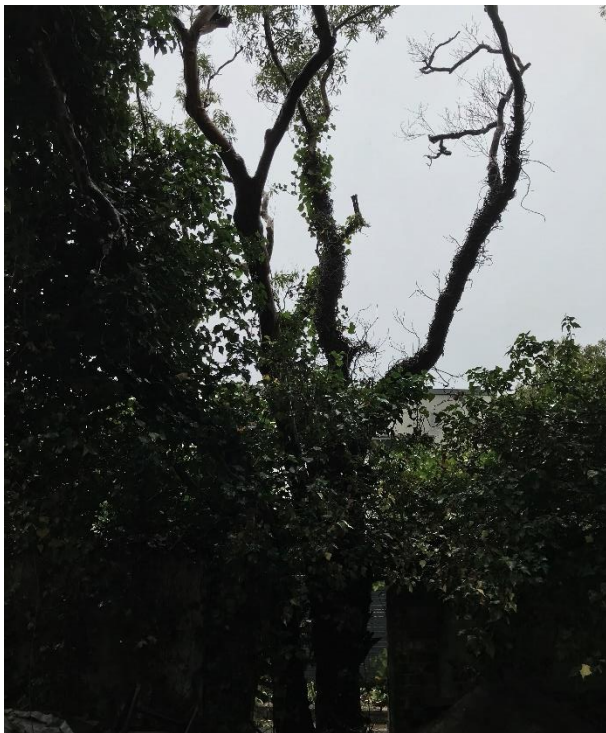
Tree 32 is in poor health; the tree is dying. This tree is likely to die within the next 5 years. Removal is recommended. See figure 14 below.

Figure 14 Tree 32, almost dead and not worthy of retention

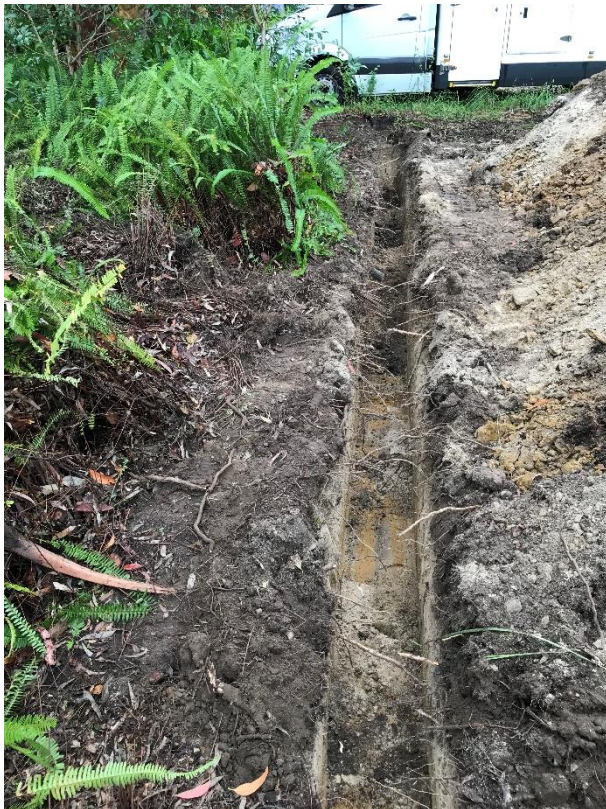
Figure 16 Trench beside tree 26 looking west

No tree roots greater than 10mm were found in the trench beside tree 26. The proposed excavation required for the basement and concrete slab construction for the first floor (eastern building) will not impact this tree. The proposed suspended slab of the first floor to reduce the impact to tree 26 is not required as there are no tree roots of significance in this area. The proposed suspended concrete slab for the western building must be retained. See figures 15, 16 and 17 below.

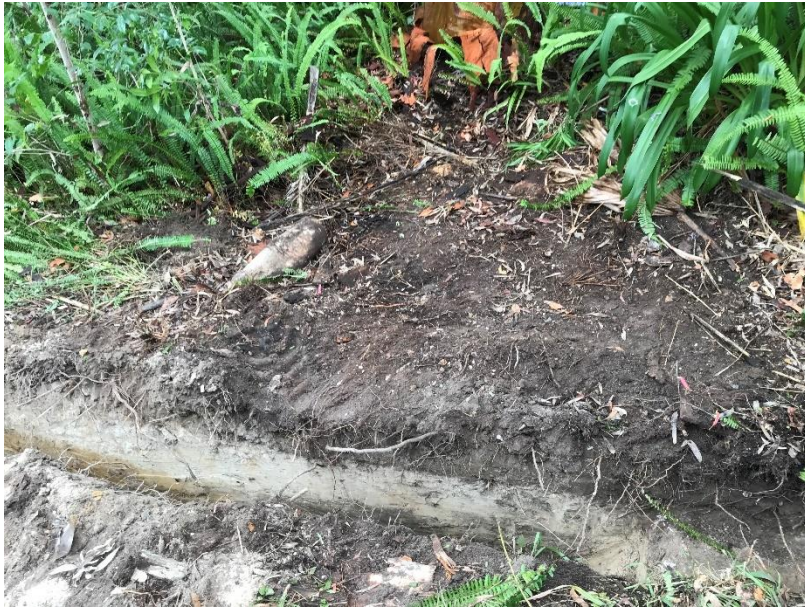
Figure 17 Face of trench beside tree 26, no roots encountered.

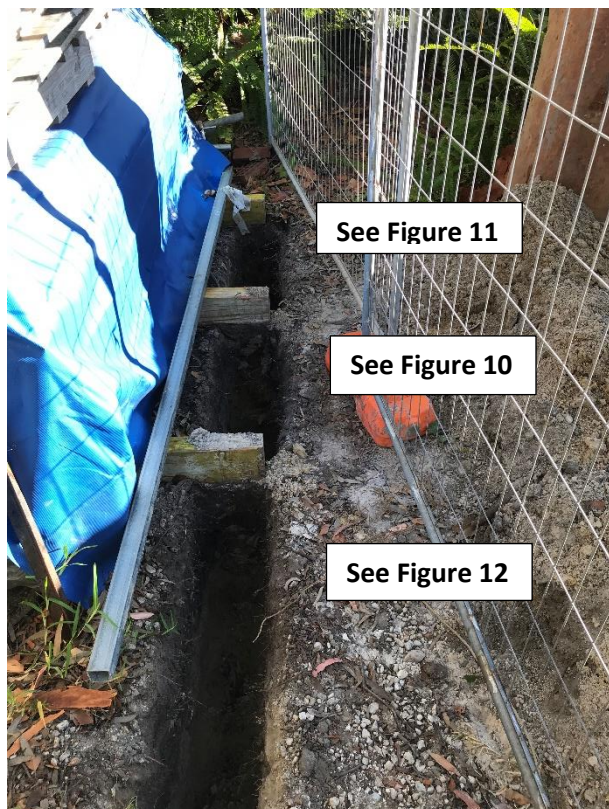
Figure 18 Trench beside tree 33

A root survey was also conducted beside tree 33 to identify what tree roots may be severed. A trench was hand excavated 700mm deep to heavily compacted sand, 3 metres from the northern boundary and 2.7 metres from the eastern boundary. The trench was 3 metres long. The location of this trench allows for over excavation to construct the basement. See section 6.2.

One tree root 20mm was located, no other significant tree roots were encountered. See figure 11

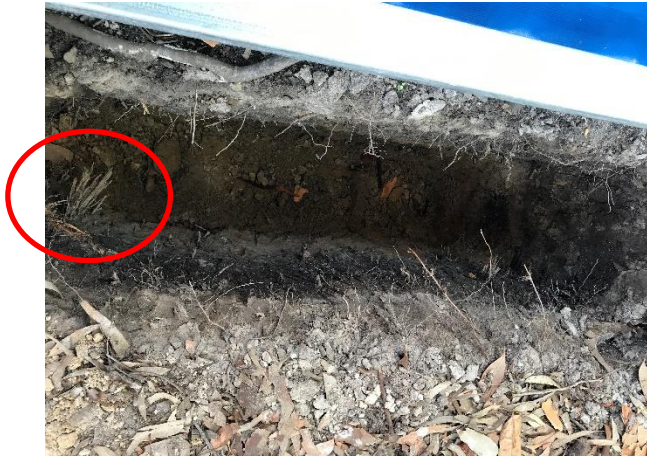
Figure 20 Northern section, 20mm tree root located.
