Report Title: Geotechnical Report <u>16 Cabarita Road, Avalon</u>
Report Date: <u>15/6/20</u>
Author: <u>BEN WHITE</u>
Author's Company/Organisation: <u>WHITE GEOTECHNICAL GROUP PTY LTD</u>

GEOTECHNICAL INVESTIGATION:

New Inclined Lifts at 16 Cabarita Road, Avalon

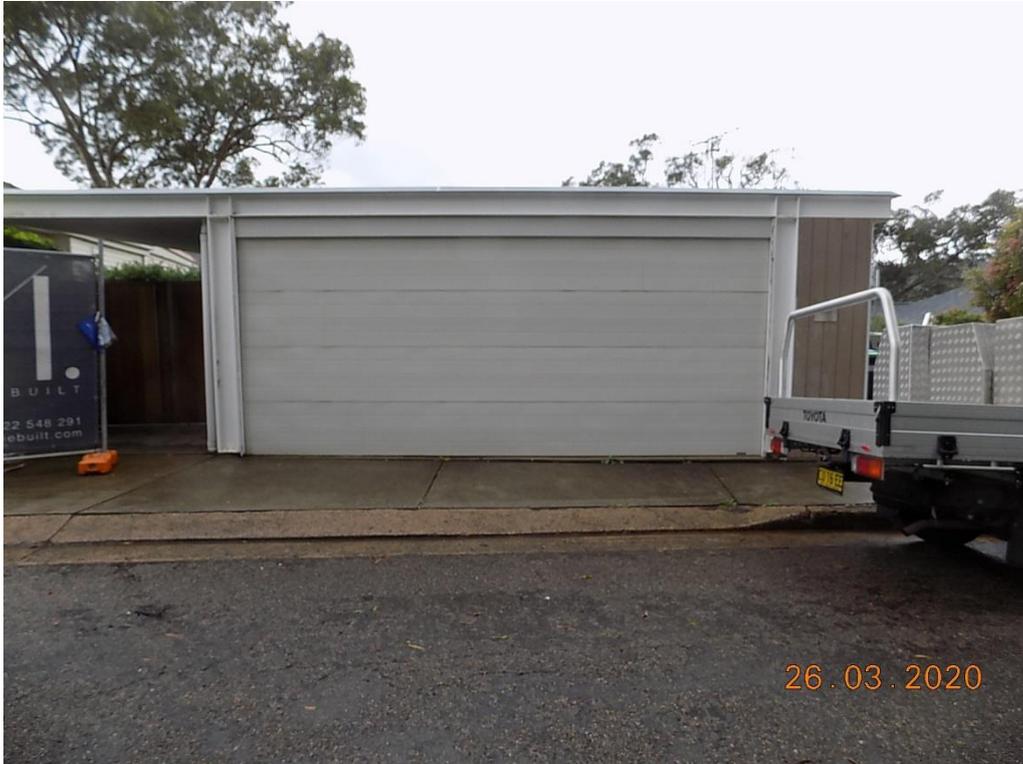
Photo 1

2.3 At the road frontage, a concrete driveway runs to a stable garage along the upper boundary of the property (Photo 1). On the downhill side of the garage, an excavation has been made into the slope for a level lawn above the house (Photo 2). The excavation is supported by rendered masonry retaining walls that appear well constructed (Photo 3). The one and two storey clad house displays no significant signs of movement in the external supporting walls (Photo 4). Construction work was currently underway on the downhill side of the property for a separate DA. This slope contains some embedded boulders (Photo 5). Most of the boulders appear to be sitting in stable positions. One of the boulders immediately above the near

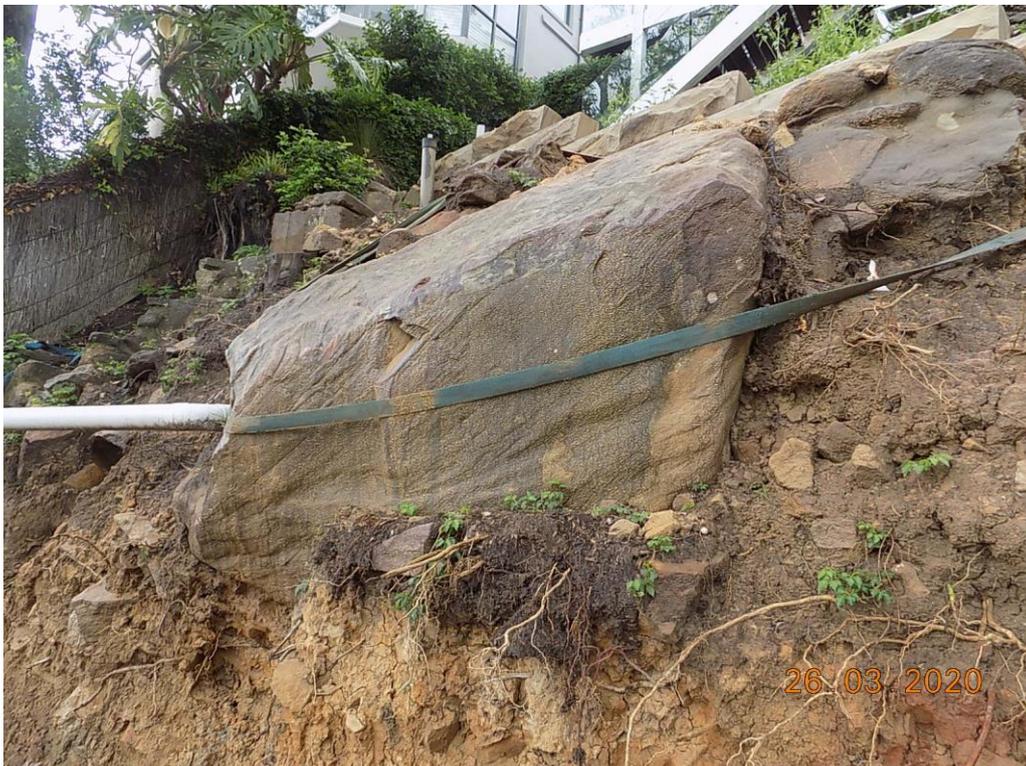
Photo 6

completed boatshed appeared to have been slightly undercut and was held in place by a strap tied back into the slope above (Photo 6). The builder on site confirmed that the boatshed would have a green roof and would be backfilled to at least 100mm above the base of the boulder. The backfill would consist of gravel. This is considered appropriate to ensure the stability of the boulder into the future. Below the property, a jetty extends into Pittwater (Photo 7).

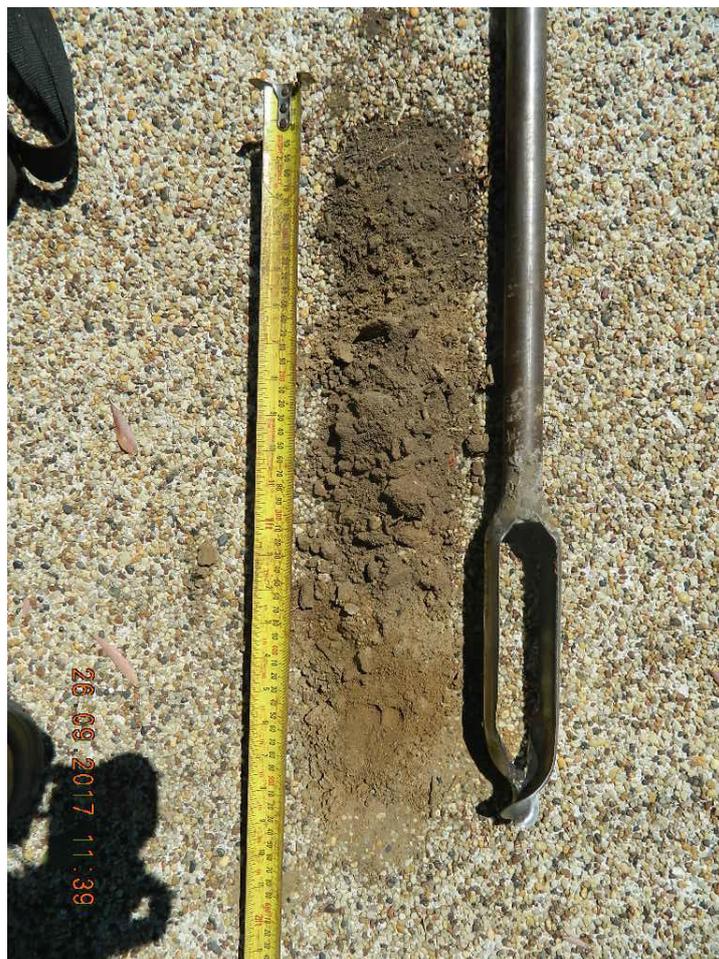
AUGER HOLE 1 (~RL3.0) – AH1 (Photo 8)

Depth (m)	Material Encountered
0.0 to 0.2	TOPSOIL , black/dark brown, loose, dry.
0.2 to 0.5	CLAYEY SAND , dark brown, medium dense, dry.

Refusal on rock @ 0.5m. Estimated to be a sandstone floater. No watertable encountered.

Photo 8: AH1 – Downhole is from top to bottom

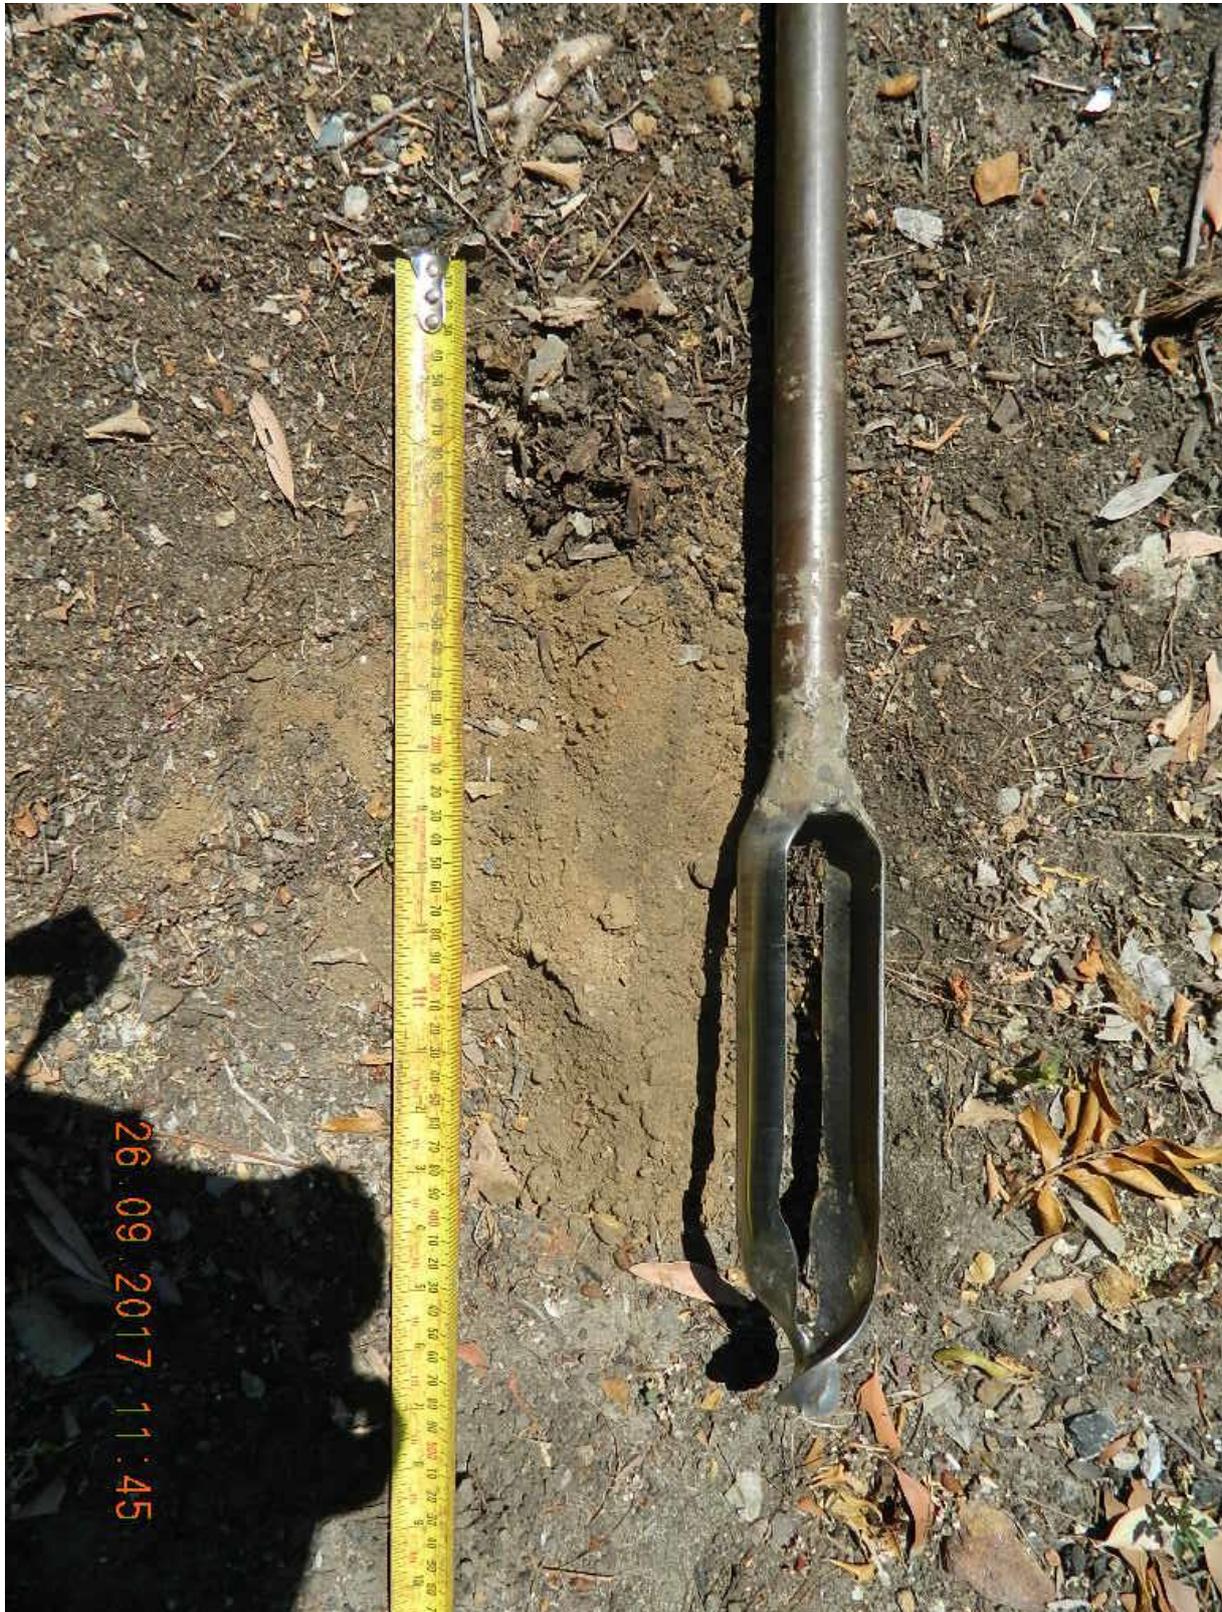
AUGER HOLE 2 (~RL5.0) – AH2 (Photo 9)

Depth (m)	Material Encountered
0.0 to 0.1	MULCH , woodchips, dry.
0.1 to 0.4	CLAYEY SAND , dark brown, medium dense, dry.

Refusal on rock @ 0.4m. Estimated to be a sandstone floater. No watertable encountered.

Photo 9: AH2 – Downhole is from top to bottom

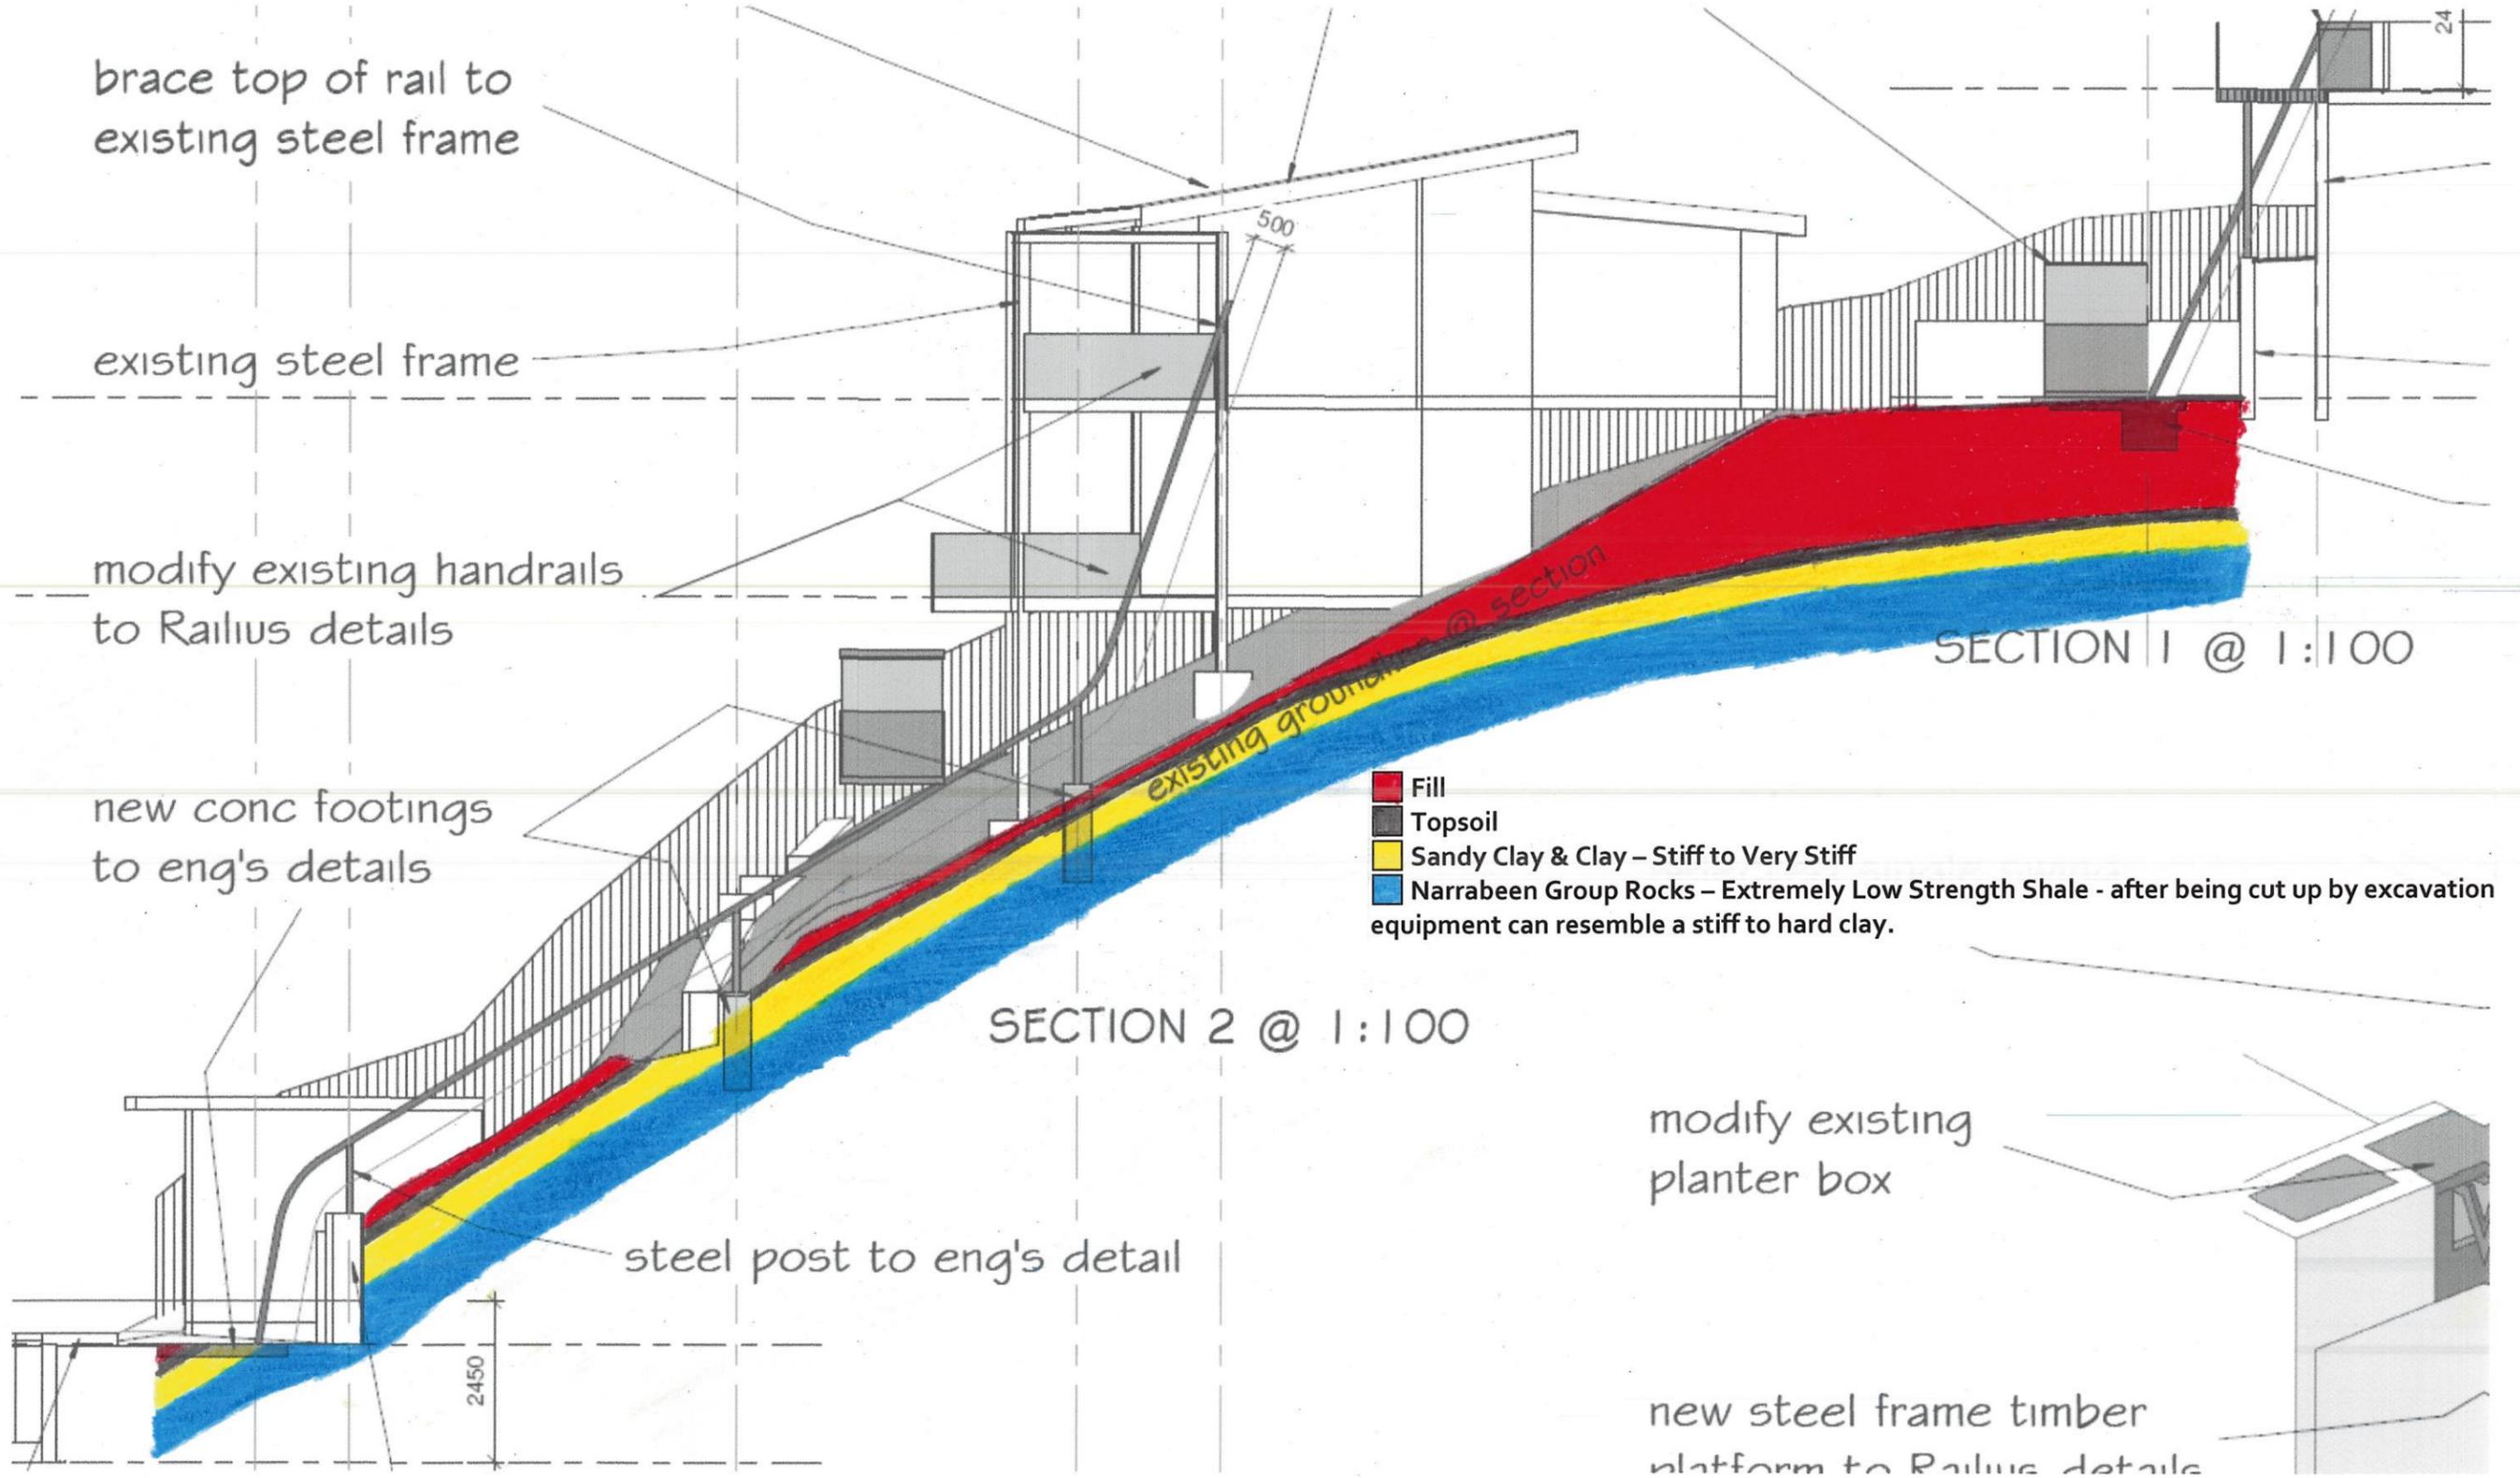
TYPE SECTION – Diagrammatical Interpretation of expected Ground Materials

The slope materials are colluvial at the near surface and residual at depth. They consist of a thin sandy topsoil over a medium dense clayey sand that is underlain by a stiff to very stiff sandy clays and clays with rock fragments throughout the profile. In the location of the proposed upper inclined lift on the uphill side of the property, the clays merge into the weathered zone of the underlying shale at an average depth of ~2.4m below the current surface. Across the downhill side of the property, the clays merge into the weathered zone of the underlying shale at an average depth of ~1.0m below the current surface. It should be noted that sandstone floaters are expected throughout the profile. The weathered zone of the underlying rock is interpreted as Extremely Low Strength Shale. It is to be noted that this material is a soft rock and can appear as a mottled stiff clay when it is cut up by excavation equipment. See Type Section attached for a diagrammatical representation of the expected ground materials.
