# ARBORICULTURAL ASSESSMENT REPORT

# WESTFIELD WARRINGAH STORMWATER & SEWER RE-ALIGNMENT Near Condamine Street

**Scentre Group**

Prepared by: Ross Jackson

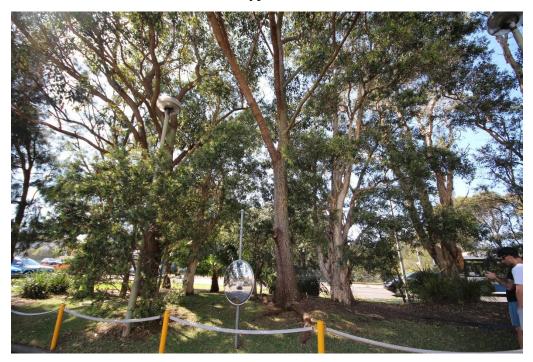
Photo of trees 21, 22, 23, 24 & 25 – typical trees for removal

- 1. The removal of the following trees as part of the sewer re-alignment along the Condamine Street side of the Site: Trees 15, 18, 19, 20, 21, 22, 23, 24, 25, 26, 27, 28, 29, 30, 31, 32, 33, 34, 35, 36, 37, 38, 39, 40, 41, 42, 43, 44, 45, 46, 47, 48, 49, 50, 51, 52, 53, 54, 55, 56, 57 & 58;

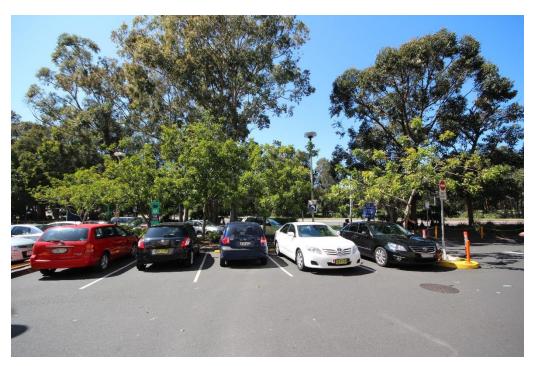
Photo of trees 61, 62, 63 & 64 – typical trees for retention

- 2. The following trees can be retained: Trees 58A, 59, 60, 60A, 61, 62, 63, 64, 66, 67 & 68;
- 3. Approval to remove these trees shall be obtained from Warringah Council as these trees are covered by their Tree Preservation Orders;
