## **Arboricultural Impact Assessment Report**

<b><u>Client Name:</u></b>	Bill Derrin
<b><u>Site Address:</u></b>	35 Moore Road Freshwater NSW
<b><u>Authors Details:</u></b>	Hugh Millington
<b><u>Email:</u></b>	<a href="mailto:hugh@hughtheArborist.com.au">hugh@hughtheArborist.com.au</a>
<b><u>Phone:</u></b>	0426 836 701
<b><u>Date Prepared:</u></b>	20 <sup>th</sup> May 2025

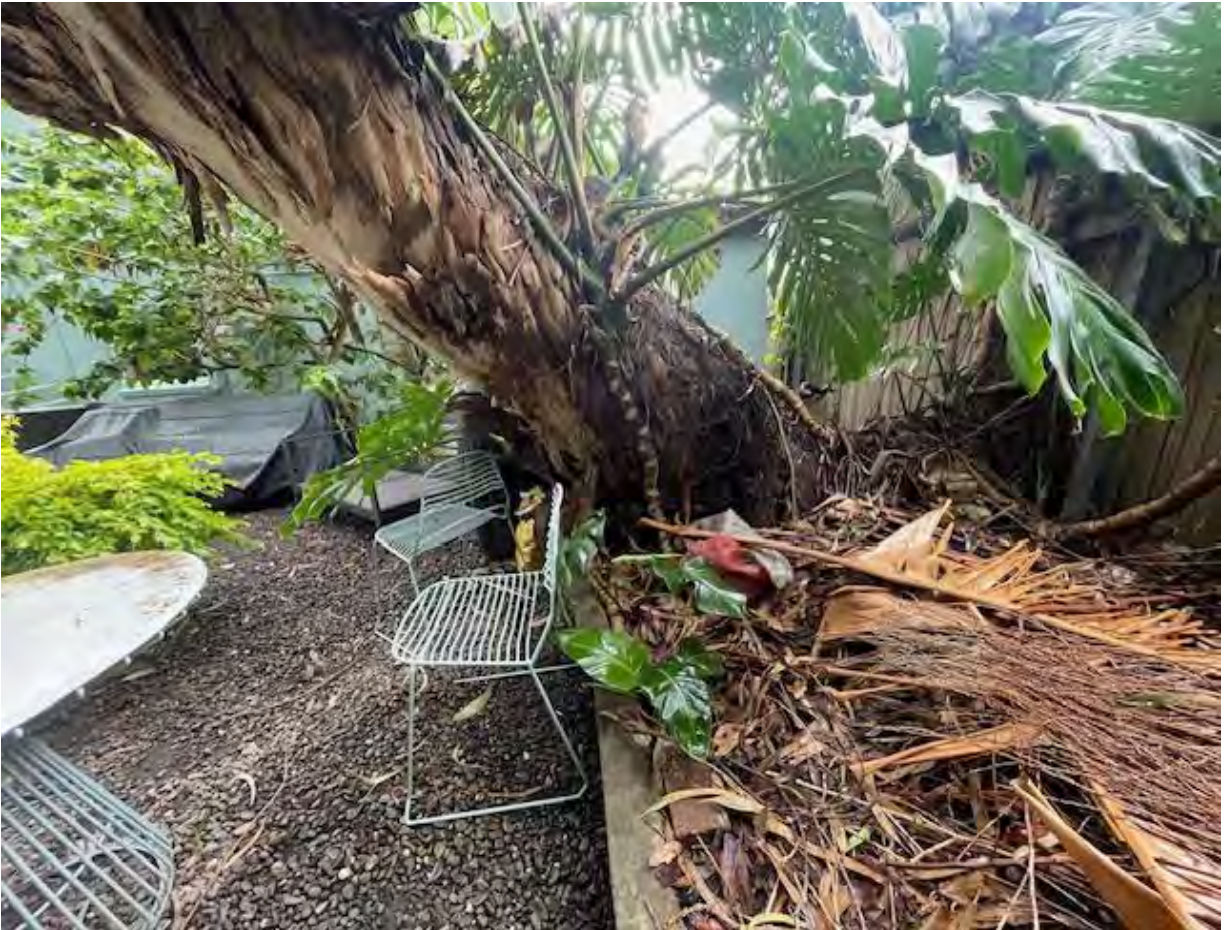
**Photo A:** Looking at the trunk of T10 from the northern side.

- 10.3 **Tree 10.** Following on from the discussion in section 7, the tree is observed to have a trunk lean of up to 55.8 degrees to the west. The canopy of the tree is also growing heavily towards the west with minimal growth on the eastern side. This is partly due to previous pruning but is also likely to be a response from the frontline salt conditions and wind exposure. The angle in which the tree is growing suggests a partial failure at its root plate. This may have occurred during the establishment period as a result of wind loading, poor root stock and planting techniques, or a combination of the three. It is also possible the tree is in the process of failing, noting it can take several years for trees to completely fail. A research Laboratory Technical Report by Thomas Smiley of Bartlett Tree Experts<sup>6</sup> titled 'Determining Change of Lean' explores and discusses the significance of leaning trees. The report states that trees with a lean greater than 45 degrees usually are considered to have a higher likelihood of failure. The report also states that there are other factors to consider with the lean such as restricted root growth and soil mounding which may increase the potential for failure. Referring this back to T10 and the photographs section, all three aspects are present indicating the tree has an increased likelihood for failure irrespective of the development. Other considerations that have been made are the weight of the canopy extending to the west and the lack of space available to the east for the tree to compensate for additional loading with root development. The results of the on site assessment and additional background investigation is that the tree has a short Safe Useful Life Expectancy of 3. Short b) which is defined as trees that could live more than 15 years but may be removed for safety or nuisance reasons. The tree has been allocated a corresponding Trees AZ retention value of Z10 which is defined as poor condition or location with a low potential for recovery or improvement. The tree is not considered to be a constraint to development on the provision its removal is offset with replacement planting as part of the development.

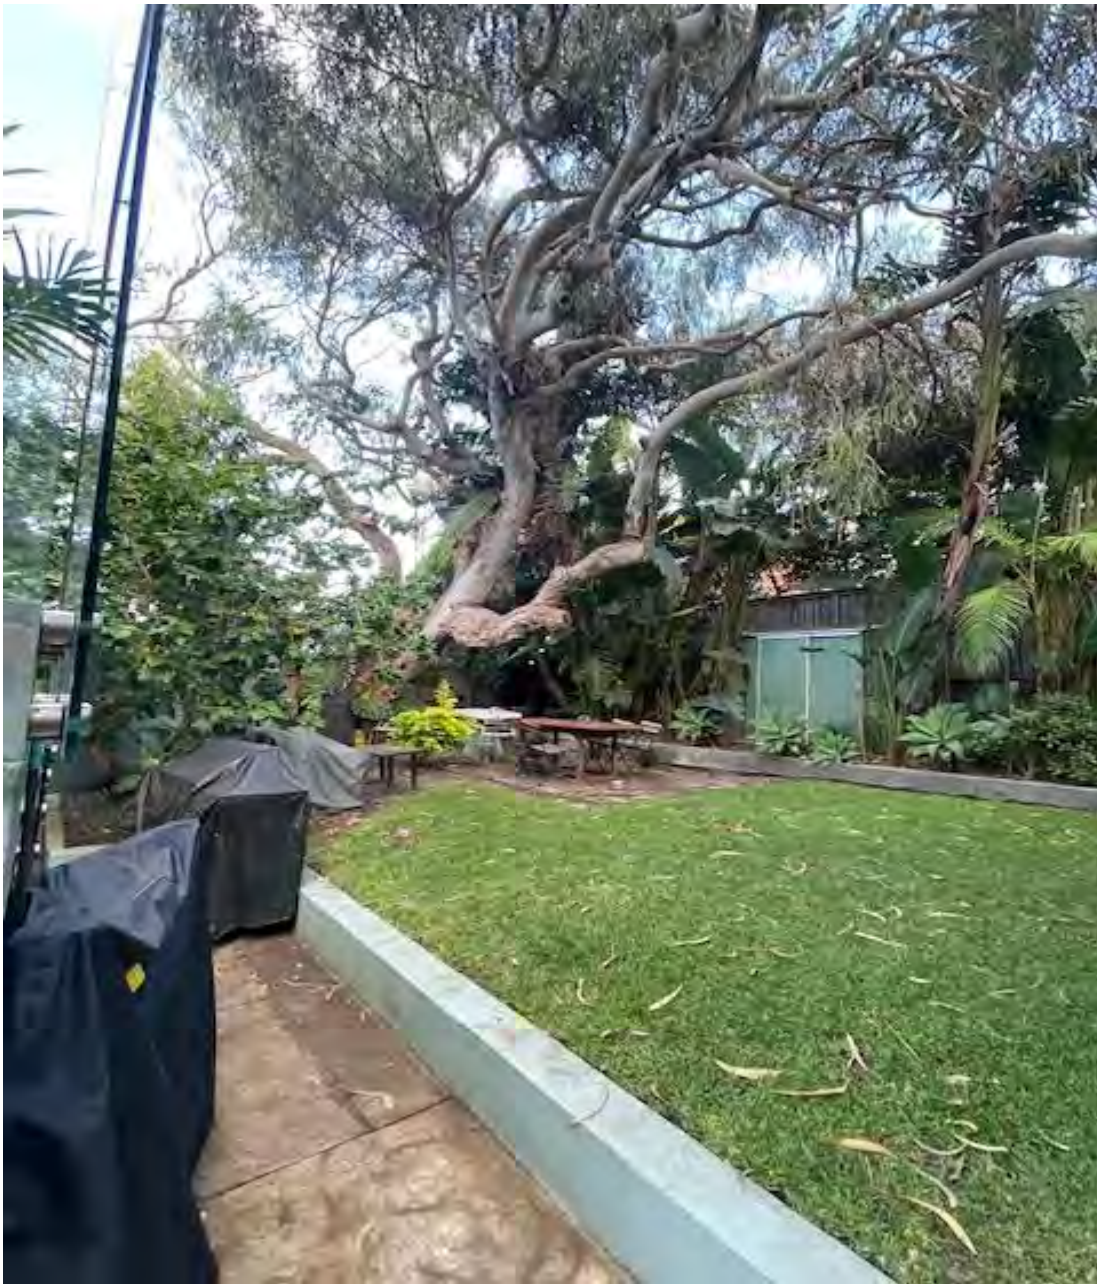
**Photo B:** Looking from the eastern side across the rear garden. Tree 10 has a significant canopy lean that is not self-corrected back over the Centrepont of the trunk.
