## Geotechnical Assessment

**Project:** Proposed Seawall, Jetty & Pontoon  
206 McCarrs Creek Road, Church Point NSW

**Prepared for:**  
Glenn Wightwick

**Ref:** AG 25015  
29 January 2025

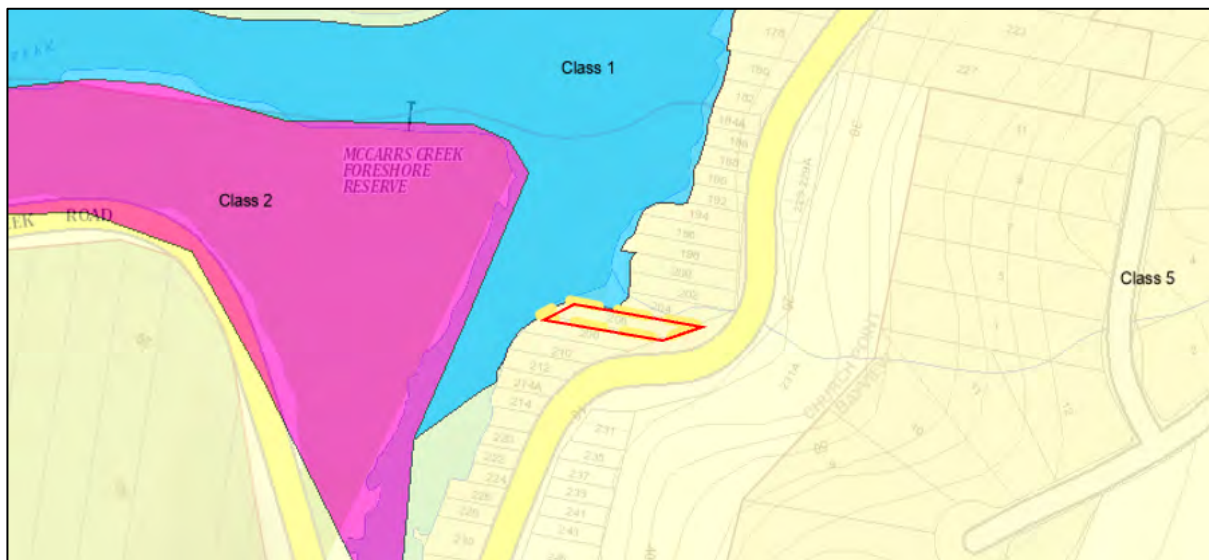
**Image 3.** Pittwater Acid Sulfate Soils Map (NBC Maps): 206 McCarrs Creek Road, Church Point.

With reference to the Northern Beaches Council (PLEP) Acid Sulfate Soils Map, the Site is classified as “Class 5”. The proposed works is anticipated to be in an area classified as “Class 1” and “Class 5” (Image 3).

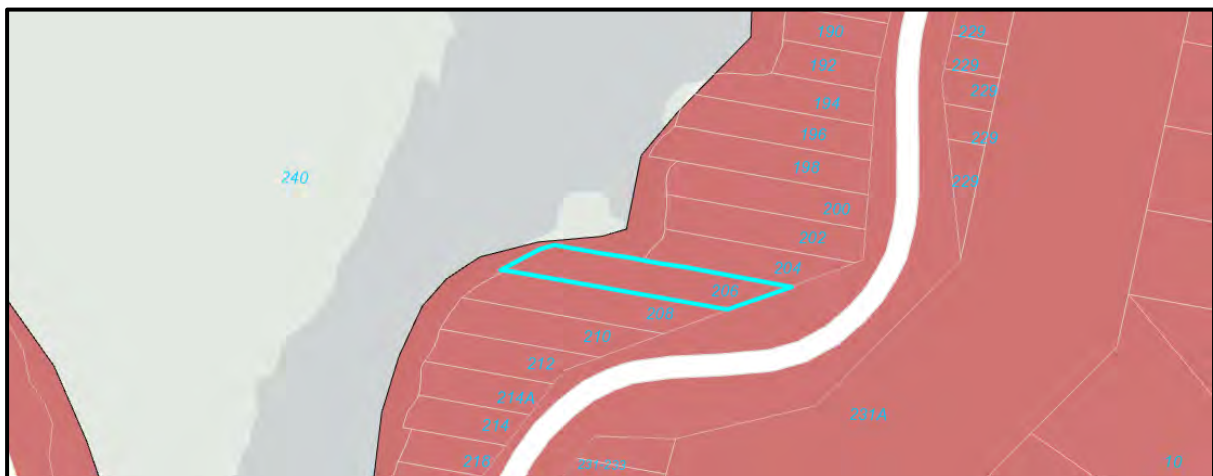
**Image 2.** PLEP Geotechnical Hazard Map  
– 206 McCarrs Creek Road, Church Point © NBC Maps

- No evidence of significant soil creep, tension cracks or landslip instability were identified across the site or on adjacent properties as viewed from the subject site at the time of our inspection.
- Based on reference to the plan entitled "Geotechnical Hazard Mapping" (Ref. P21DCP-BC-MDCP2002, dated 2007) prepared by GHD LONGMAC on behalf of Northern Beaches Council (Pittwater), the site is mapped in a **Geotechnical Hazard H1** zone.

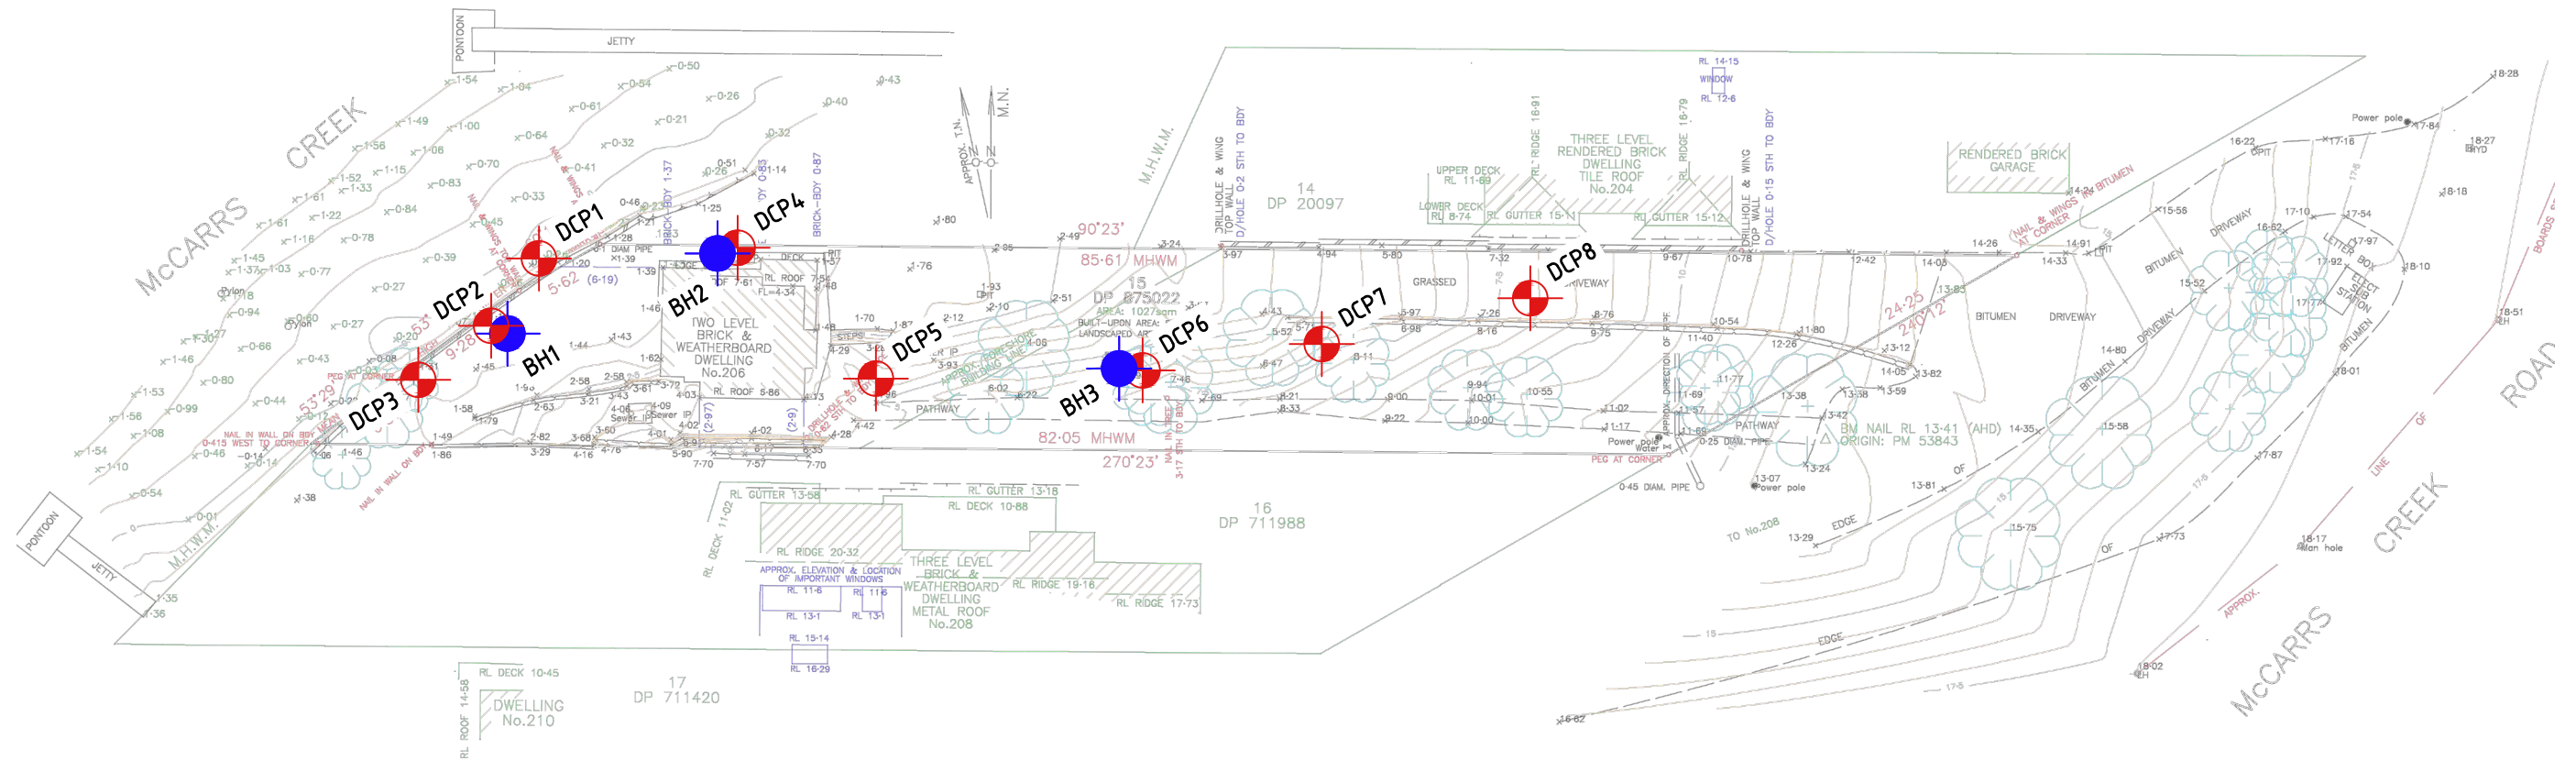
**SITE PLAN/GROUND TEST LOCATIONS**  
SCALE NTS

Test	Summary
DCP 1	Refusal @ surface. Bouncing on bedrock. Brown sand on moist tip.
DCP 2	Refusal @ 1.0m Bouncing on inferred bedrock. Brown sand on wet tip.
DCP 3	Refusal @ 1.0m Bouncing on inferred bedrock. Brown sand on wet tip.
DCP 4	Refusal @ 1.0m Bouncing on inferred bedrock. Brown clay on moist tip.
DCP 5	Refusal @ 1.1m Bouncing on inferred bedrock. Brown clay on moist tip.
DCP 6	Refusal @ 1.3m. Bouncing on bedrock. Brown clay on moist tip.
DCP 7	Practical Refusal @ 1.4m. Slowly penetrating bedrock. Brown clay on moist tip.
DCP 8	Practical Refusal @ 1.0m. Slowly penetrating bedrock. Brown clay on moist tip.

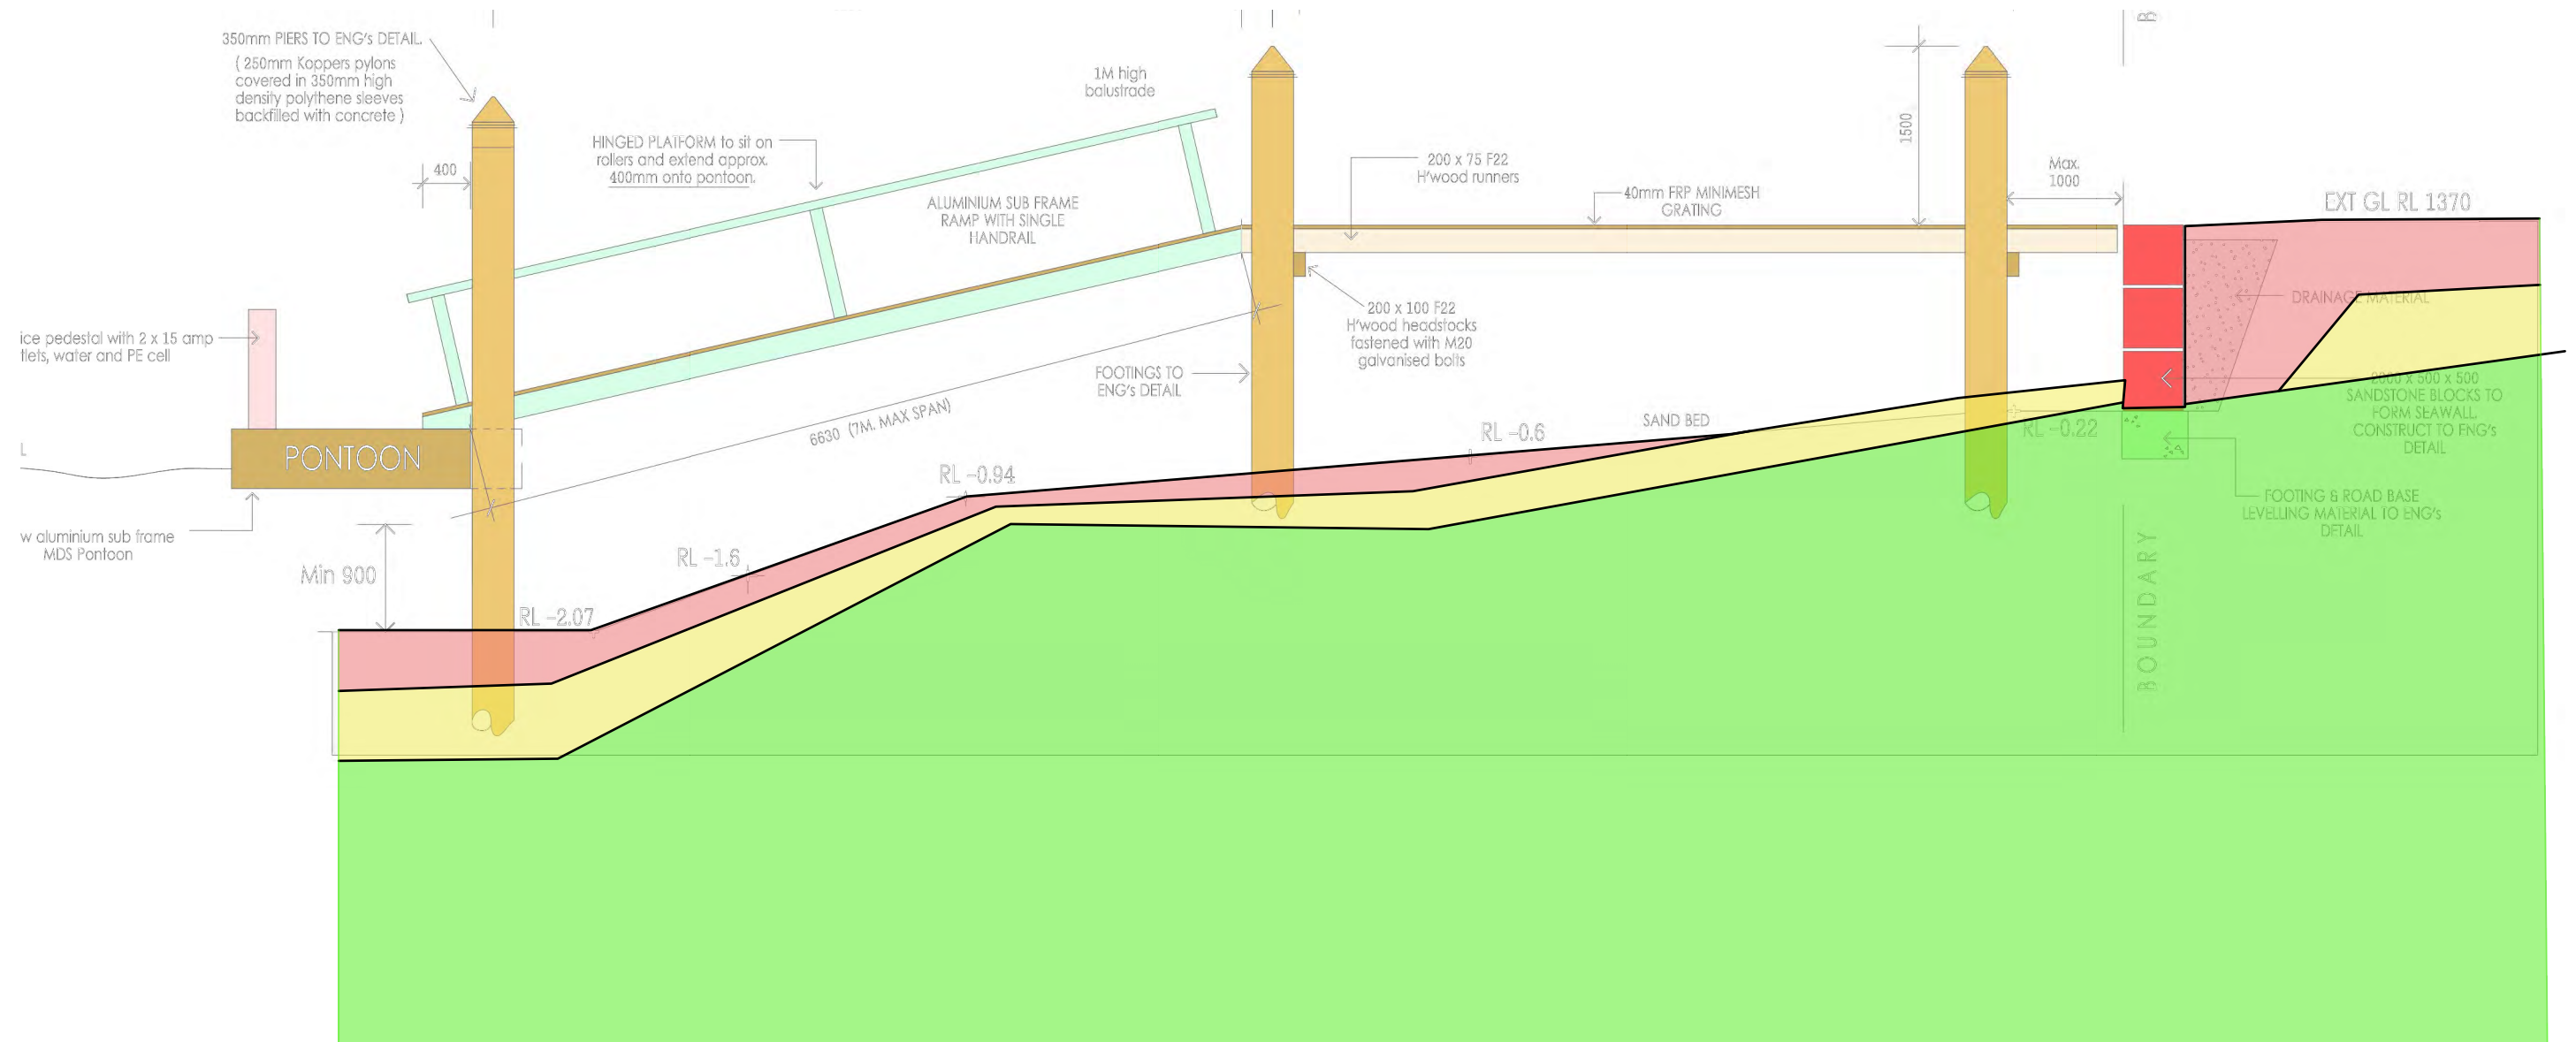
**INFERRED GEOLOGICAL SECTION**  
SCALE NTS

Unit	Material	Comments
1	Topsoil / Fill	Sandy disturbed topsoil and uncontrolled, poorly compacted fill material.
2a	Silty Clay	Low to medium plasticity Silty Clay. Firm to stiff consistency, increasing stiffness with depth.
2b	Silty Sand	Fine to coarse grained, Silty Sand. Loose to medium dense in consistency, increasing density with depth.
3	Sandstone	Low strength or greater sandstone bedrock ( IV+*) expected to be found below the weathered crust ( Class V*).

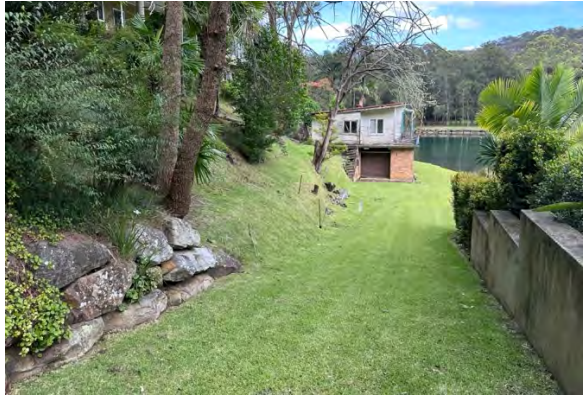
**Photo 1:** Site frontage, looking west.

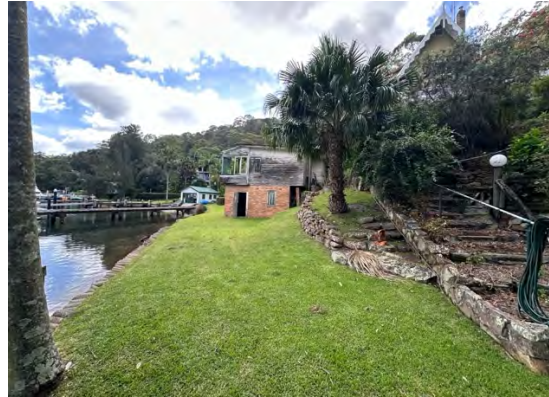
**Photo 2:** Rear of site, looking east.

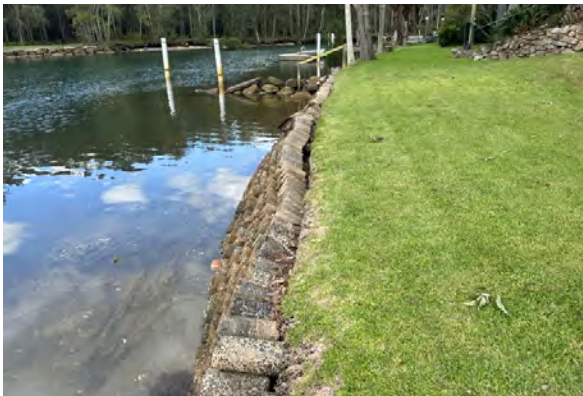
The existing building at the site is a dilapidated two-storey brick dwelling with a large grassed front yard and a smaller grassed backyard area. A dilapidated seawall was observed on the western boundary of site. The western portion of the southern boundary has a steep slope of approximately 35 Degrees, inclined to the north (falling to the site centre). Neighbouring buildings are mostly single and double storey dwellings.

**Photo 3:** Concrete cylinder seawall in dilapidated condition on western boundary of site. Image showing rock rubble and sediments overlaying bedrock shelf in McCarrs Creek watercourse, photo looking north.

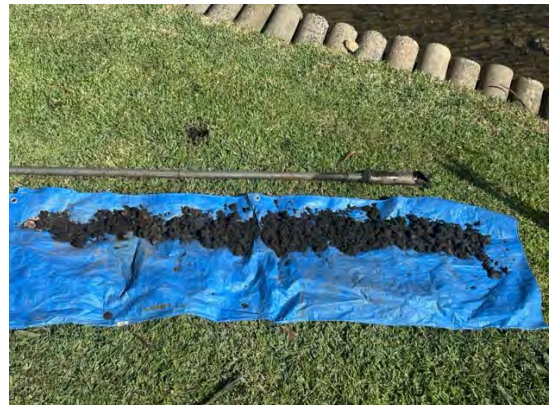
**Photo 4:** Subsurface soil profile of BH01.
