ARBORICULTURAL

IMPACT ASSESSMENT

53B WARRIEWOOD ROAD

LEGENDWAY PTY LTD

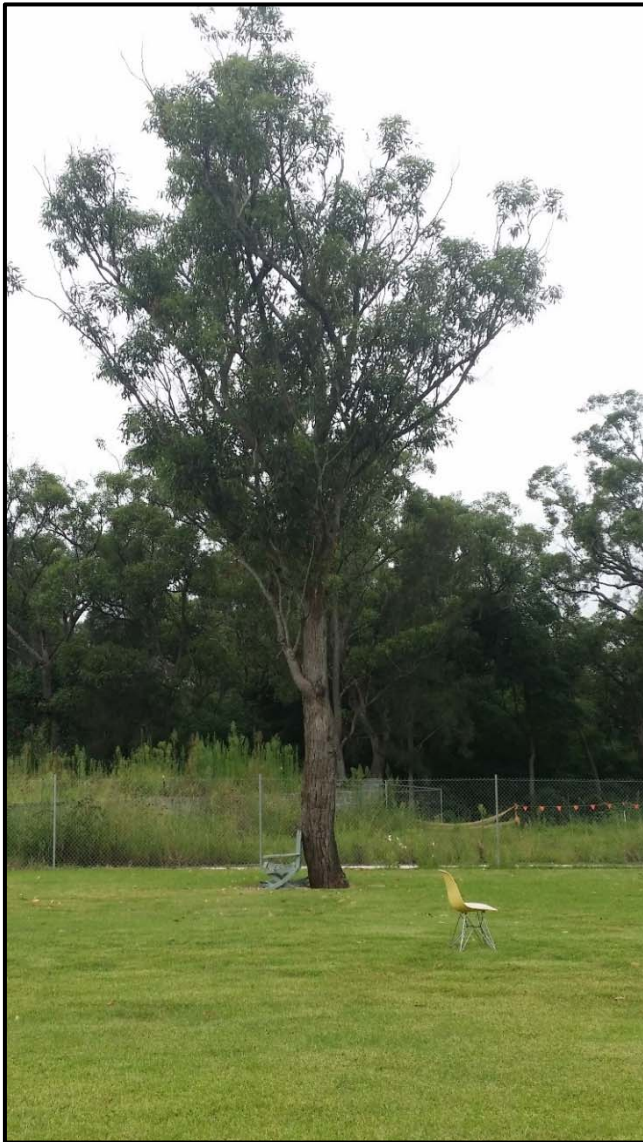
- a. **Health & Vitality:** Low – the foliage of this is sparse, with twig and branch dieback through its upper canopy (see Plates 1 & 3). This relates to its reduced ability to sustain its life processes, and is evident by the reduced crown density and a deterioration of their functions with reduced resistance to predation.
- b. **Tree Form:** Average – it has formed a single stem with DBH of 450mm, with an asymmetrical canopy towards the northwest that is 16.5m in height, and a crown spread of 10x18xm.
- c. **Structural Condition:** Poor – The lower trunk and root crown of this tree have typical symptoms of Armillaria Root Decay, and this has impacted on its health and vitality (see Plate 2)

Plate 1 – decline & dieback in canopy of tree 39 (2019)

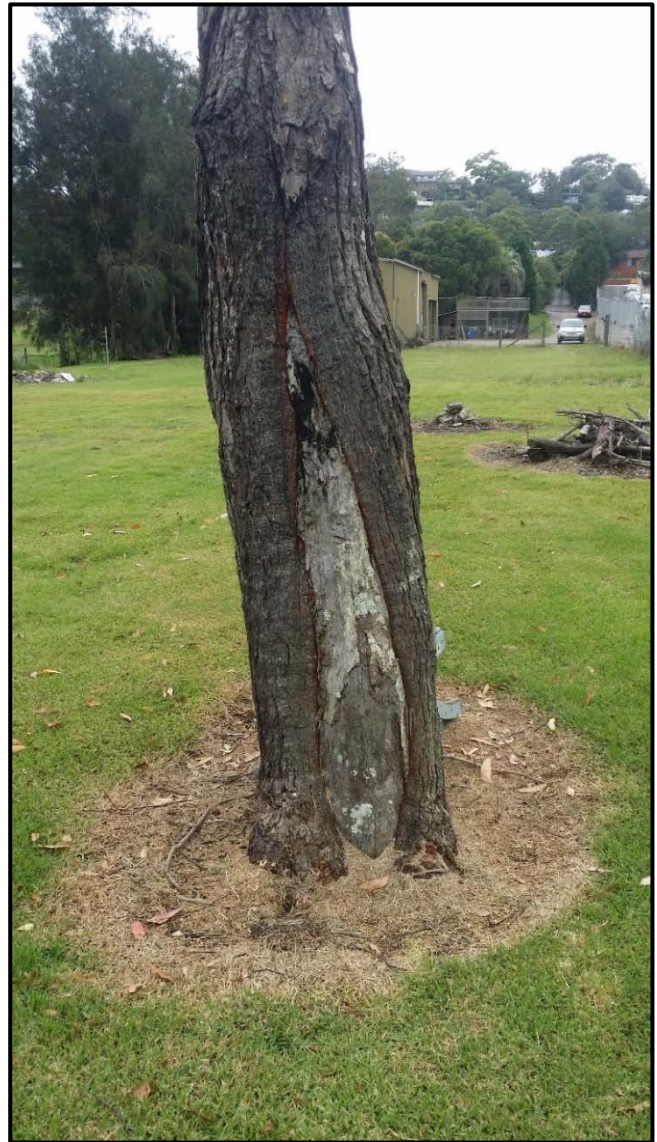
Plate 2 – showing large wound on tree No. 39

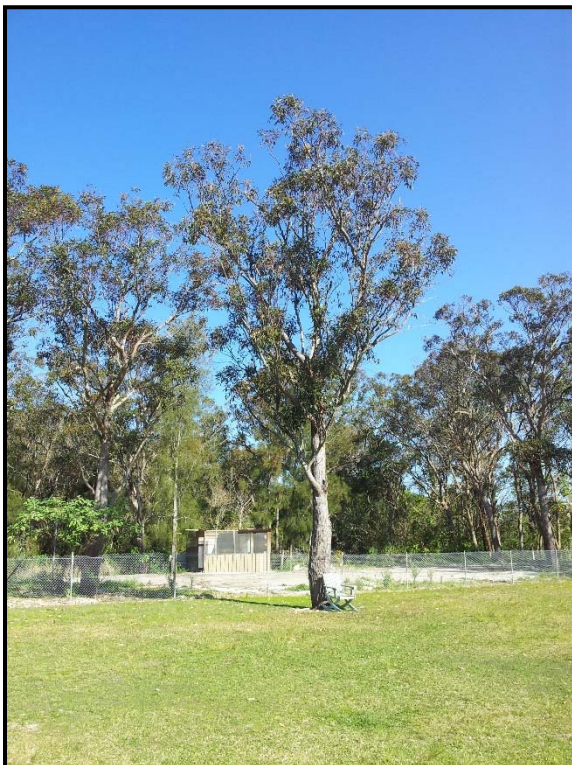
Plate 3 – decline of canopy of tree No. 39 (2014)

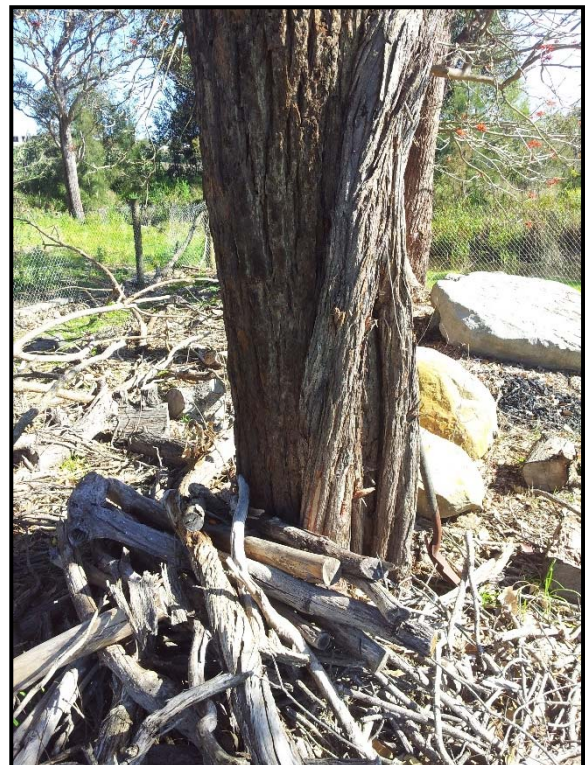
Plate 4 – showing trunk damage on tree No. 40

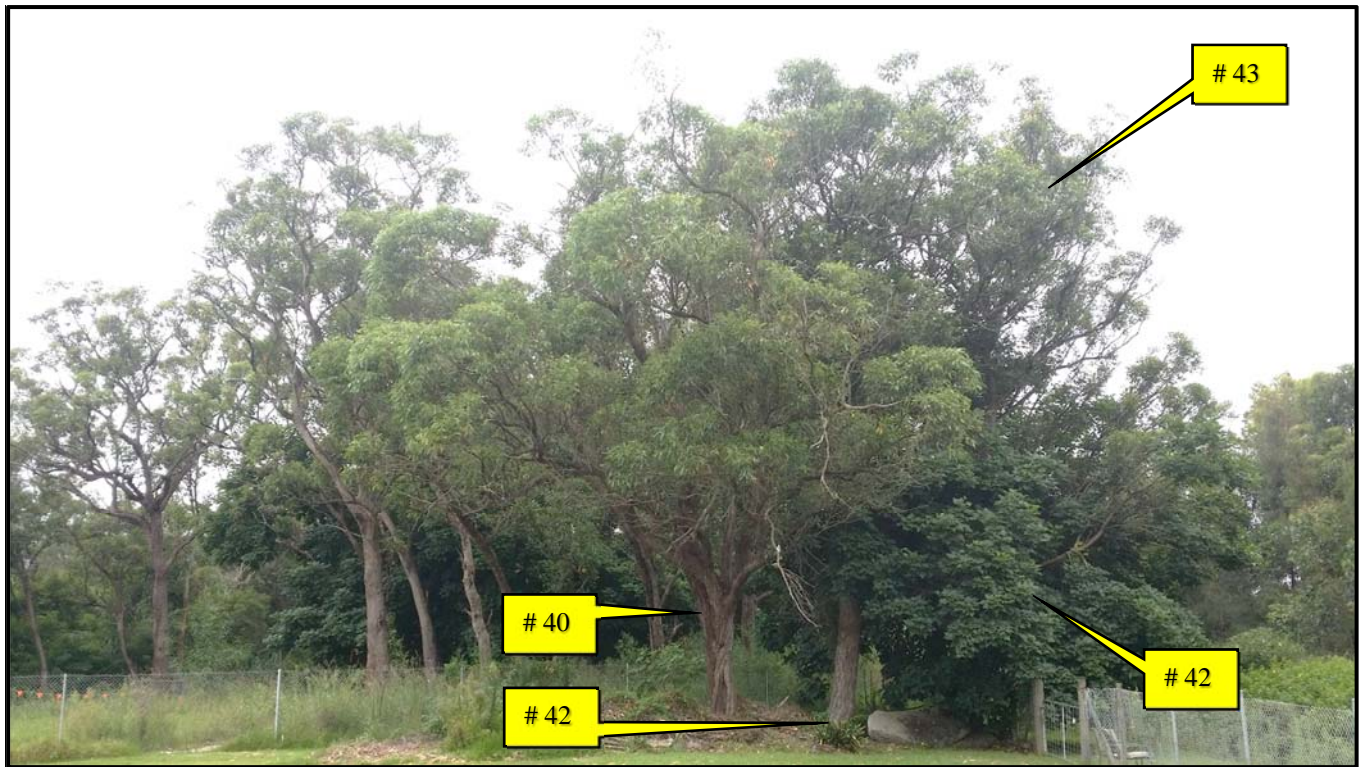
- a. **Health & Vitality:** Low – the foliage of this is sparse, with twig and branch dieback through its upper canopy (see Plate 5 & 6). This relates to its reduced ability to sustain its life processes, and is evident by the reduced crown density and a deterioration of their functions with reduced resistance to predation.
- b. **Tree Form:** Fair – it has formed a single stem with a DBH of 450mm, with a heavily suppressed asymmetrical canopy towards the north which is 22m in height, with a crown spread of 10x22m.
- c. **Structural Condition:** Fair – it has a misshapen form misshapen, and some physical indication of decline due to the early effects of predation by pests and diseases, and/or modification of the

- a. **Health & Vitality:** Average – the foliage of this tree appears to be generally healthy and growing vigorously, with no visible symptoms of decline (see Plate 5).
- b. **Tree Form:** Fair – Its structure is comprised of two codominant stems with a DBH's of 250 and 500mm, and forms a suppressed canopy which is 10m in height, with a crown spread of 6x6m.
- c. **Structural Condition:** Average – This tree originated as an opportunistic seedling and is growing against the trunk of Tree No. 43 and its canopy is being heavily suppressed by the more dominant tree.

Plate 3 – showing tree No's 40 - 43

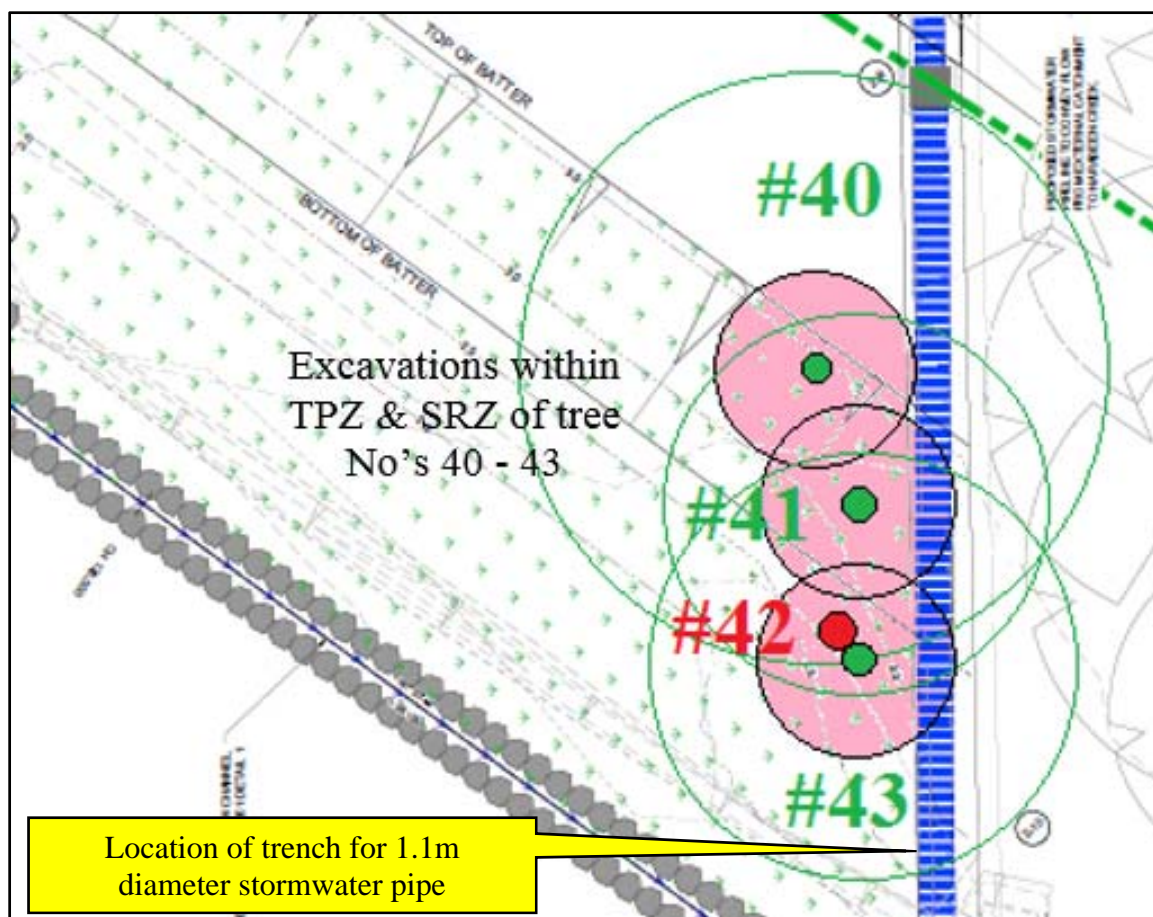
Diagram 1 – showing extent of TPZ's and SRZ's of tree No's 40 – 43

- This tree will require a TPZ with a radius of 6.0m COT, and this represents an area of 113.1m².
- It has a SRZ with a radius of 2.9m COT, and a significant impact is expected
 - **Excavations for Batters:** This tree is located within the area of proposed battering and the necessary excavation works will impact on 60% of its TPZ
 - **Stormwater:** It has a setback of 2.9m from the proposed excavations for the 1.1m wide Stormwater Pipe that passes through the south-eastern side of its TPZ. This encroachment is greater than 30%, which also included a significant encroachment into the SRZ. As such, excavations for the proposed trench is likely to have a high impact on its health and stability.

- The accumulative impacts of the proposed excavations for batters within the south-western side of the Tree Protection Zones and Structural Root Zone of tree No's 39 – 41 & 43 combined with an excavation for a 1.1m wide trench for the Stormwater Pipe along their south-eastern sides will significantly compromise their health and stability.
- As no realistic alternative option is available to undertake the proposed works, it is recommended that tree No's 39 – 41 & 43 be removed.
- Tree No. 42 is listed as a Biosecurity Risk, it should also be removed
