# Geotechnical Assessment

**Project:** Alterations & Additions  
19 Emma Street, Mona Vale NSW

**Ref:** AG 25405  
22 September 2025

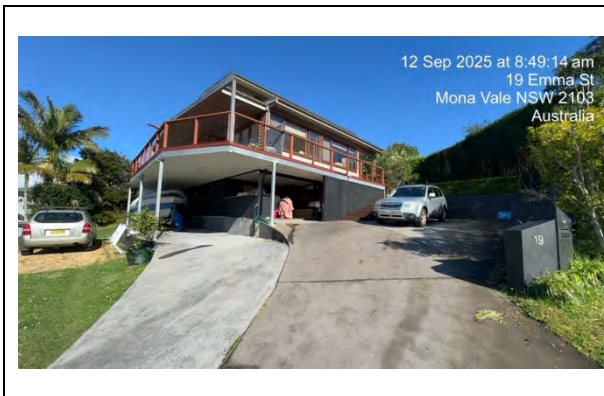
**Photo 1:** Site frontage, looking south-west.

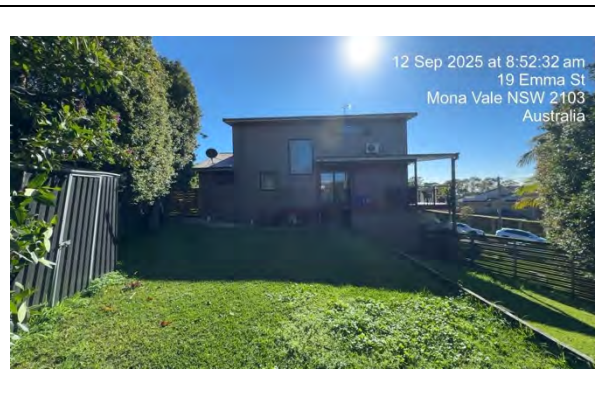
**Photo 2:** Site backyard, looking north.

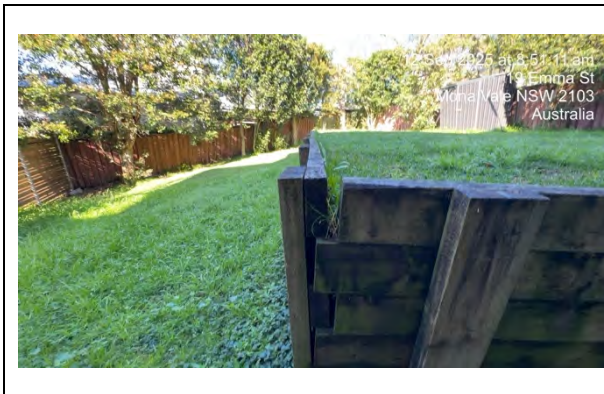
| Parameter | Description |
|---|---|
| Retaining structures | Wooden walls appear to be in fair condition except the wooden walls on the south-western at the backyard area, display slightly budging and rotation from vertical.<br><br>Concrete/brick walls appear to be in fair condition. |

**Photo 3:** Wooden soldier pile wall, looking south.

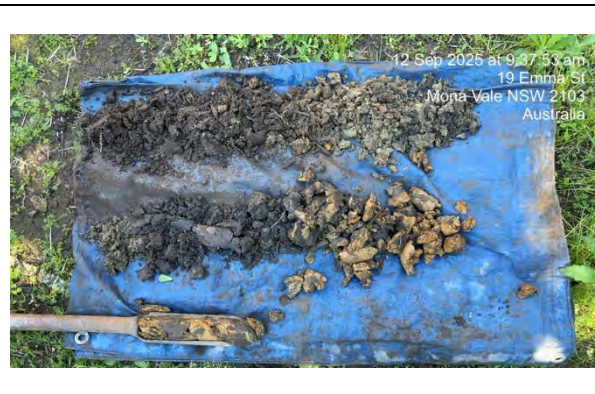
**Photo 4:** Subsurface soil profile of BH1.

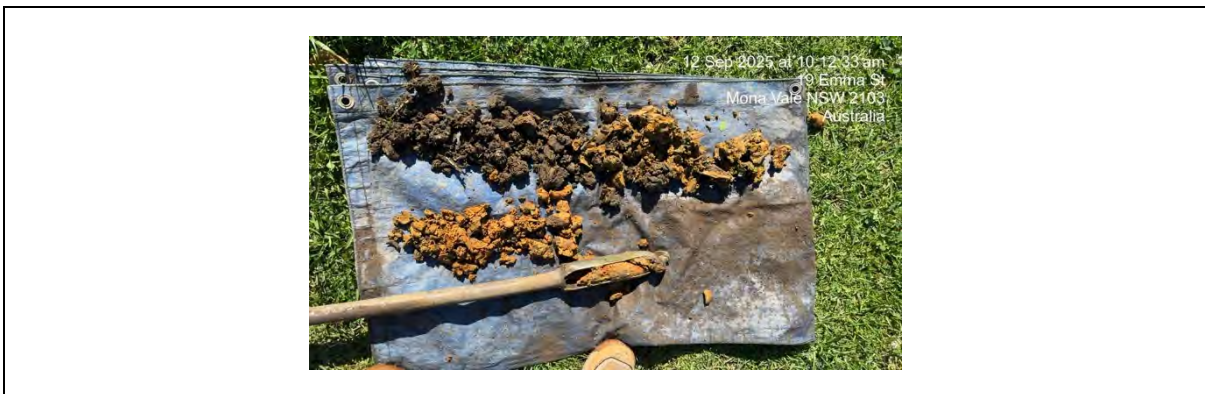
**Photo 5:** Subsurface soil profile of BH2.
