## **REPORT ON GEOTECHNICAL SITE INVESTIGATION**

### **PROPOSED ALTERATIONS AND ADDITIONS**

**15 BURRENDONG PLACE, AVALON BEACH**

**Project No.: 2020-142**

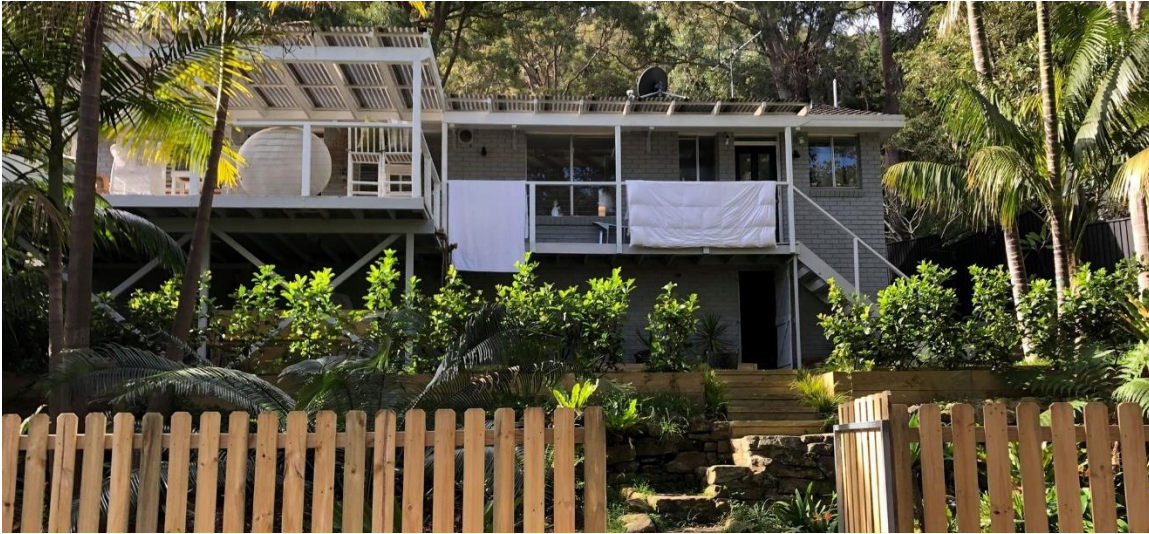
*Photograph 2: View of the rear of the site and main structure, looking north east*

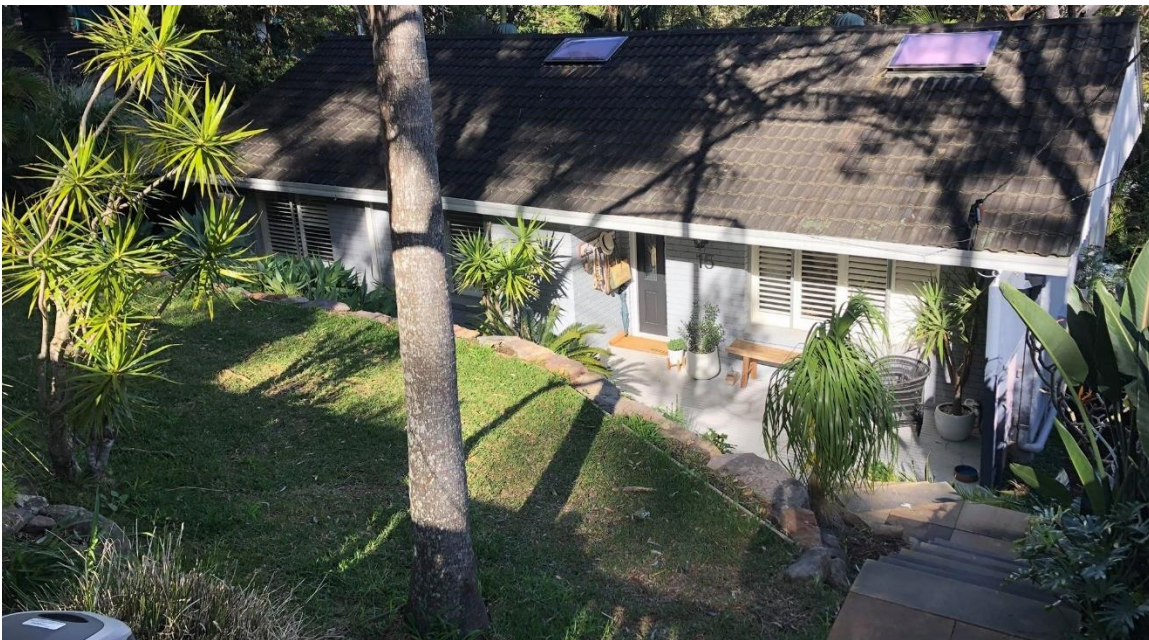
*Photograph 3: View of the front of the site and main structure, looking south*

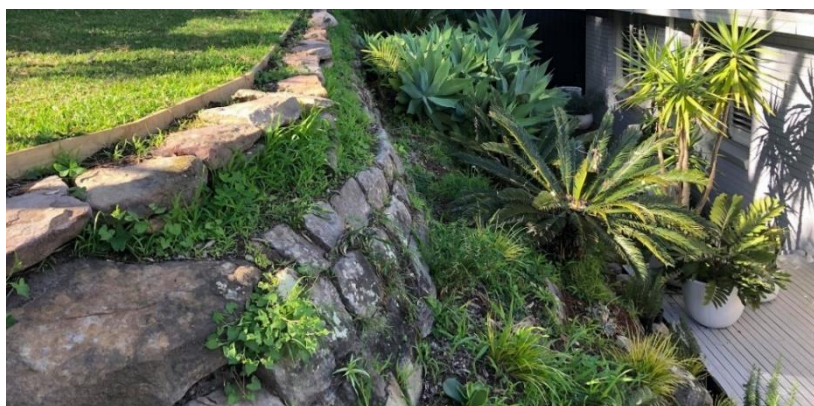
Retaining walls and grassed terrace lawns occupy the front of the site. The top dry stack stone retaining wall is ~1.2m high with the lower retaining wall within the front of the site extending to a height ~0.8m. The base of the lower retaining wall is level with the front decking area and concrete side access walkway. The sub vertical retaining walls within the front of the site appear to be in good condition, the lower retaining wall is shown in Photograph 5. Large gum trees are positioned within the front of the site and along the front boundary.

*Photograph 5: Lower front retaining wall, facing south east*

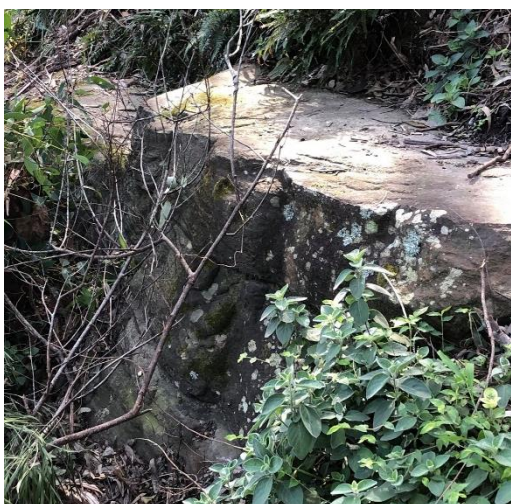
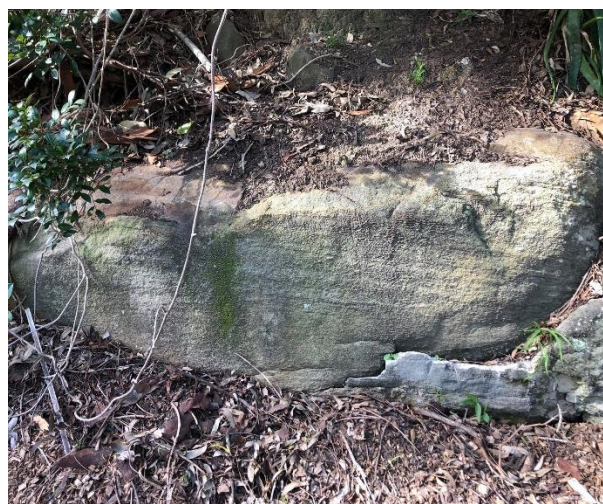
Sandstone rock outcrops were observed on the high side of Burrendong Place within No.2 Burrendong Place. The interpreted outcropping bedrock is formed with tabular blocks, consisting of medium to coarse grained sandstone. Approximately ten individual outcrops were noted across the front portion of the adjacent property, some of these outcrops are shown in Photograph 6, 7 and 8.

*Photograph 6 & 7: Rock outcrops within No. 2 Burrendong Place.*

The bedrock profile appears to step down the moderate south west to west dipping slope. Exposed planar bedrock is evident on the high side of the street, as shown in Photograph 6, it is anticipated that these cliff drops continue throughout the site. No seepage or groundwater was encountered during the investigation however, it is likely that minor seepage will be intersected at the soil - rock interface and on defects in the bedrock during excavation. A freestanding water table was not encountered and is not expected within the site due to the topography of the site and surrounds.

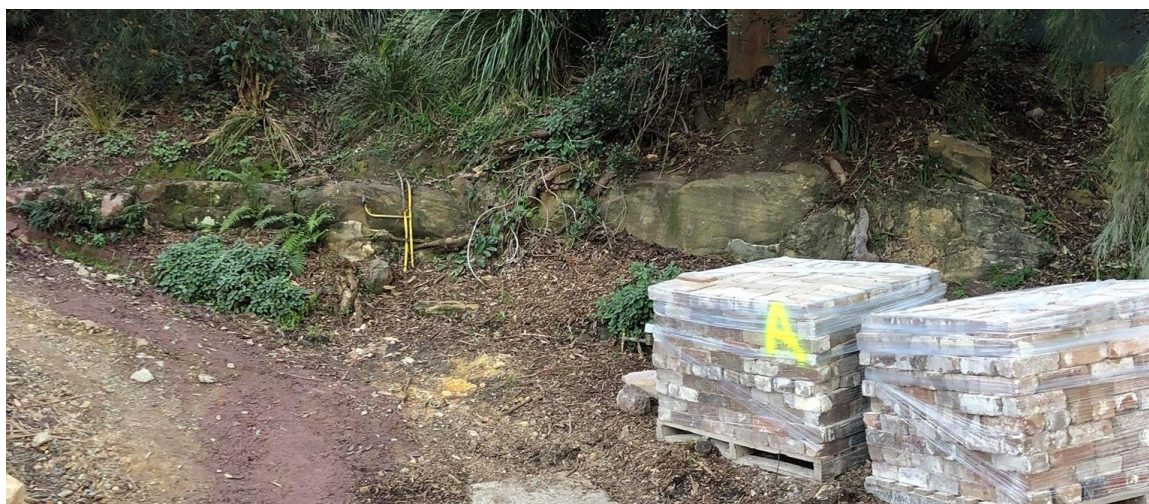
*Photograph 8: Rock outcrops within eastern portion of the front of No. 2 Burrendong Place.*

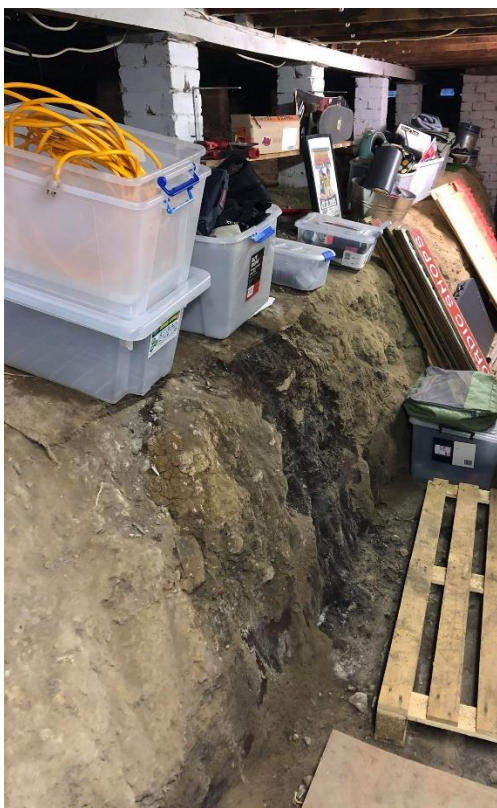
*Photograph 8: Stepped soil profile in basement sub floor level, facing south east*

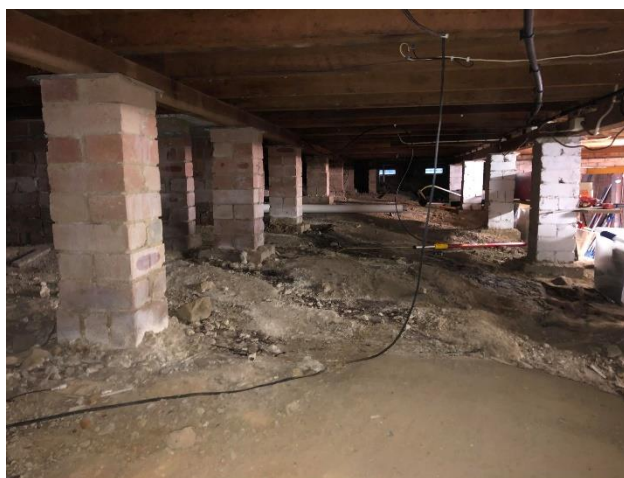
*Photograph 9: Exposed footings in basement sub floor level, facing south east*
