# Geotechnical Assessment

**Project:** Alterations & Additions  
48 Upper Clifford Avenue, Fairlight NSW

**Ref:** AG 25268

25 June 2025

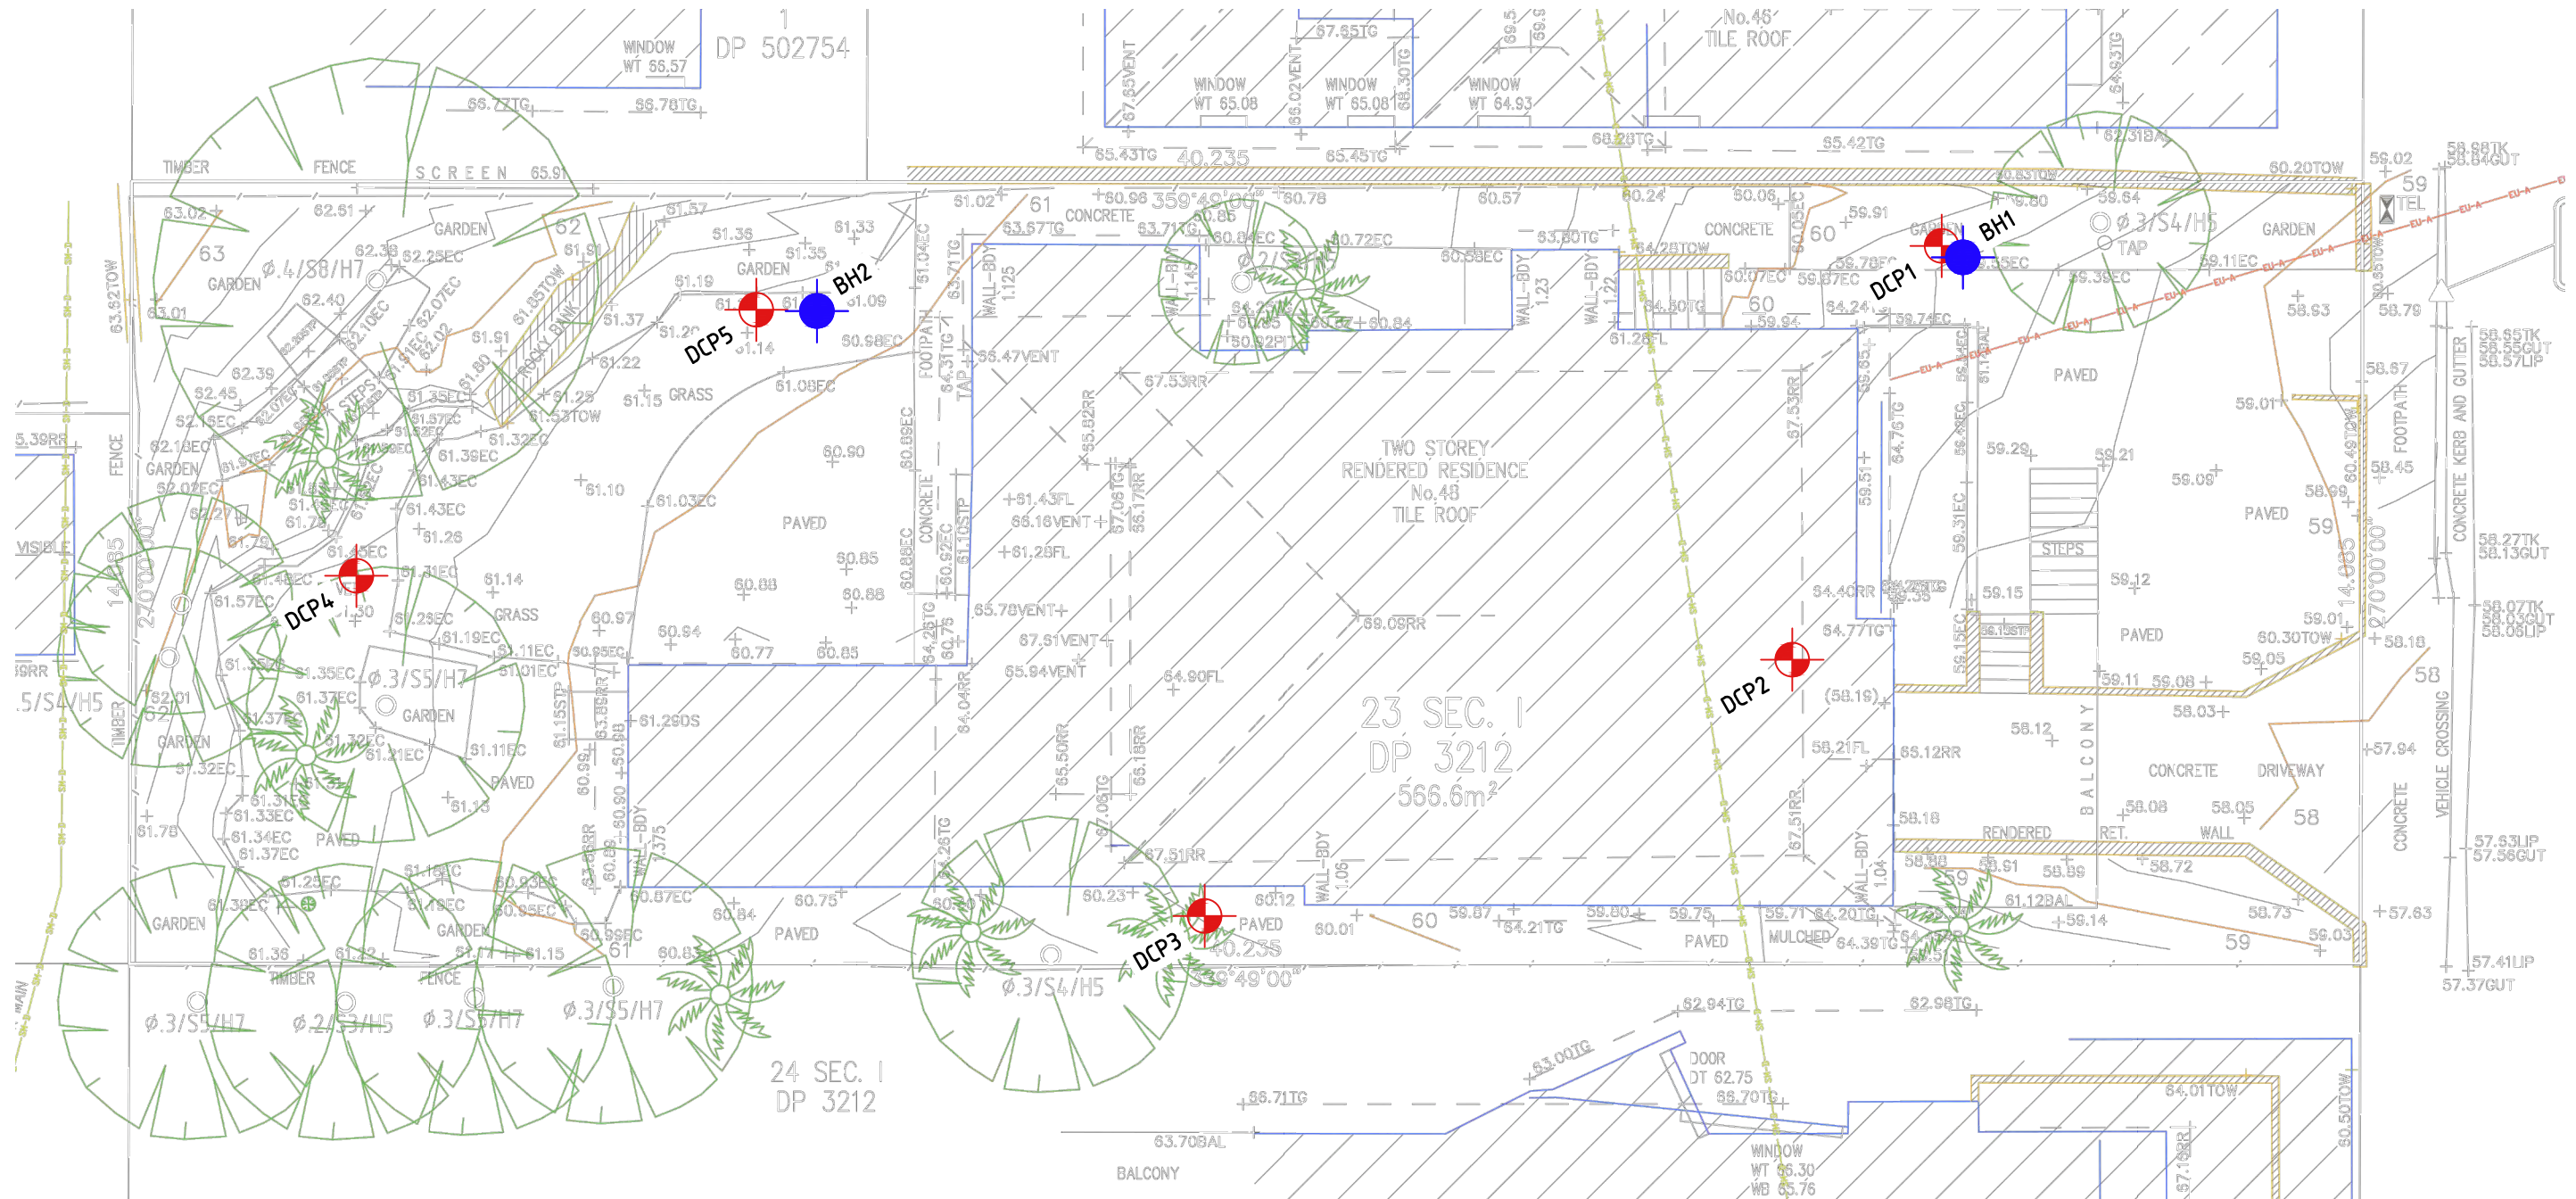
## SITE PLAN/GROUND TEST LOCATIONS

| Test | Summary |
|---|---|
| DCP 1 | Refusal @ 0.7m Bouncing on bedrock. Brown sand on moist tip. |
| DCP 2 | Refusal @ 0.6m Bouncing on bedrock. Brown sand on moist tip. |
| DCP 3 | Refusal @ 0.5m Bouncing on bedrock. Brown sand on moist tip. |
| DCP 4 | Refusal @ 0.5m Bouncing on bedrock. Brown sand on moist tip. |
| DCP 5 | Refusal @ 0.4m Bouncing on bedrock. Brown sand on moist tip. |

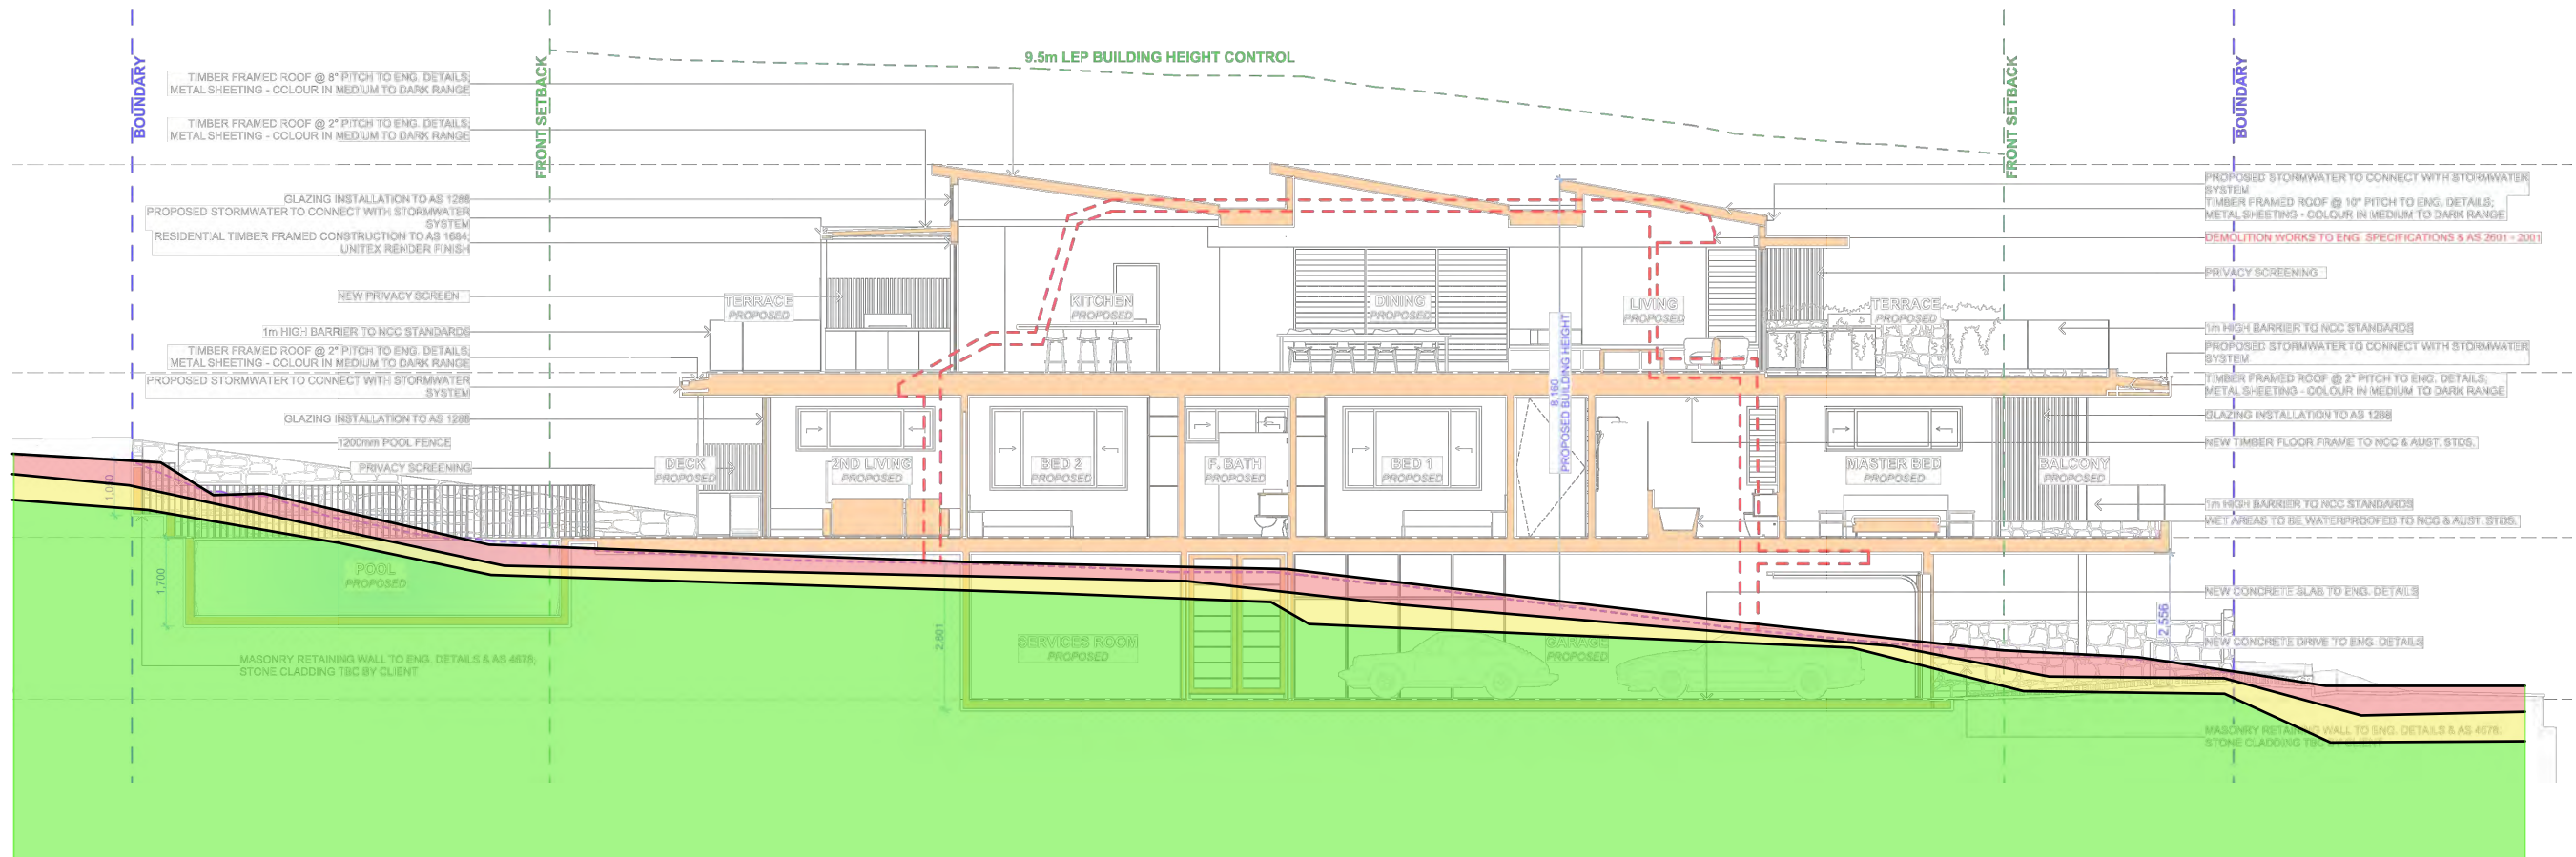
**INFERRED GEOLOGICAL SECTION**  
SCALE NTS

| Unit | Material | Comments |
|---|---|---|
| 2 | Silty Sand | Fine to medium grained, Silty Sand. Loose to medium dense in consistency, increasing density with depth. |
| 3 | Sandstone | Medium strength or greater sandstone bedrock (Class III+*) expected to be found below the weathered crust (Class IV-V*). |

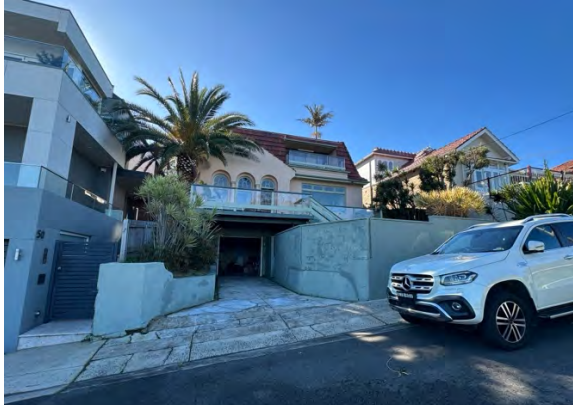
**Photo 1:** Site frontage, looking north.

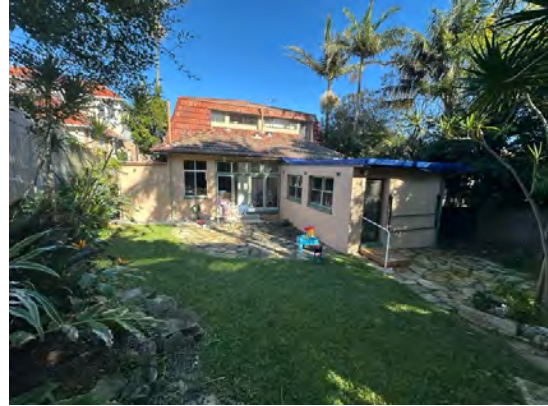
**Photo 2:** Photo taken from northern boundary, looking south.

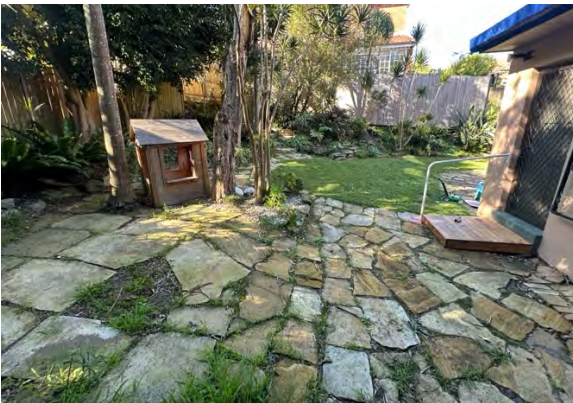
**Photo 3:** Photo of rear yard, looking east.

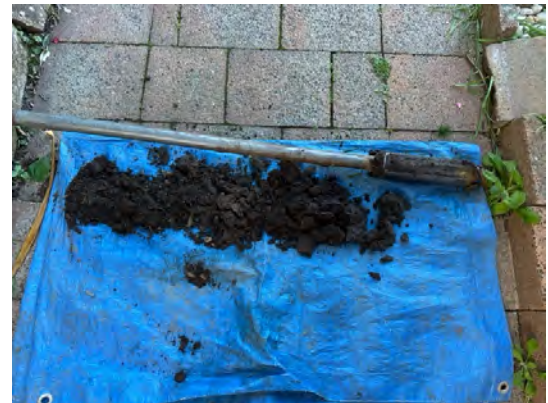
**Photo 4:** Subsurface soil profile of BH1.
