5 Portions, Lovett Bay, Lovett Bay

Geotechnical Investigation and Landslide Risk Assessment

September 2023

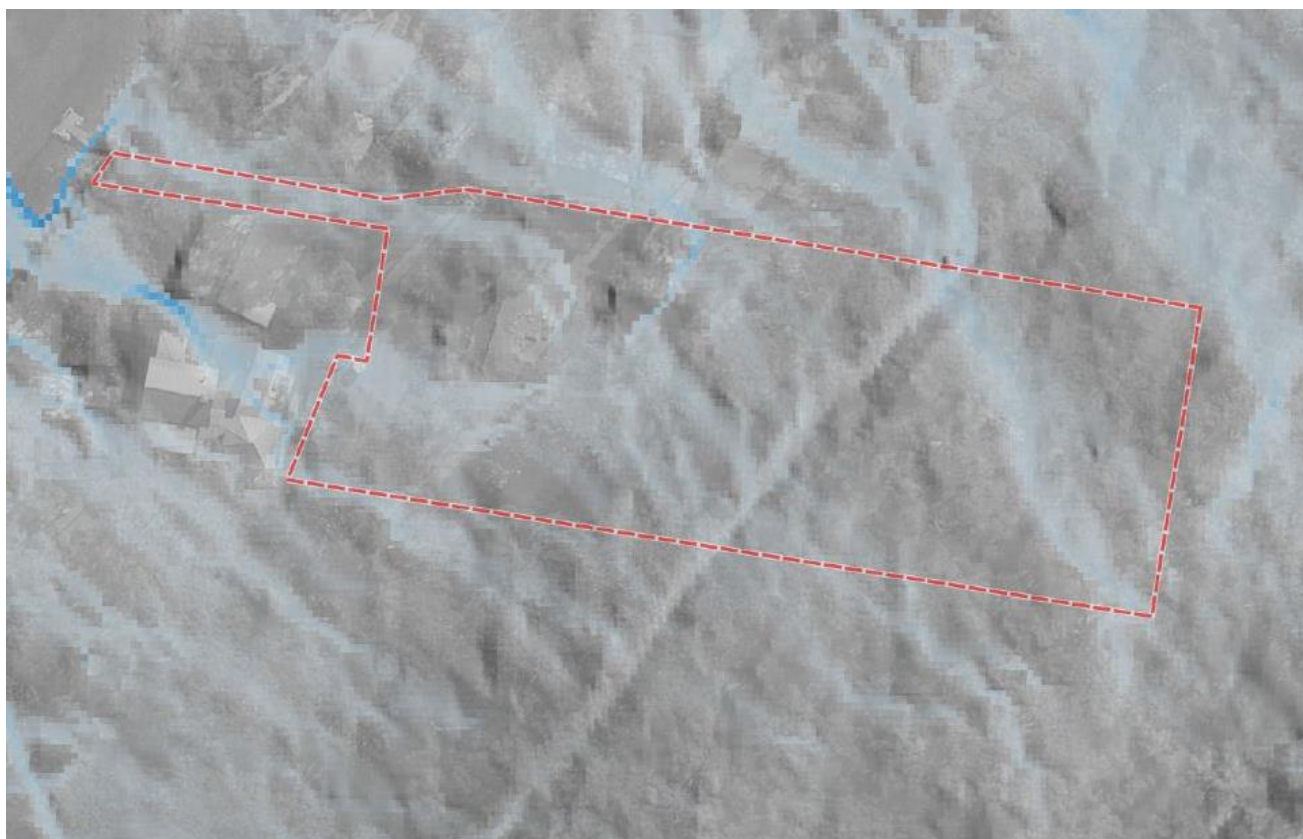
Figure 3.2: Terraflow analysis of the slope terrain – no significant flow paths identified.

In order to prevent run-on from the slope saturating the building envelope, it is recommended an upslope diversion bund is installed to redirect excess surface water around the development

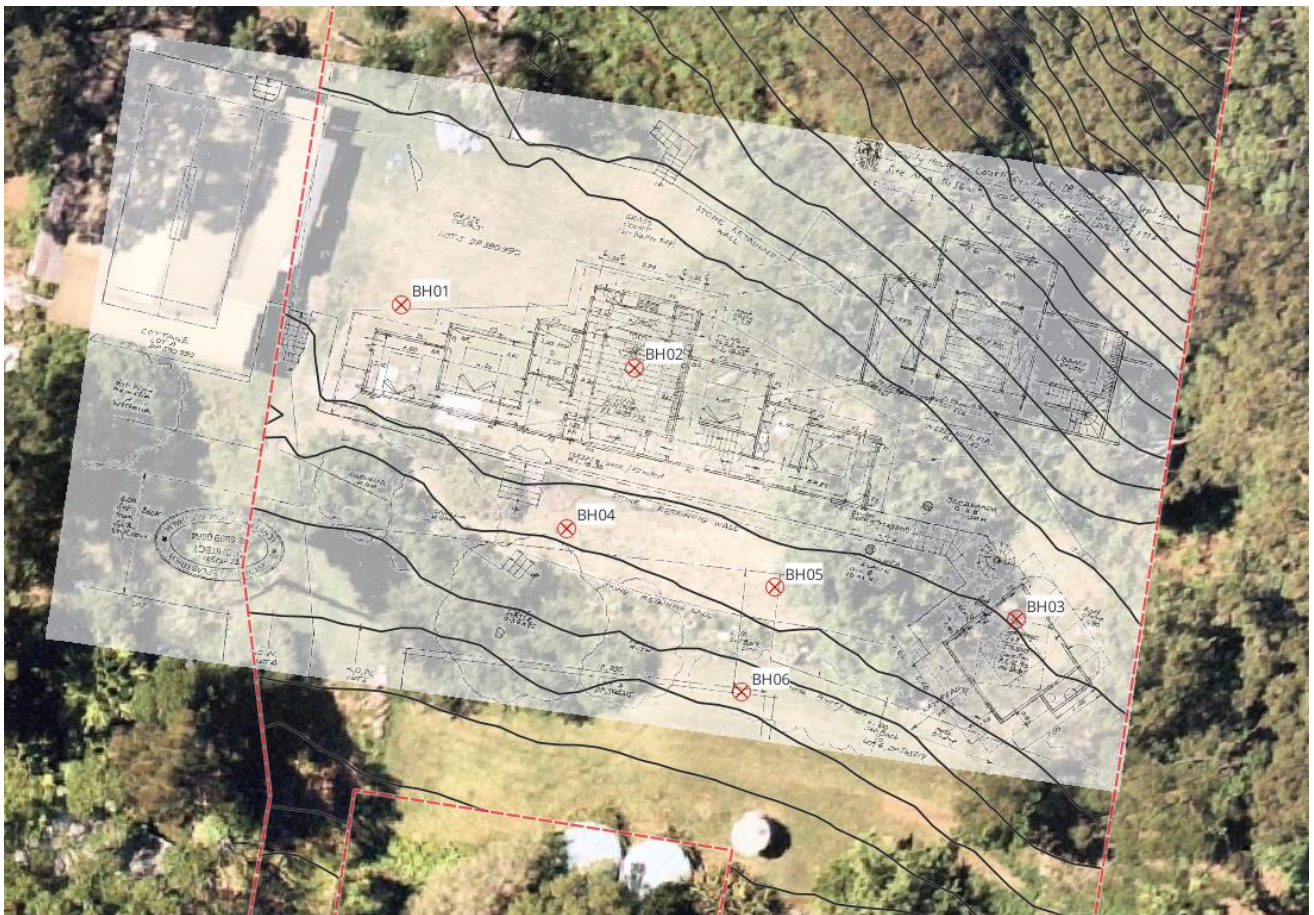
Figure 4.1: Borehole locations

The locations of the boreholes are shown in Figure 4.1 below. The subsurface conditions are summarised in Table 4.1.

Soil Type	Unit Name	General Description	Thickness (m)	R.L (m BEGL)
0	Top Soil	SAND , grey, loose, trace silt/clay content, organics	0.2	0 – 0.2
1	Colluvial	SAND , grey, loose, trace silt/clay content	0.8	0.2 - 1.0
A	XW	Sandy CLAY , brown/yellow/red, firm, trace gravel	0.9	1.0 - 1.9
B	Bedrock	Bedrock (shale/sandstone) -, anticipated low-medium strength	-	-
