# ARBORIST REPORT

1955 PTTWATER RD,

BAYVIEW

August, 2022

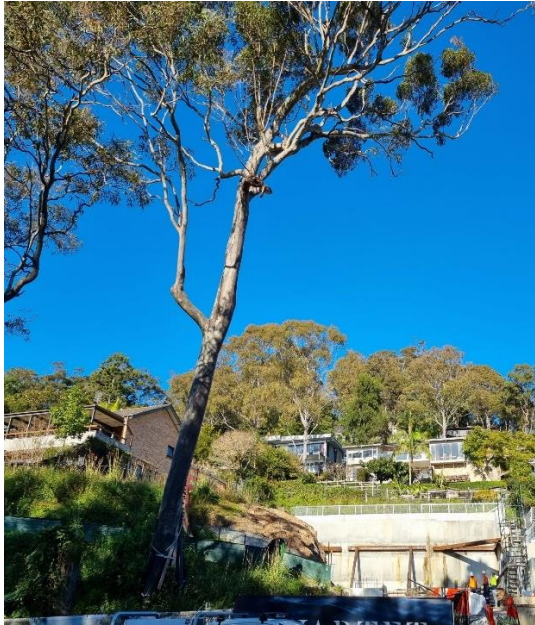
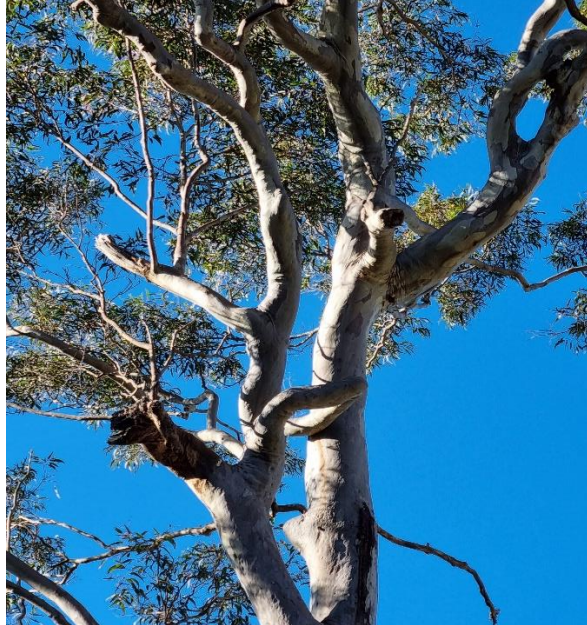
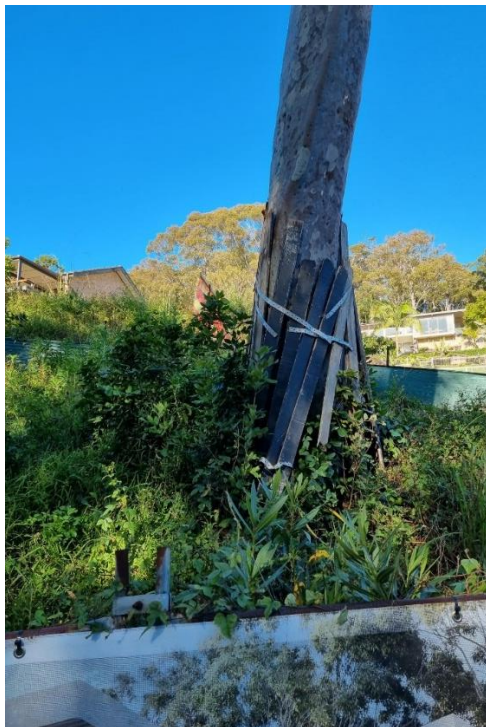
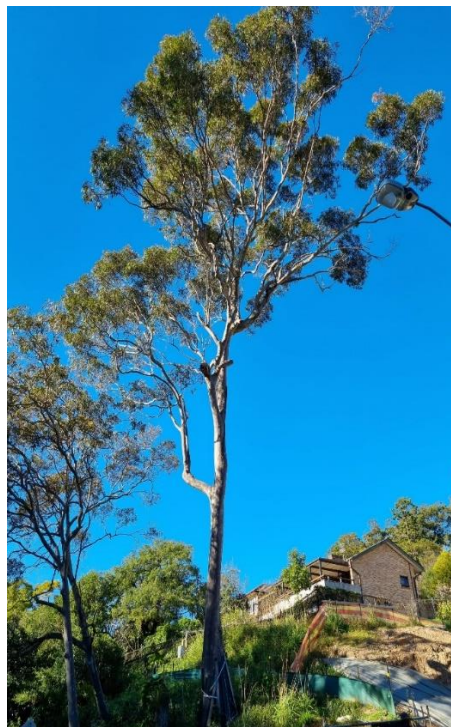
*Corymbia maculata*, 1955 Pittwater Rd, Bayview

| SULE rating | 3B Removal |

This *Corymbia maculata* is large tree with a single dominant trunk. It has a prominent lean to the north west. Approximately 80% of the canopy is to the North and west of the main trunk giving the tree an unbalanced morphology. There is evidence of historical storm damage resulting in tear outs and crowded branch regrowth in the canopy. The ground around the base of the tree appears to be the original soil profile with recent vegetation clearing evident. The slope on the north and western side of the trunk has been excavated to expose some secondary and feeder roots.

Several small hollows have formed in this tree due to previous storm damage. The tree could possibly be used by fauna including arboreal mammals and birds.

Given the information provided by the client, there will be further impact on primary, secondary and feeder roots in order to meet FRNSW requirements for the hardstand and hydrant access. It is likely that the tree's stability will be compromised and therefore it is recommended that the tree be removed and replaced by a ratio of 9:1 with locally endemic species (see list below). We recommend that a condition of removal be that the tree is replaced by a minimum of four *Corymbia maculata* as well as a minimum of five species from the list below.
