5 May 2020

DA2019/1478

**1 NARRABEEN PARK PARADE – NORTH NARRABEEN, NSW
MINOR LANDSCAPE ADDITIONS & ALTERATIONS
ARBORICULTURAL IMPACT ASSESSMENT REPORT**

Ref No RTC-8420

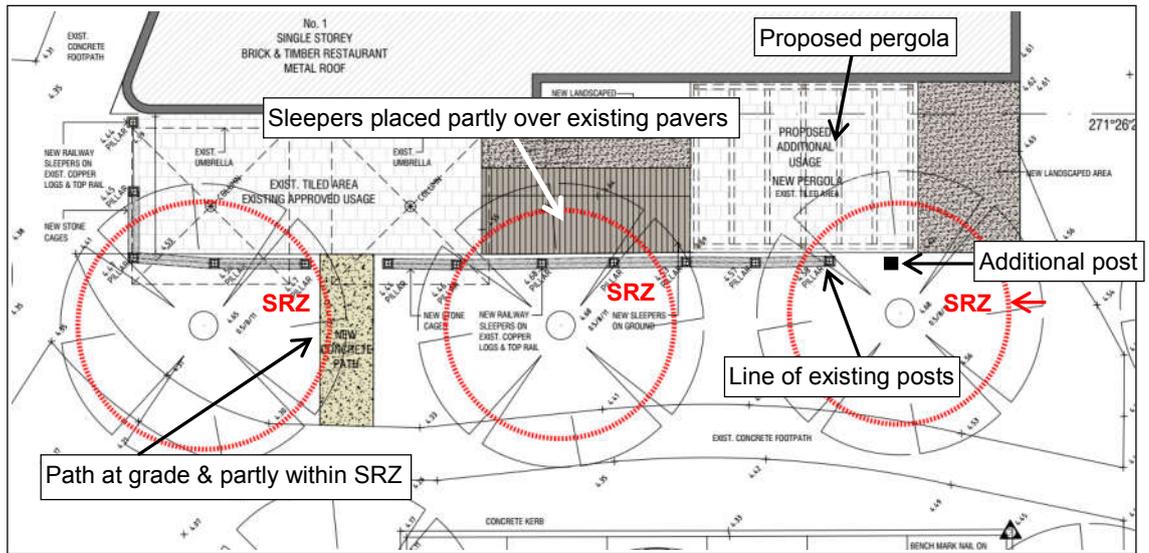
Figure 1, showing landscape works within SRZ radiuses

1. As shown within Figure 1 p3 the structural root zone (SRZ) radiuses have been identified which shows areas of previous and proposed works to be conducted adjacent the trees. Works within the SRZ is considered a Major encroachment under AS4970-2009 where existing surfaces have been upgraded to accommodate new landscape design. The SRZ is the primary area discussed within this report.

2. In determining impacts within the SRZ by previous additions and alterations the assessment conducted determined a negligible impact by design, however, no detailed tree root investigation by manual (exploratory hand root mapping) or pneumatic air spade inspection was conducted. The assessment concluded the likelihood of negligible impact due to the following discussions:

- i. Probing along retaining wall sleepers adjacent T3 & 2, and adjacent the new concrete footpath between T1 & 2 detected no root resistance at 250mm in depth. Soil type was considered very sandy and not compacted corresponding with Grozier Geotechnical Investigation report of deep sandy soils to the SSE of the site. Being sandy soils it is likely deep descending roots occur beyond the SRZ radius.

- ii. The new concrete access footpath to the cafe was constructed to finish above ground level, matching the existing raised level of the public verge pathway. It is likely minimal excavation was required to accommodate the construction of the path with no root resistance when soil probed at the path edge detected.

- iii. The four sleeper post vertical design supporting the steel table tops are cosmetic only with the exception of one (1) post located directly adjacent T3 at 0.7m (700mm) from the face of tree. It is unclear if tree roots were damaged during central post and footing placement.
The remainder of the sleepers do not extend below ground level and are directly attached to existing copper log posts. Some minor alteration (straightening) and concrete footing work may have occurred, with the works occurring in the existing post footprint indicating a likely negligible impact by the design upgrade.

- iv. Timber sleeper path adjacent T2 is constructed to meet existing ground levels with minimal excavation to meet grade. The grated SW drain adjacent T3 is located outside of the SRZ radius with likely negligible root impact due to minor (<10%) excavation occupancy within the TPZ.

- i. There is to be no excavation within SRZ radiuses without prior root mapping or investigation works to determine impact on critical underlying tree roots, refer SRZ & TPZ distance column Appendix- C. The SRZ should be considered a development exclusion zone with no works occurring within the SRZ without prior arborist advice and certification.

- iii. In specific detailed root mapping or exploratory root investigations should occur for pergola pier footing locations adjacent T3.
 - iv. *Stone cage wall proposal*: construction methodology for the stone cage wall proposal should be more clearly detailed within construction drawings. In specific there should be no excavation or compaction to accommodate the wall proposal within the SRZ. Where the wall is proposed on natural ground level within the SRZ root mapping should occur to provide more information on the location, distribution and effect of works on critical underlying tree roots. Tree sensitive design such as placing the wall directly on top of or spanning the wall above ground level over the SRZ may be achievable pending the results of exploratory root investigations.

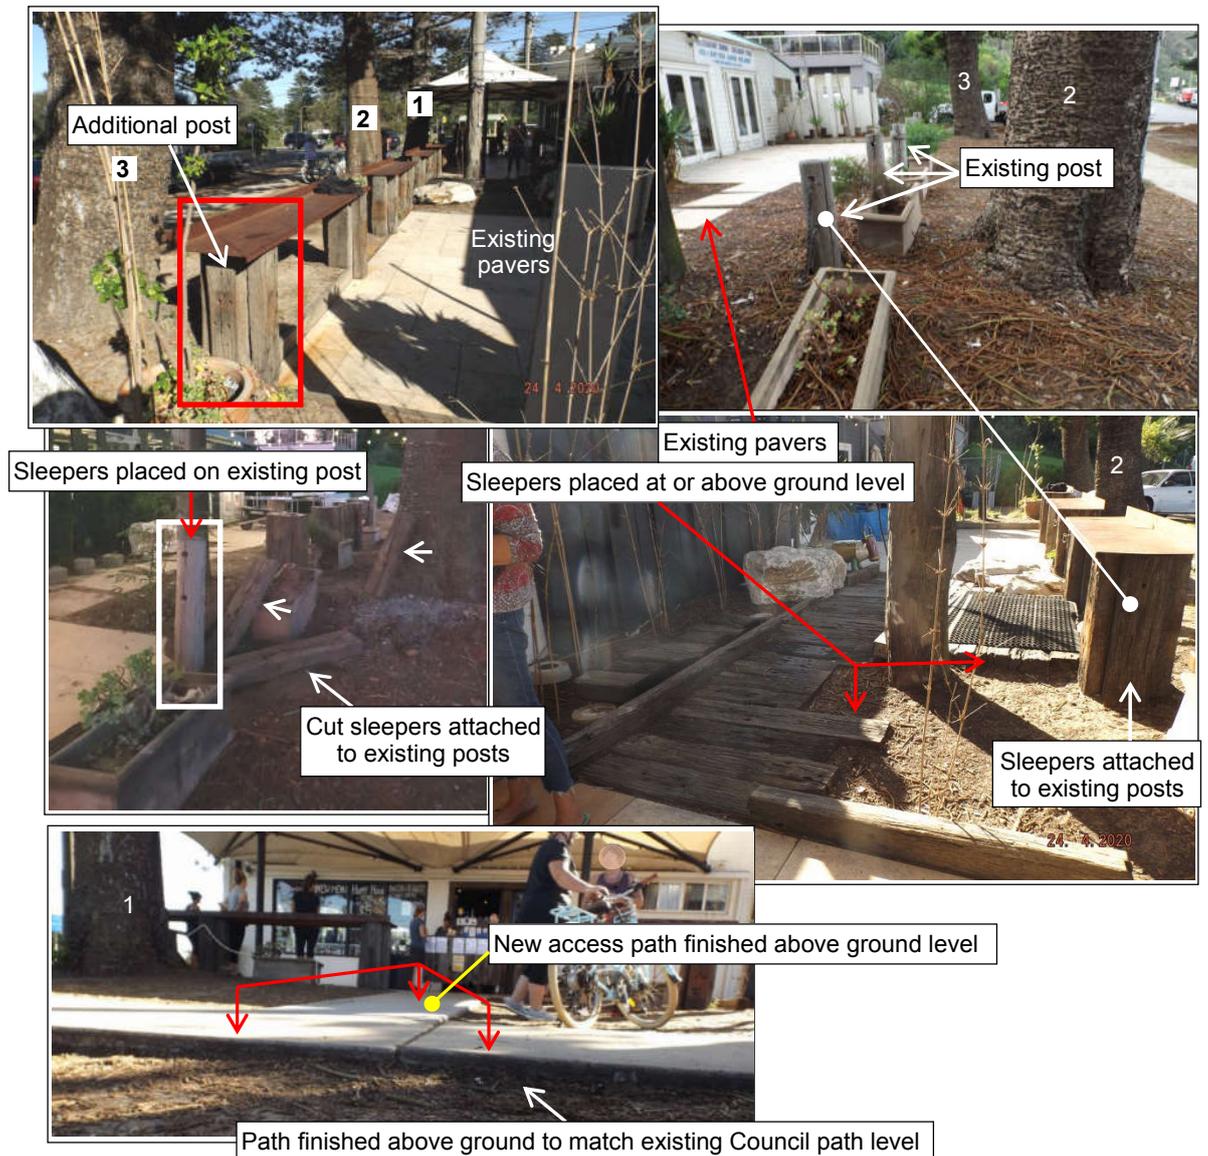
Figure 2, showing works within 5m of trees

3. Additional works to complete the landscape upgrade design proposal consist of an additional usage area and pergola adjacent T3 with line of stone wall cages under outdoor bar table tops. Works are located within SRZ setbacks with the following recommendations provided to minimise impacts to trees by design:

- v. All tree roots at or >30mm(Ø) are to be retained. Should such roots require pruning all works are to be conducted by the site arborist, clean cutting and/or protecting encountered roots in accordance with AS4970-2009 – section 4.5.4 *Root protection during works within the TPZ*. Should there be any uncertainty with root management requirements a minimum AQF Level 5 project arborist is to be consulted.

- vi. There is to be no compaction or additional excavation i.e. SW / hydraulics or electrical service trenching within the TPZ radius without prior arborist advice.
