**Proposed Mixed-Use Development
351-353 Barrenjoey Road, Newport NSW**

Preliminary Geotechnical Assessment

Our ref: 5622-G1 Rev 1
11 December 2020

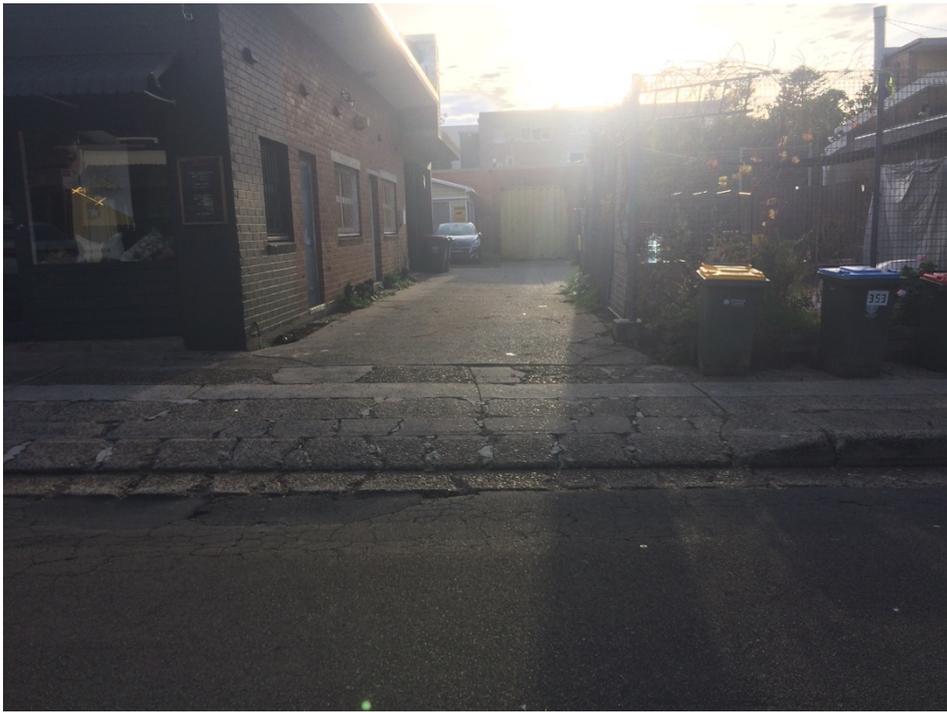
Photo 1

Driveway via Robertson Road, cracks on concrete pavement

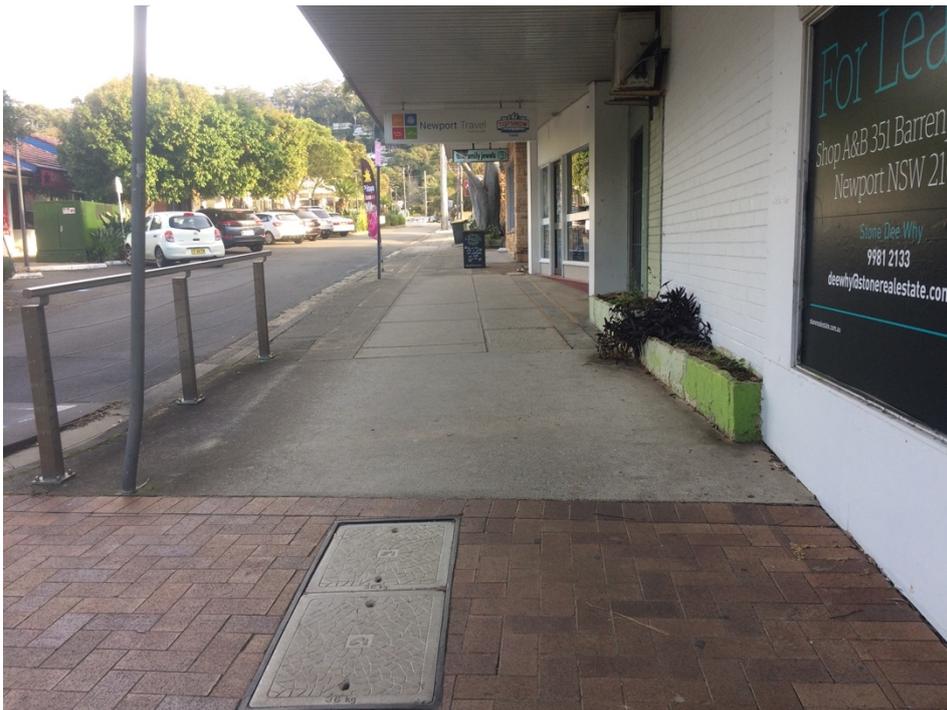
Photo 2

Existing retail on Robertson Road
