Report Title: Geotechnical Report 7B Trentwood Park, Avalon  
Report Date: 14/12/21

## **GEOTECHNICAL INVESTIGATION:**

New House at **7B Trentwood Park, Avalon**

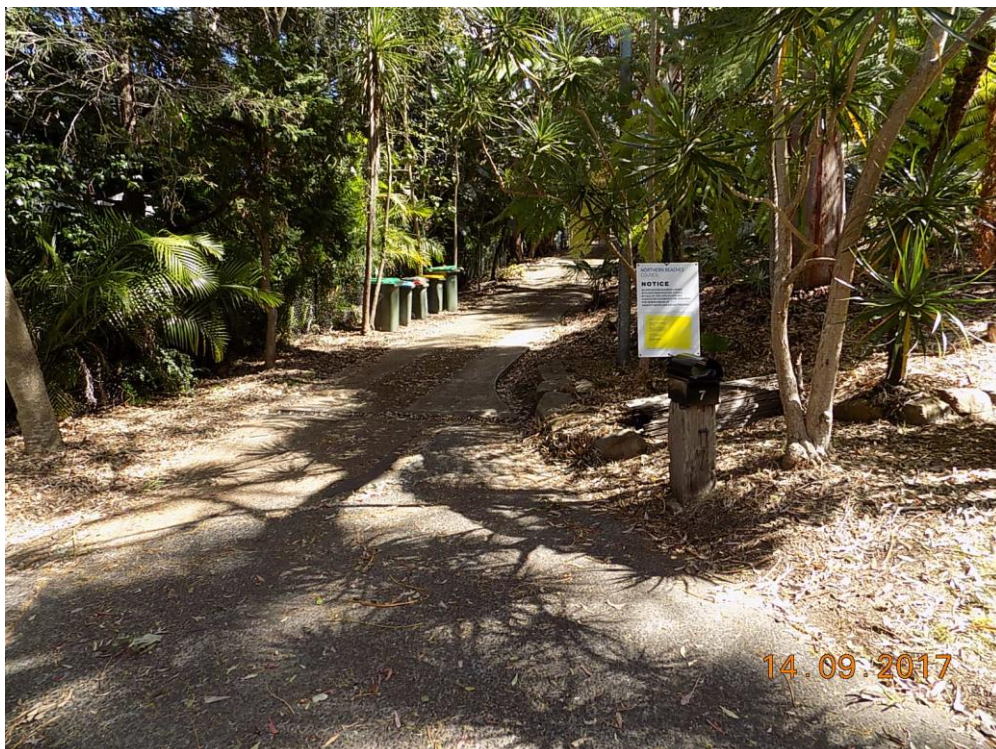
Photo 1

- 2.1** The site was inspected on the 14<sup>th</sup> September, 2017.
- 2.2** This residential property is on the high side of the road and has an E aspect. It is positioned on the moderate to steeply graded middle reaches of a hillslope. The natural slope rises across the property at an average angle of ~20°. The slope above and below the property continues at similar angles.
- 2.3** At the road frontage, a concrete driveway runs up the slope past the S side of the property (Photo 1). The driveway diverts to a lawn-covered parking area on the uphill side of the property (Photo 2). The fill for the lawn-covered parking area is battered to stable angles and merges into the natural slope (Photo 3). Between the road frontage and the lawn-covered parking area, the slope is sparsely vegetated with native trees (Photo 4).

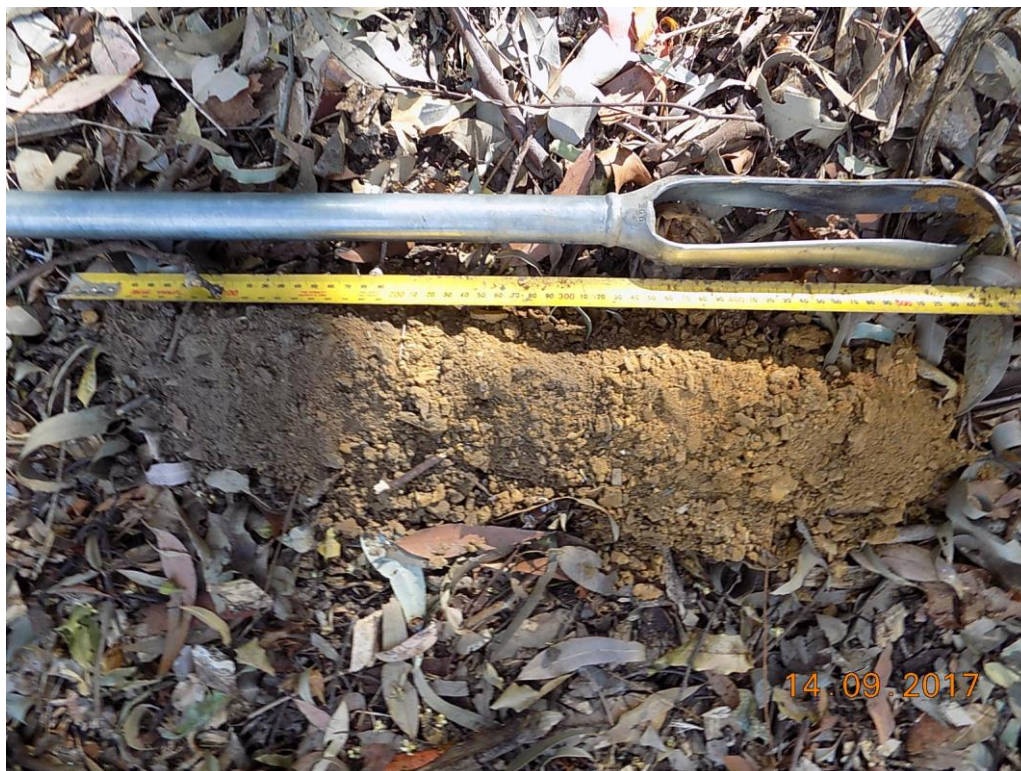
Photo 5: AH1 – Downhole is from left to right

### AUGER HOLE 1 (~RL46.1) – AH1 (Photo 5)

Depth (m)	Material Encountered
0.0 to 0.3	<b>TOPSOIL</b> , sandy soil, brown-grey, fine to medium grained with fine trace organic matter and trace silt.
0.3 to 0.6	<b>CLAY</b> , orange-brown, firm to stiff, fine grained.

End of hole @ 0.6m in firm to stiff clay. No water table encountered.

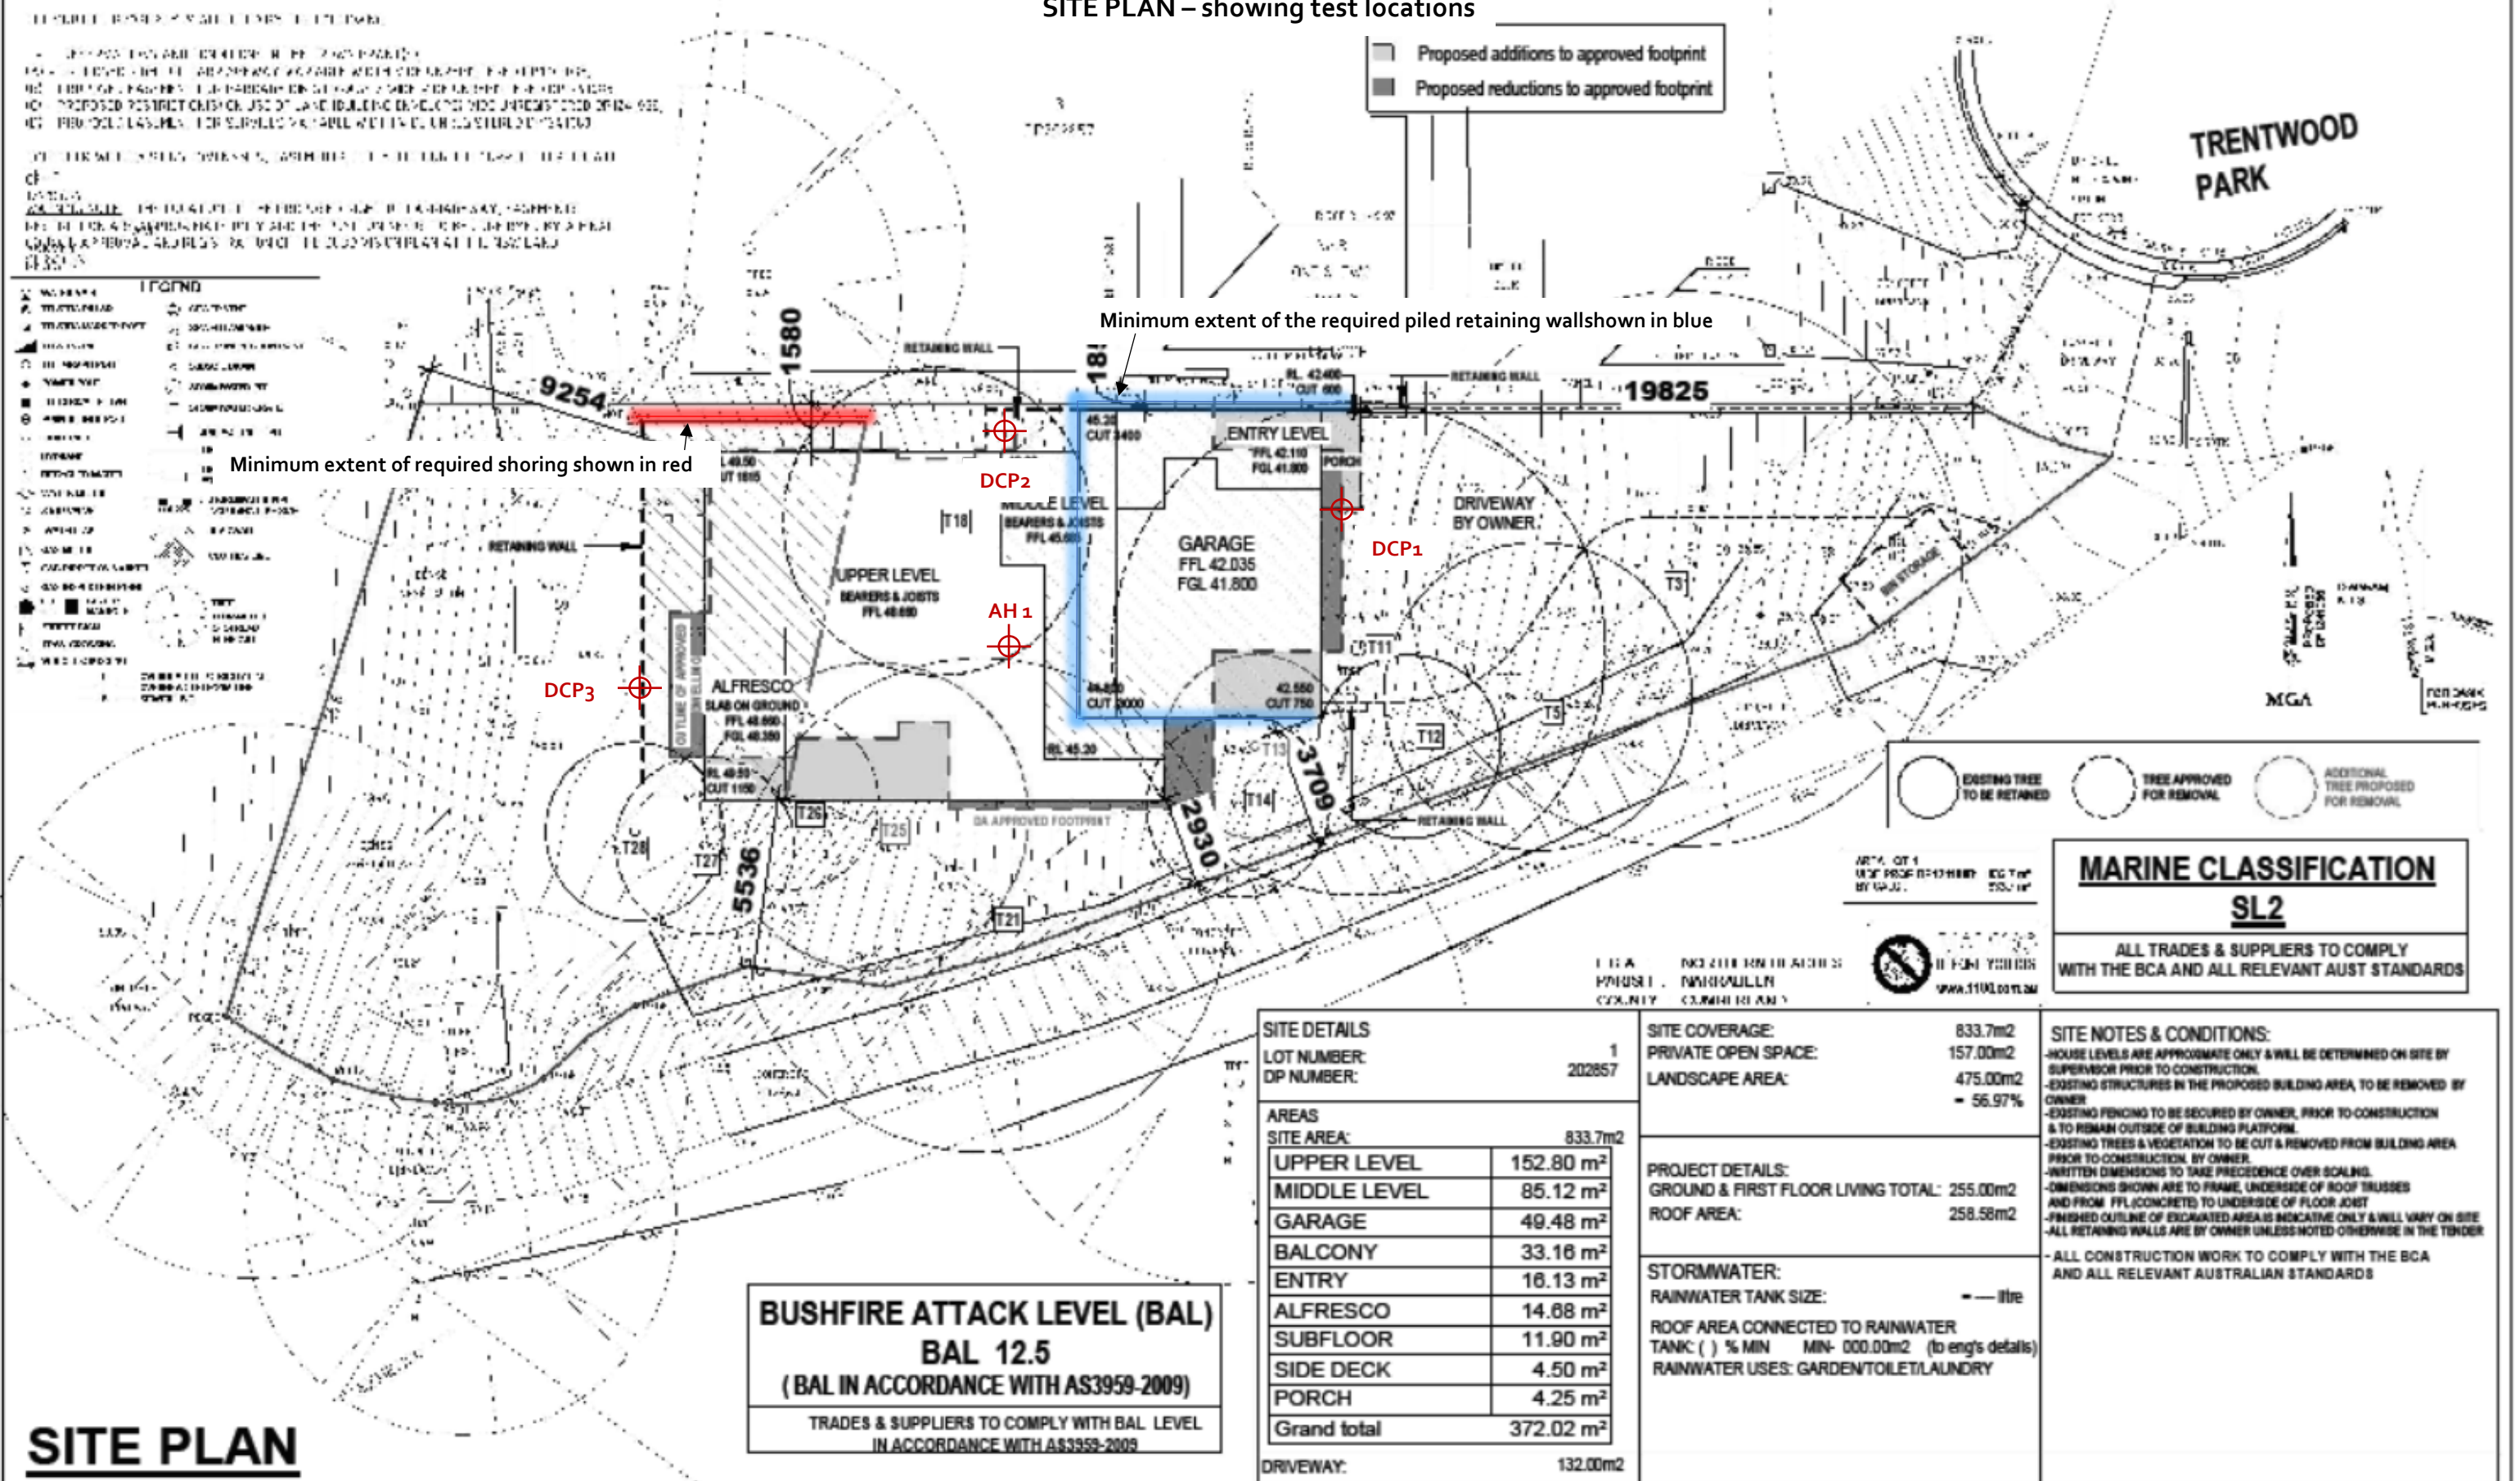
# SITE PLAN – showing test locations

One hand Auger Hole (AH) was put down to identify the soil materials. Three Dynamic Cone Penetrometer (DCP) tests were put down to determine the relative density of the overlying soil and the depth to bedrock. The locations of the tests are shown on the site plan attached. It should be noted that a level of caution should be applied when interpreting DCP test results. The test will not pass through hard buried objects so in some instances it can be difficult to determine whether refusal has occurred on an obstruction in the profile or on the natural rock surface. This is not expected to be an issue for the testing on this site. However, excavation and foundation budgets should always allow for the possibility that the interpreted ground conditions in this report vary from those encountered during excavations. See the appended "Important information about your report" for a more comprehensive explanation. The results are as follows:

The cut will require staged sacrificial temporary support such as braced form ply or similar support installed along the N side as the excavations are progressed in spans not less than 2.0m horizontally. The support is to be designed by the structural engineer. The temporary support is to remain in place until the retaining walls are built. See the site plan attached for the minimum extent of the required shoring.

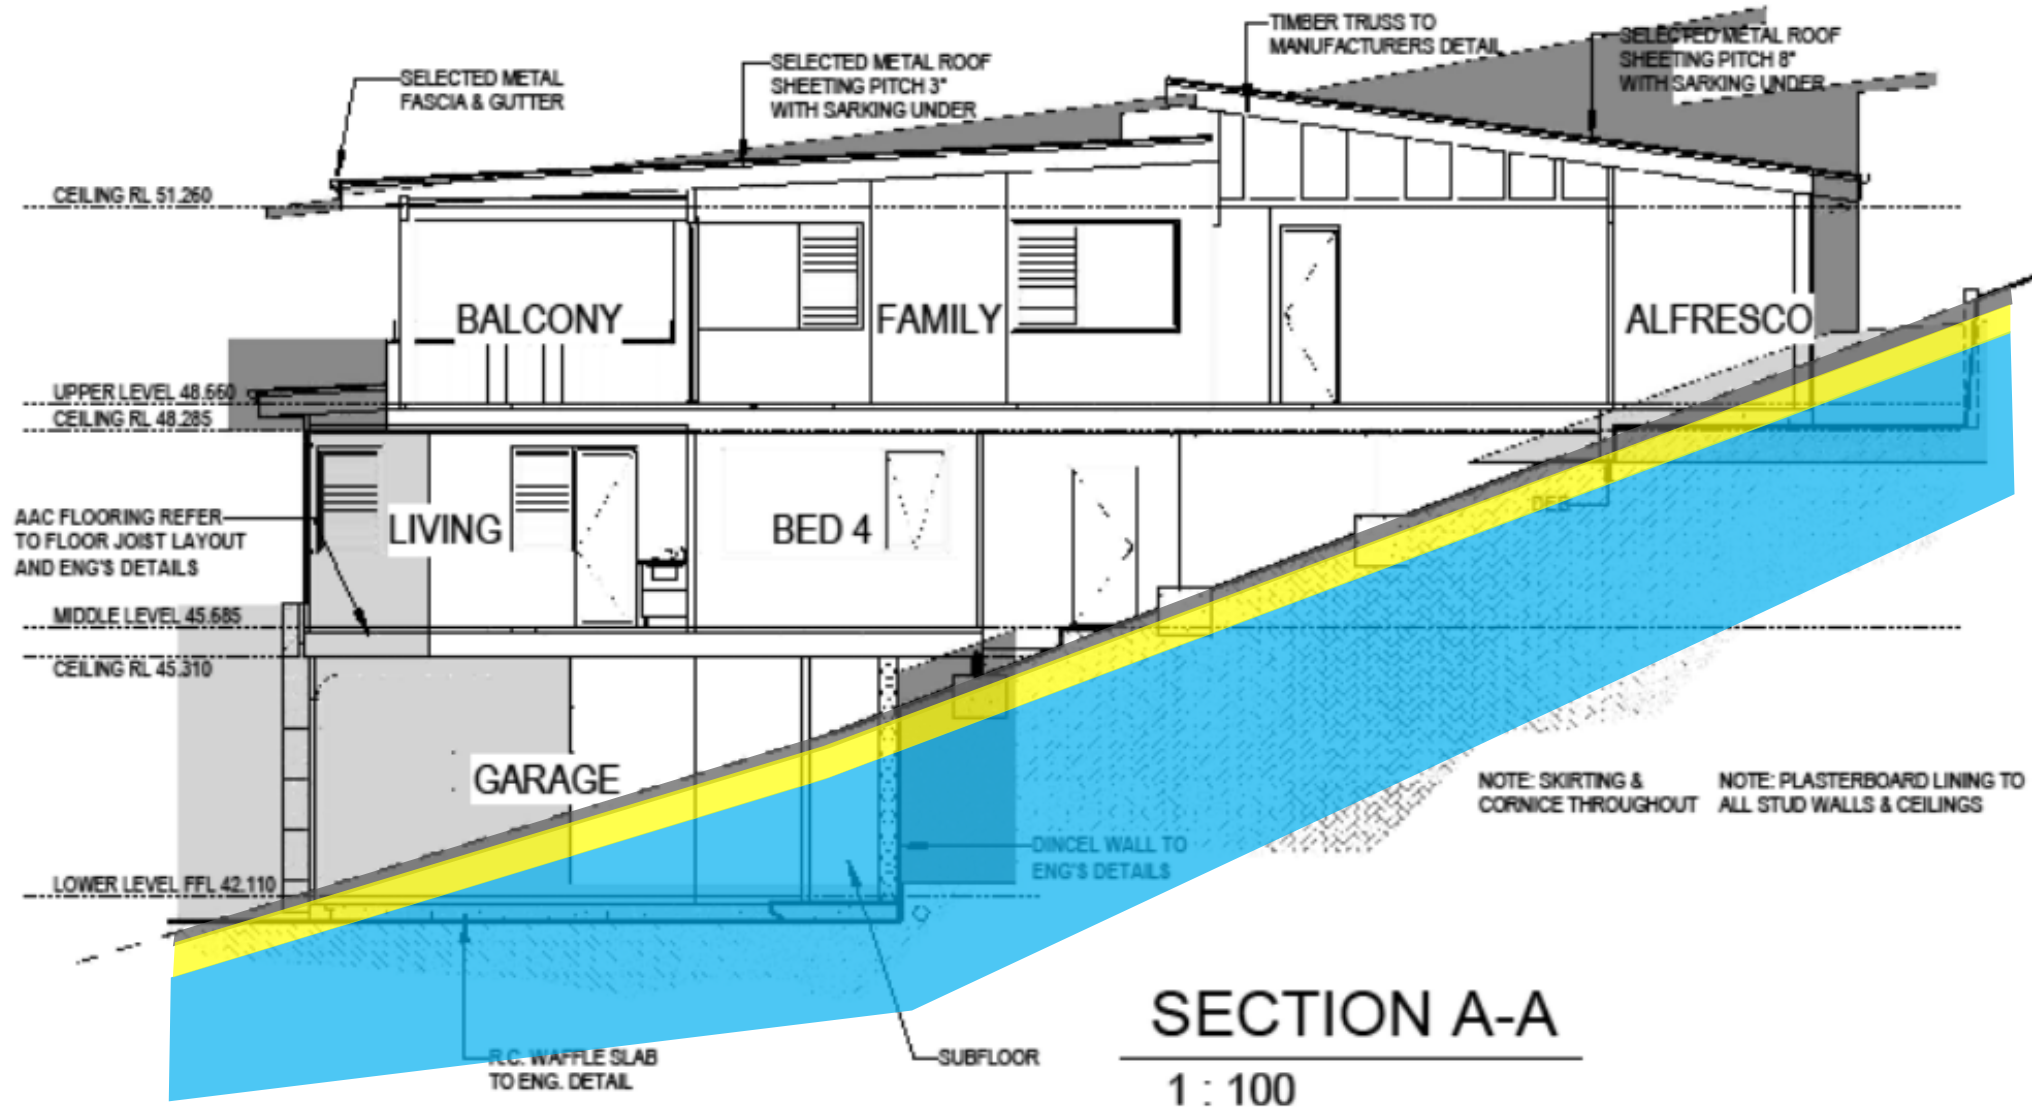
TYPE SECTION – Diagrammatical Interpretation of expected Ground Materials

The slope materials are colluvial at the near surface and residual at depth. They consist of a thin sandy topsoil over firm to stiff clays. In the test locations, the clays merge into the weathered zone of the underlying rocks at an average depth of ~0.6m below the current surface. The weathered zone of the underlying rock is interpreted as Extremely Low to Very Low Strength Shale. It is to be noted that this material is a soft rock and can appear as a mottled stiff clay when it is cut up by excavation equipment. See Type Section attached for a diagrammatical representation of the expected ground materials.

Topsoil

Silty Clay – Firm to Stiff

Narrabeen Group Rocks – Extremely Low to Very Low Strength Shale - after being cut up by excavation equipment can resemble a stiff to hard clay.
