TREE MANAGEMENT CONSULTING ARBORICULTURISTS

ARBORICULTURAL IMPACT ASSESSMENT

STATION BEACH BOATHOUSE WHARF
1191 BARRENJOEY ROAD
PALM BEACH

FEBRUARY 2021

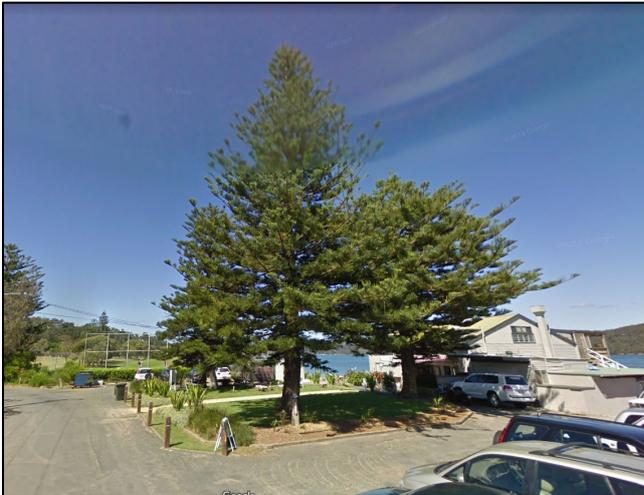
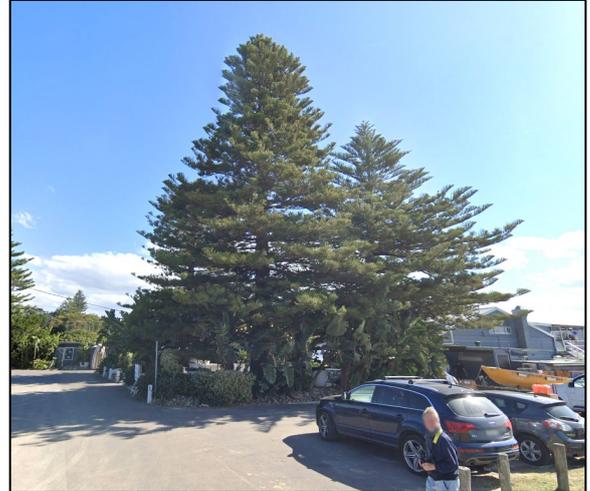
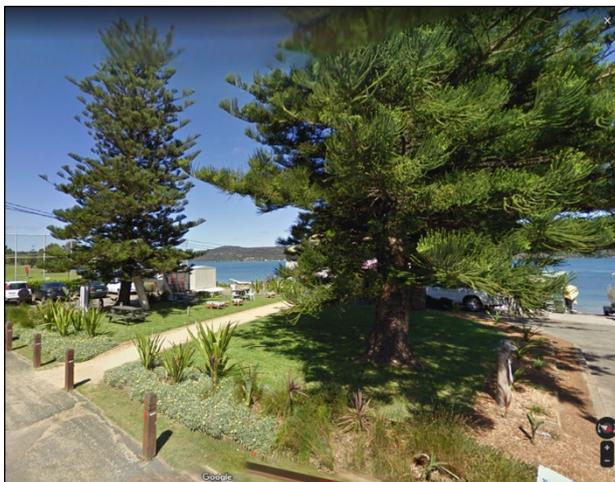
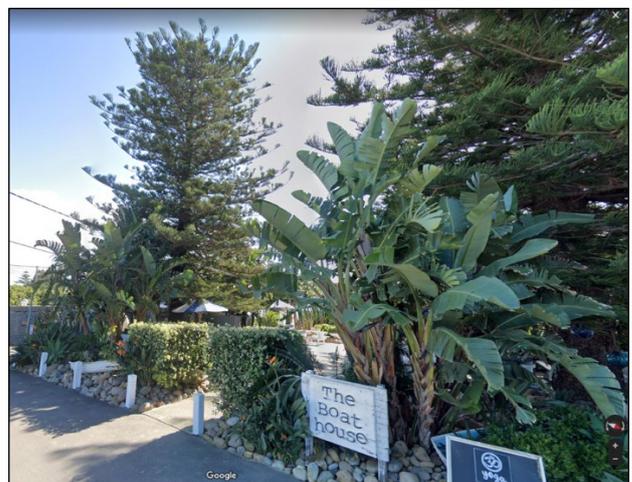
View to southwest from road

3.1.13 Google street view images from 2009 to 2019 below effectively demonstrate the changes from the approved landscape at natural grade to a landscape that has built up its levels around the trees and the perimeter of the Licenced Area to create an enclosed space.

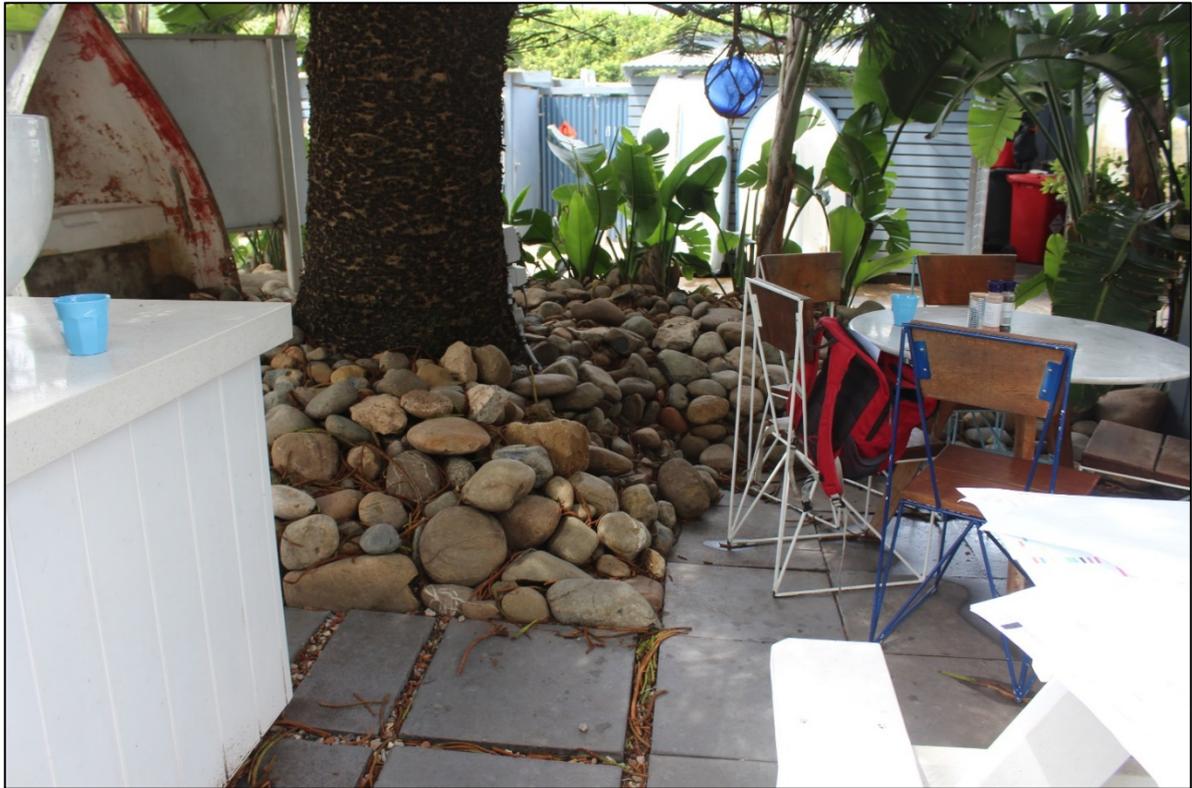
Figure 1 – Tree 1

Shows the existing pavers and structures within the SRZ of Tree 1. These will be removed and replaced with landscaping only. Refer to the ecologist's landscape report and the Landscape Plan LP01-C for planting details.

- Removal of existing pavers, pavement and structures north and northwest of the tree (diagonal hatched areas on Plan DA04), low level of clean 80% sand 20% loam (80/20 sandy loam) fill, use of existing river stones to protect the SRZ, and landscaping with tubestock (e.g. forestry tubes) size plantings.
- Shallow depth of clean 80/20 sandy loam fill after removal. Replace with new pavers with approximately 50mm gaps to assist with oxygen and water movement to tree roots and to provide space for 'gap-filler' plantings – see notes on Landscape Plan LP01-C.
- No excavation is proposed inside the tree's SRZ.

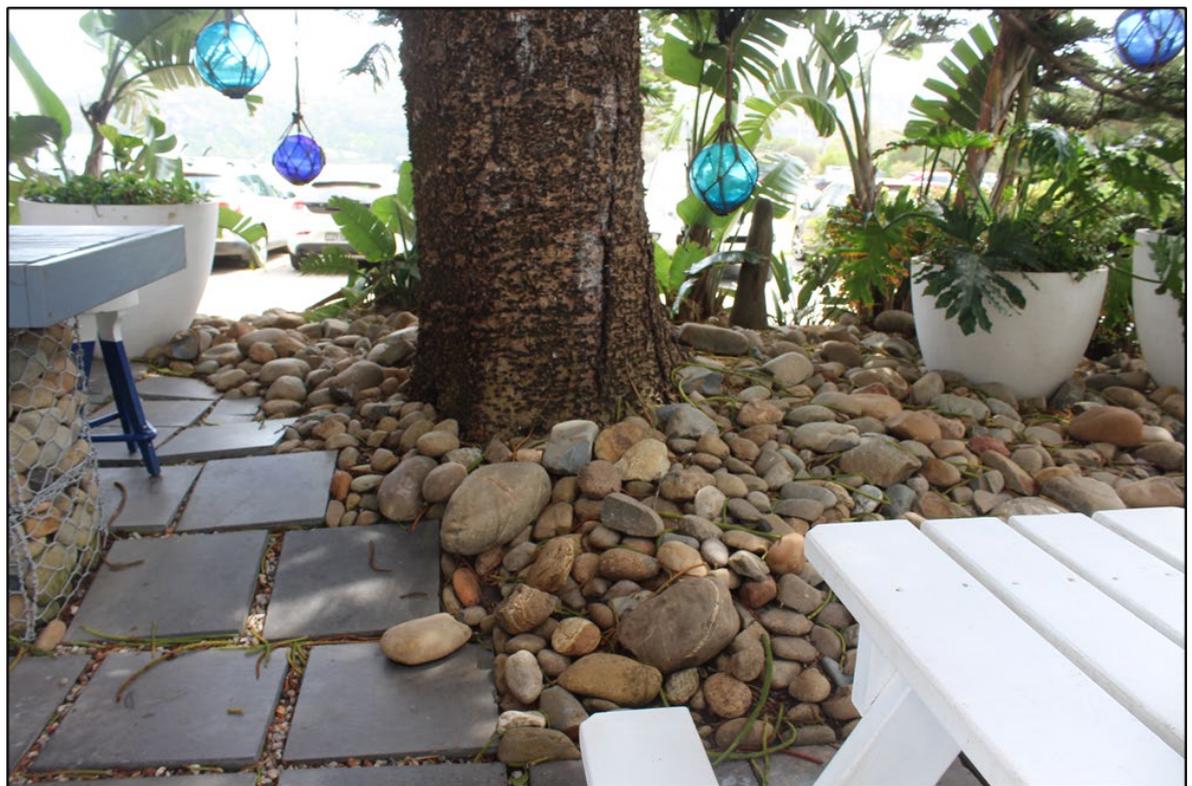
Figure 2 – Tree 2

Shows the existing pavers and structures within the SRZ of Tree 2. These will be removed and replaced with landscaping, with a small section of paved area within the SRZ area to the south retained for use. The pavers will be removed, new 80/20 fill to a depth no greater than 100mm depth and then new pavers seated on sand with 20mm gaps to maintain soil moisture and gaseous exchange to soil beneath. Refer to the ecologist's landscape report and Landscape Plan LP01-C for planting details.

- Removal of existing pavers, pavement and structures to the immediate west of the tree (diagonal hatched area on Plan DA04), low level of clean 80% sand 20% loam fill (80/20 sandy loam), use of existing river stones to protect the SRZ, and landscaping with small container size plantings.
- Remove existing pavers. Shallow depth of clean 80/20 sandy loam fill after removal of pavers. Replace with new pavers with approximately 50mm gaps to assist with oxygen and water movement.
- No excavation is proposed inside the tree's SRZ.

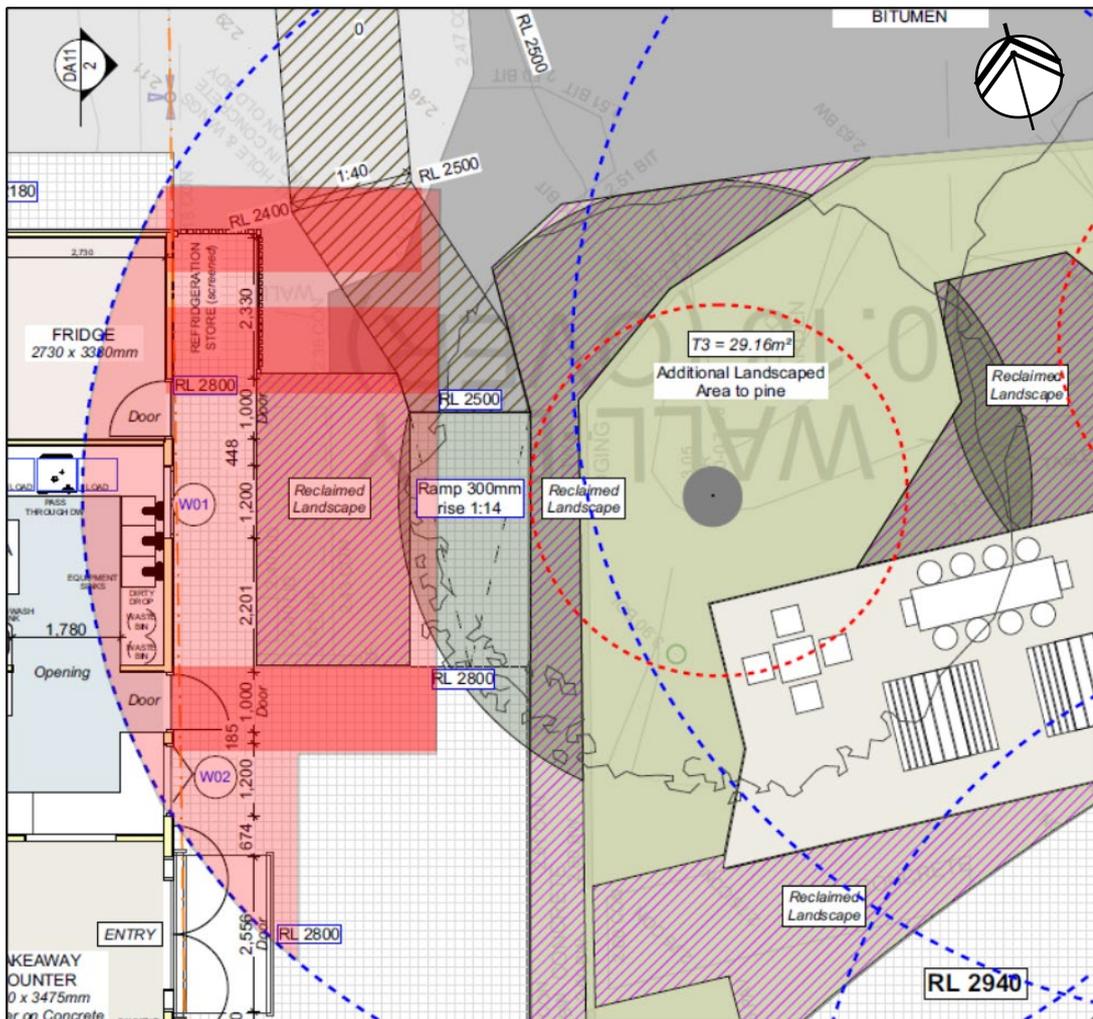
Figure 3 – Tree 3

The shaded red areas show the extent of excavation, including generous ‘disturbance’ area around the proposed ground anchors, drainage service pipes, and the like, within the TPZ of Tree 3. Following excavation and installation of services and the other structures, fine roots can generate and grow into those areas not occupied by the below ground structures. Note proposed extension of landscape area (shaded pink) to west of the tree. Marked up excerpt of DA04, by C. Mackenzie. Not to scale.
