Report Title: Geotechnical Report 2 Milga Road, Avalon
Report Date: 25/7/24

GEOTECHNICAL INVESTIGATION:

New Retaining Wall at 2 Milga Road, Avalon

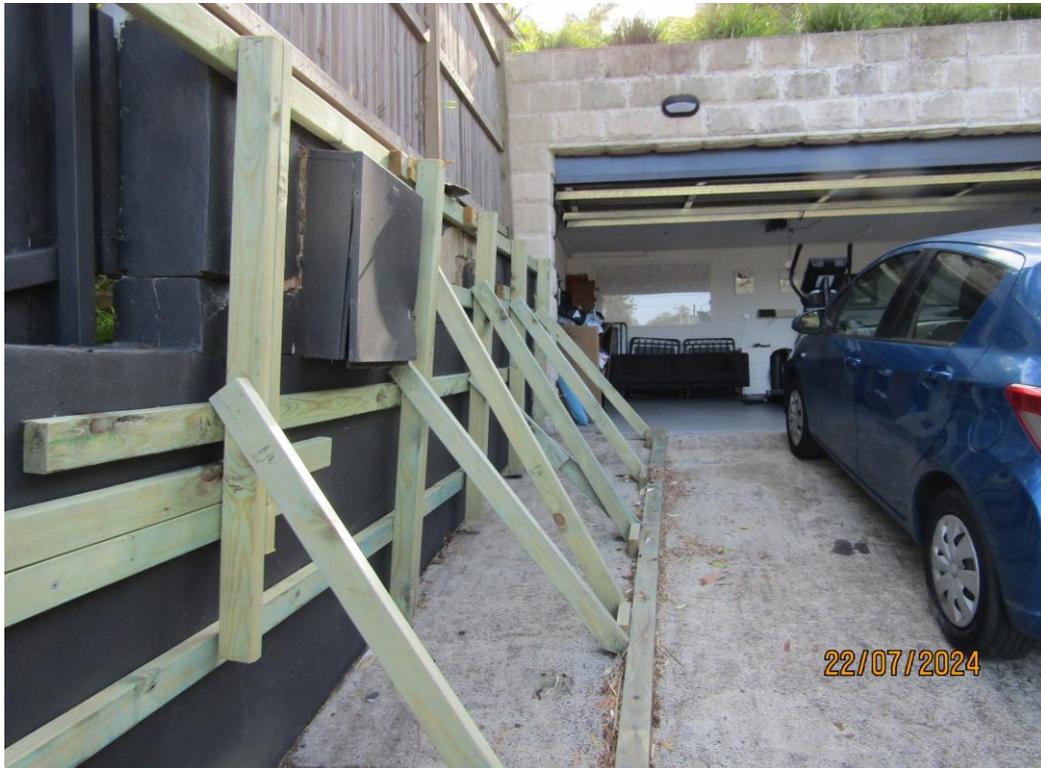
Photo 1

- 2.3** At the road frontage, a concrete Right of Carriageway (ROW) runs up the slope to a concrete driveway and stable concrete block garage at the downhill side of the property (Photos 1 & 2). A rendered masonry retaining wall up to ~1.6m high supports a cut for the driveway and fill for a lawn and garden area above (Photos 2 & 3). The wall is tilting downslope and displays stepped and horizontal cracking. The wall is currently braced with timber. We have been informed by the owner that the wall was damaged by a vehicle. We have also been informed that the wall was tilting downslope significantly prior to being damaged by the vehicle. It is expected that the previous movement has been caused by a palm tree on the uphill side of the wall (Photo 13). These types of plants are supported by a large root ball. As the tree grows and the

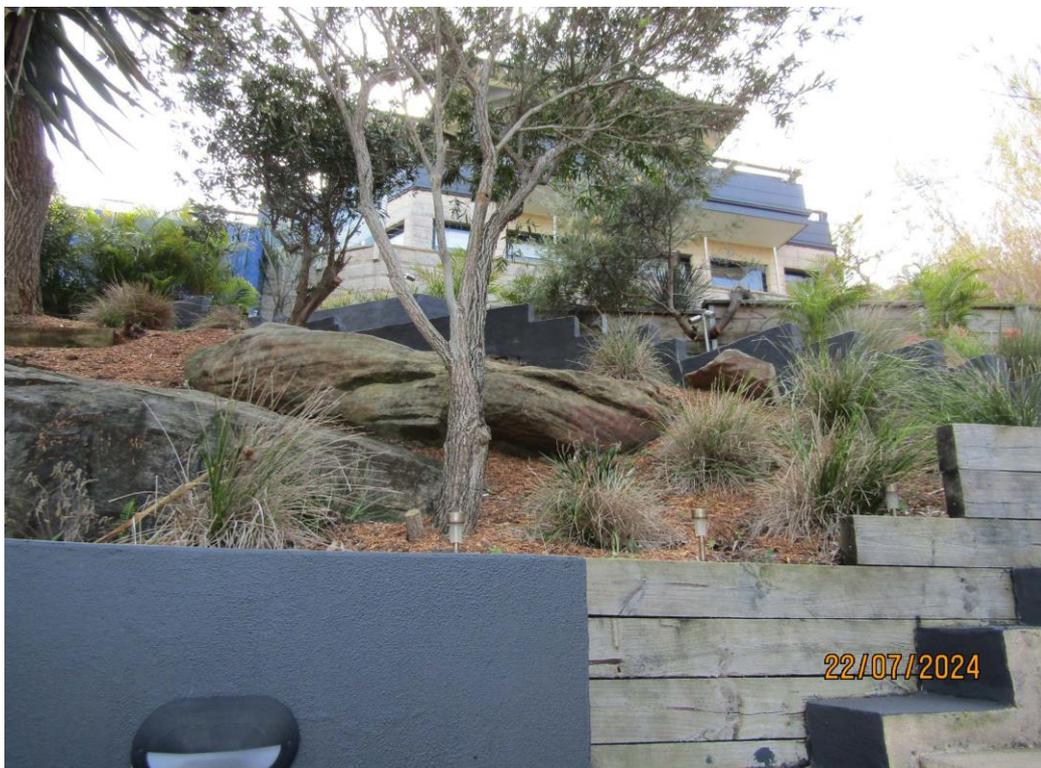
Photo 4

Timber and masonry retaining walls up to ~2.0m high terrace the slope between the ROW and the house (Photos 4 to 6). The timber retaining wall along the downhill property boundary is tilting downslope slightly. See 'Section 16 Ongoing Maintenance'. Sandstone is exposed at the surface beside and upslope of the garage (Photos 4 & 5). The lower rock (Photo 4) is interpreted to be a detached sandstone joint block. It is unknown if the upper rocks (Photo 5) are detached joint blocks or if they are bedrock. An inclined lift runs from the uphill side of the garage to the SW side of the house (Photo 7). A pool that shows no significant signs of movement is located SW of the house (Photo 8). The exterior of the two storey sandstone-dressed and timber clad house with deck shows no significant signs of movement (Photos 6 & 9). A timber retaining wall up to ~1.5m high and a rendered masonry retaining wall up to ~3.0m high support a cut for the uphill side of the house with deck (Photos 10 & 11). The rendered masonry retaining wall appears to be stable. The timber retaining wall is tilting downslope slightly. See 'Section 16 Ongoing Maintenance'. A moderately graded garden area extends from the uphill side of the retaining walls to the uphill property boundary. The slope above the property is densely vegetated (Photo 12). Apart from the damaged retaining wall that will be replaced, no signs of slope instability were observed on the property that could have occurred since the property was developed. The adjoining neighbouring properties were observed to be in good order as seen from the street and subject property.

The tilting timber retaining walls across the property (Photos 4 & 11) are to be monitored by the owners on an annual basis or after heavy and prolonged rainfall events, whichever occurs first. A photographic record of these inspections is to be kept. Should further movement occur the walls are to be remediated or replaced so that they meet current engineering standards. We can carry out these inspections upon request.
