GEOTECHNICAL INVESTIGATION:

New House and Pool at **1005-1009 Barrenjoey Road, Palm Beach**

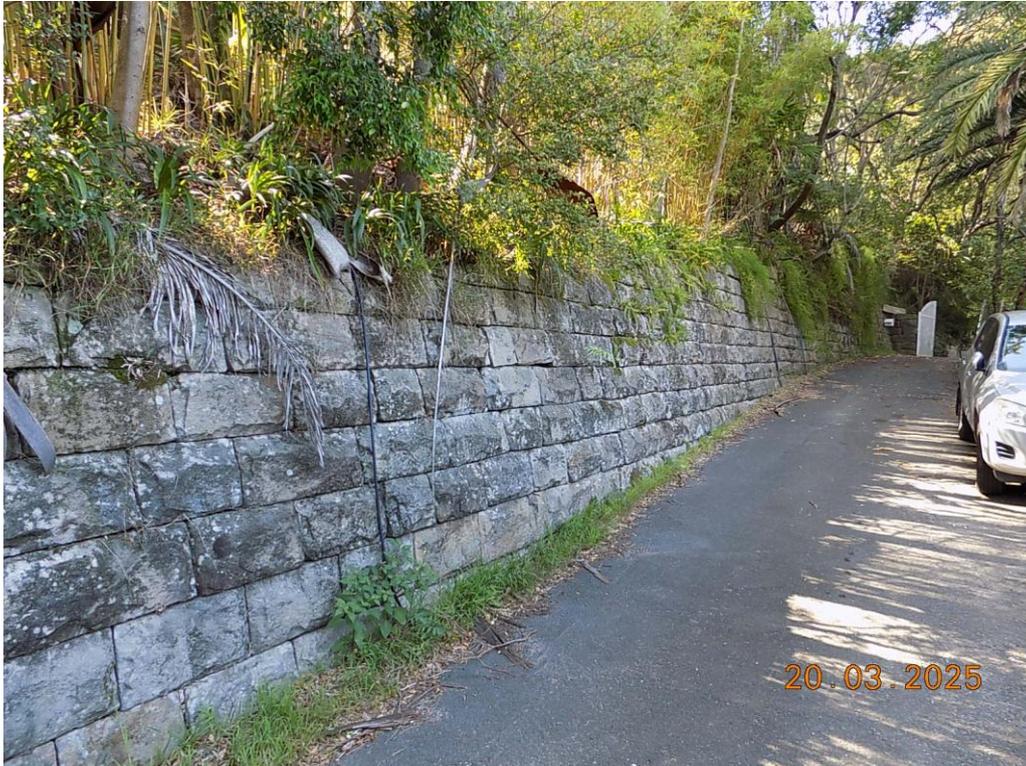
Photo 1

- 2.1** The site was inspected on the 20th March, 2025.
- 2.2** This large residential property is accessed via a shared driveway in the road reserve, that runs parallel and at a lower level to the main roadway of Barrenjoey Road and has a SW aspect. It is located on the gentle to near level lower reaches of a hillslope. The natural slope falls below the ROW at gentle angles before continuing at near level angles of <math><5^\circ</math> to the waterfront. The slope above the property quickly increases in grade.
- 2.3** Above the subject property, a cut for the uphill side of the ROW and fill for Barrenjoey Road is supported by a stable ~2.5m high sandstone block retaining wall (Photo 1 & 2). The gently graded slope on the downhill side of the ROW is supported by retaining walls of timber crib, brick, and mortared sandstone construction (Photo

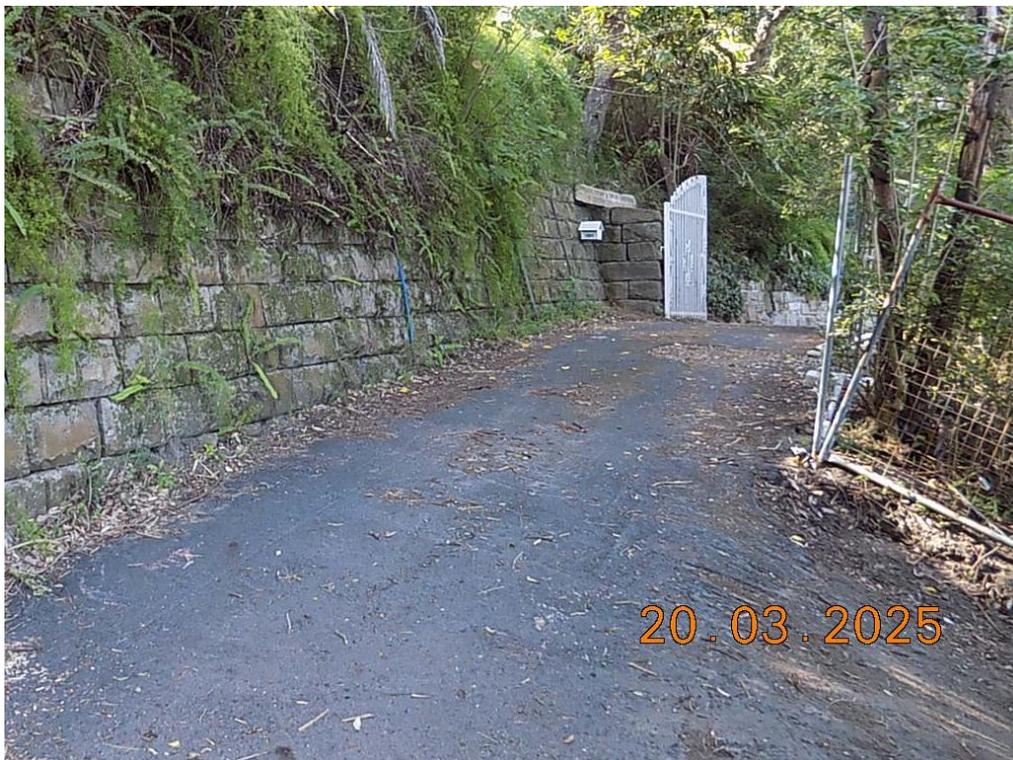
Photo 2

HAZARDS	Hazard Three	Hazard Four
TYPE	Following the demolition of the brick retaining wall (Photo 3), the exposed cut batter failing and impacting on the subject property and ROW (Photo 2) before retaining walls are in place.	The finished pool being emptied, resulting in it floating on the water table and popping out of the ground.
LIKELIHOOD	'Possible' (10^{-3})	'Possible' (10^{-3})
CONSEQUENCES TO PROPERTY	'Medium' (15%)	'Medium' (12%)
RISK TO PROPERTY	'Moderate' (2×10^{-4})	'Moderate' (2×10^{-4})
RISK TO LIFE	8.3×10^{-6} /annum	8.3×10^{-7} /annum
COMMENTS	This level of risk to property is 'UNACCEPTABLE'. To move risk to 'ACCEPTABLE' levels, the recommendations in Section 13 and 14 are to be followed.	This level of risk to property is 'UNACCEPTABLE'. To move risk to 'ACCEPTABLE' levels the recommendations in Section 17 are to be followed.

It is proposed to demolish a ~0.8m high failing brick retaining wall (Photo 3) which approximates the uphill boundary and supports fill for the ROW (Photo 2). As such, the uphill boundary and the bitumen ROW will lie within the Zone of Influence of the exposed cut batter following the retaining wall demolition. In this instance, the zone of influence is the area above a theoretical 30° line through sand from the base of the cut batter towards the surrounding boundaries or structures.

This wall is to be demolished from the top down in an orderly manner. The fill, soil, and sand behind the wall will need to be temporarily or permanently supported prior to the commencement of the demolition, or during the demolition process in a staged manner, so cut batters are not left unsupported. The support will need to account for surcharges imparted by vehicles from the ROW immediately upslope and is to be designed by the structural engineer in consultation with the Geotechnical Consultant. See the site plan attached for the minimum extent of the required shoring shown in blue.

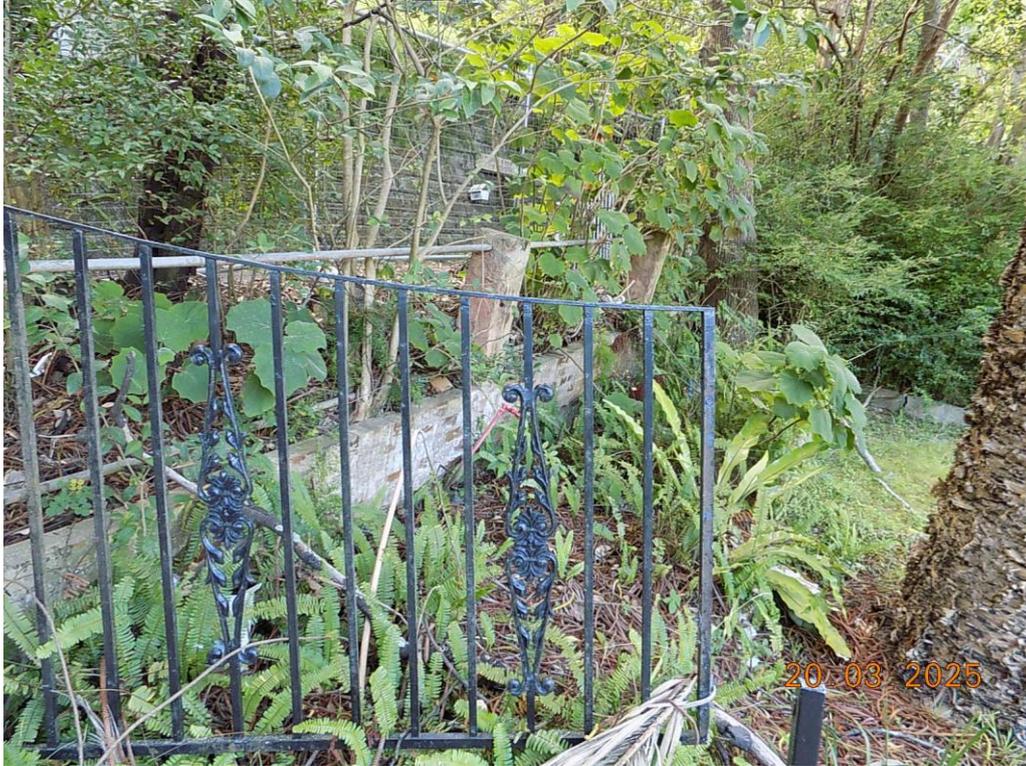
Photo 3

3). These walls will be demolished as part of the proposed works. The bitumen ROW runs to two driveways of concrete, brick paving, and gravel construction. The gravel driveway runs to a garage on the ground floor of the house (Photo 4). Between the ROW frontage and the house is a near-level lawn and garden area (Photo 5). The two-story house is supported on brick walls and brick piers. No significant signs of movement were observed in the visible supporting walls, and the supporting piers stand vertical. The land surface surrounding the house is near level lawn. The lawn continues below the house for some ~32m before stepping down slightly to the sand at the beach front (Photo 6).

Upslope runoff is to be diverted from the retaining wall demolition for the uphill boundary retaining wall by sandbag mounds or other diversion works.

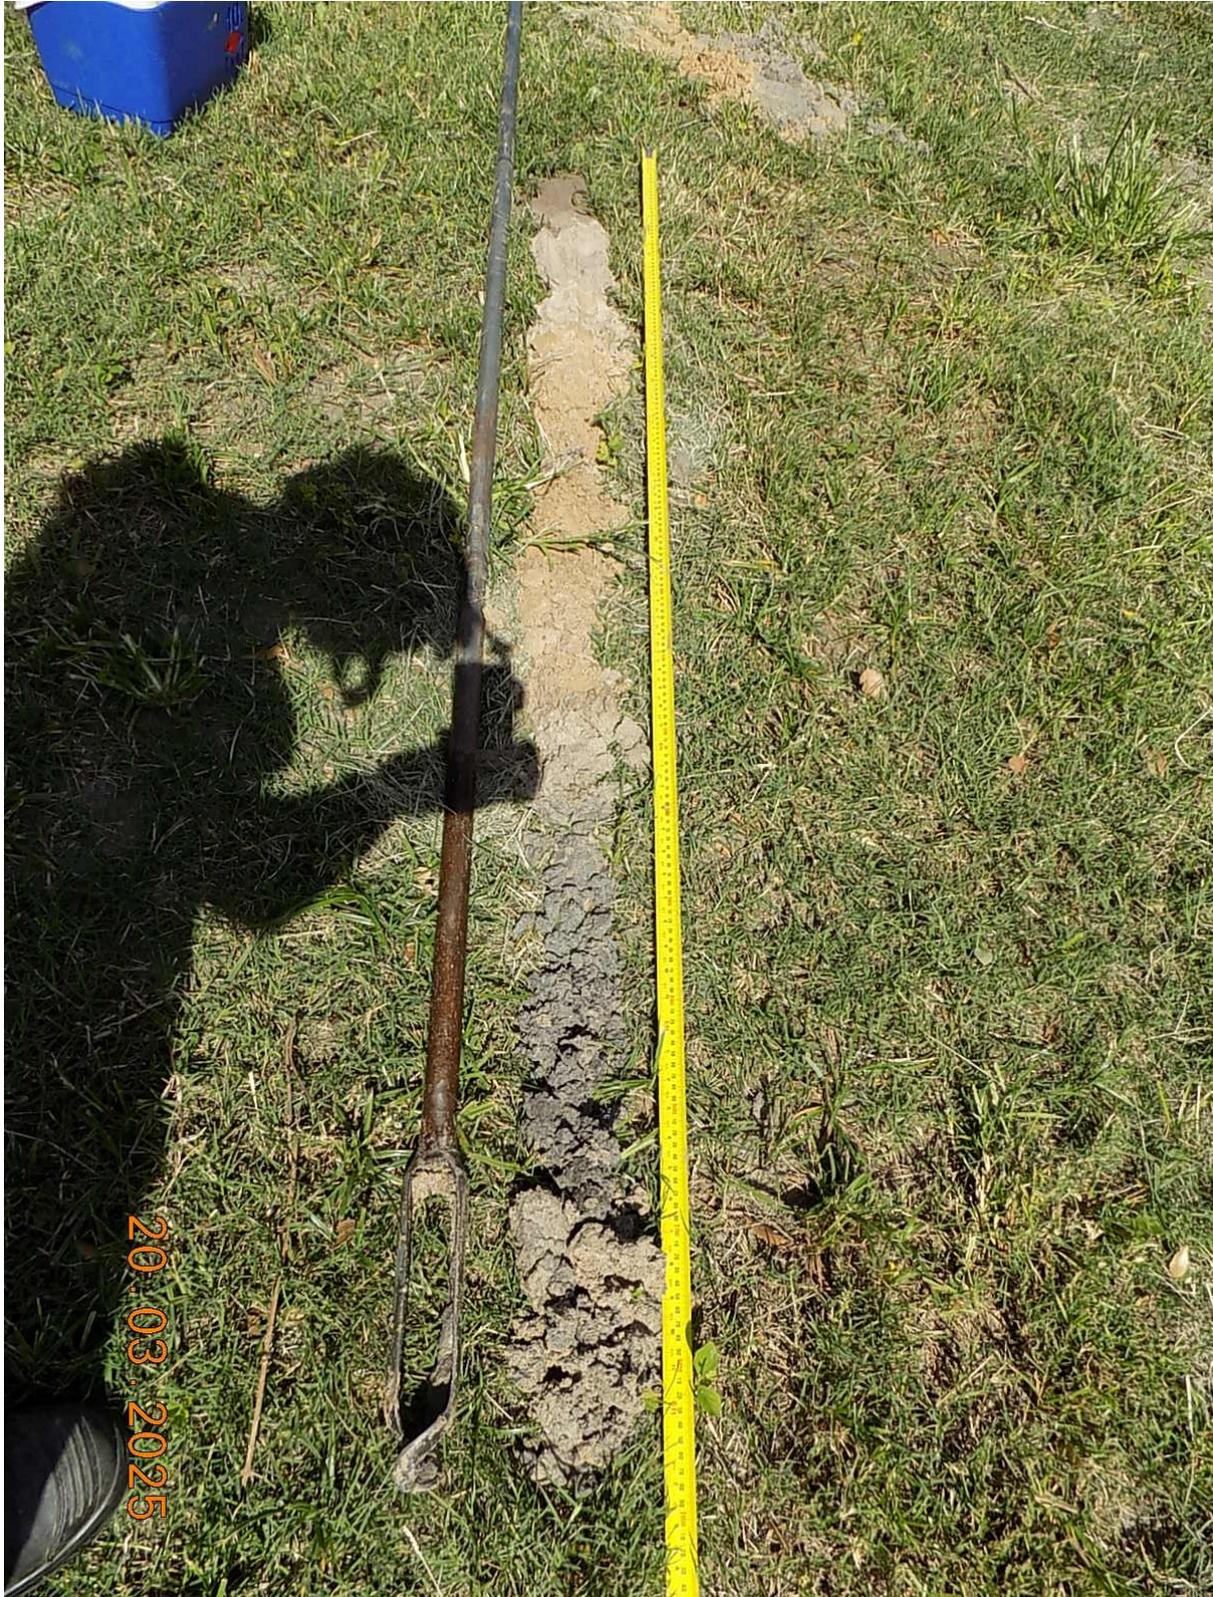
Photo 7 – downhole is top to bottom

AUGER HOLE 1 (~RL1.6) – AH1 (Photo 7)

Depth (m)	Material Encountered
0.0 to 0.2	TOPSOIL , silty sandy soil, brown, Dense, dry, fine to medium grained.
0.2 to 1.2	MARINE SEDIMENT , clean quartz sand, yellow, Medium Dense to Dense, dry to damp, medium grained, shell fragments throughout.
1.2 to 1.9	MARINE SEDIMENT , clean quartz sand, grey, Medium Dense, wet, medium to coarse grained, shell fragments throughout.

End of hole @ 1.9m in marine sediment. Hole collapsing due to presence of water. Water table encountered at ~1.3m.

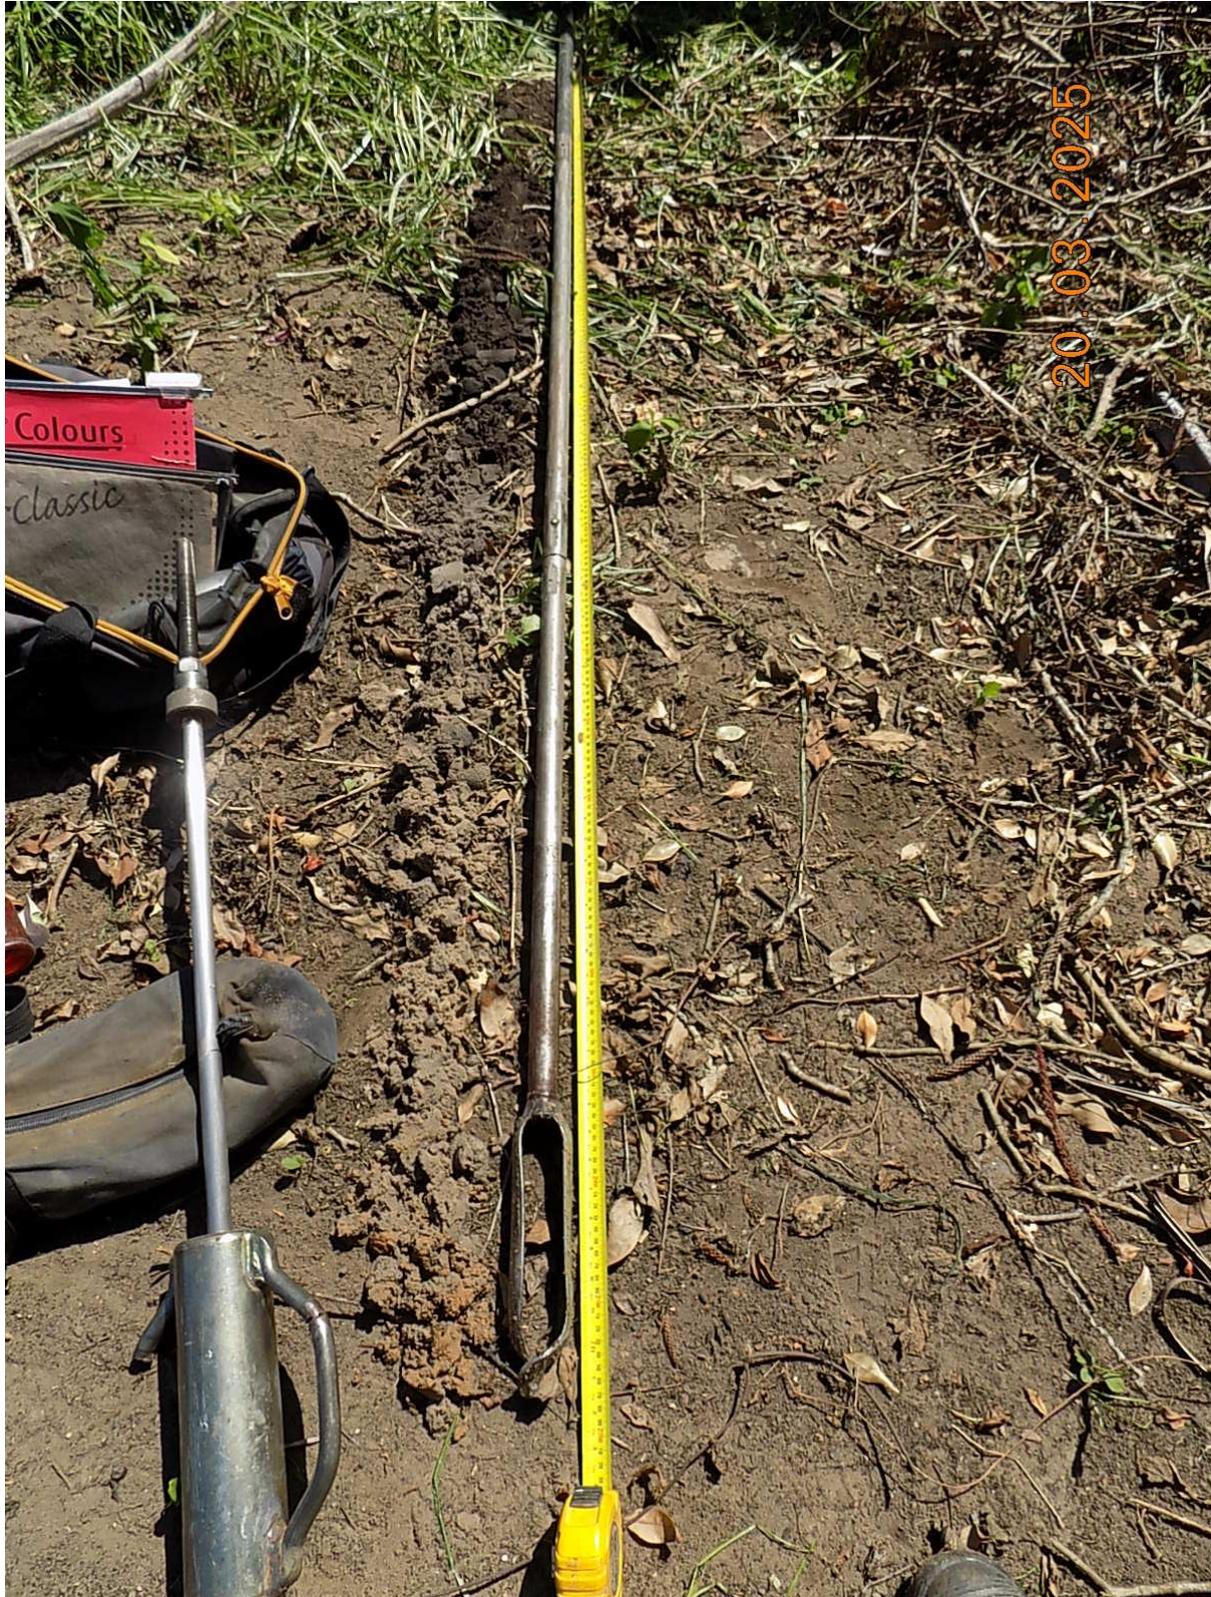
Photo 8 - downhole is top to bottom

AUGER HOLE 2 (~RL2.2) – AH2 (Photo 8)

Depth (m)	Material Encountered
0.0 to 0.4	FILL , sandy fill, dark brown, Very Dense, dry, medium grained.
0.4 to 0.7	TOPSOIL , sandy, dark brown, Medium Dense to Dense, dry, fine to medium grained.
0.7 to 1.1	SANDY LOAM , dark brown, Medium Dense, dry, fine to coarse grained.
1.1 to 2.1	MARINE SEDIMENT , clean quartz sand, grey to orange, Medium Dense, dry to wet, medium to coarse grained, shell fragments throughout, maroon clay flecks at base of auger.

End of Hole @ 2.1m in marine sediment. Hole collapsing due to presence of water. Water table encountered at ~1.6m.

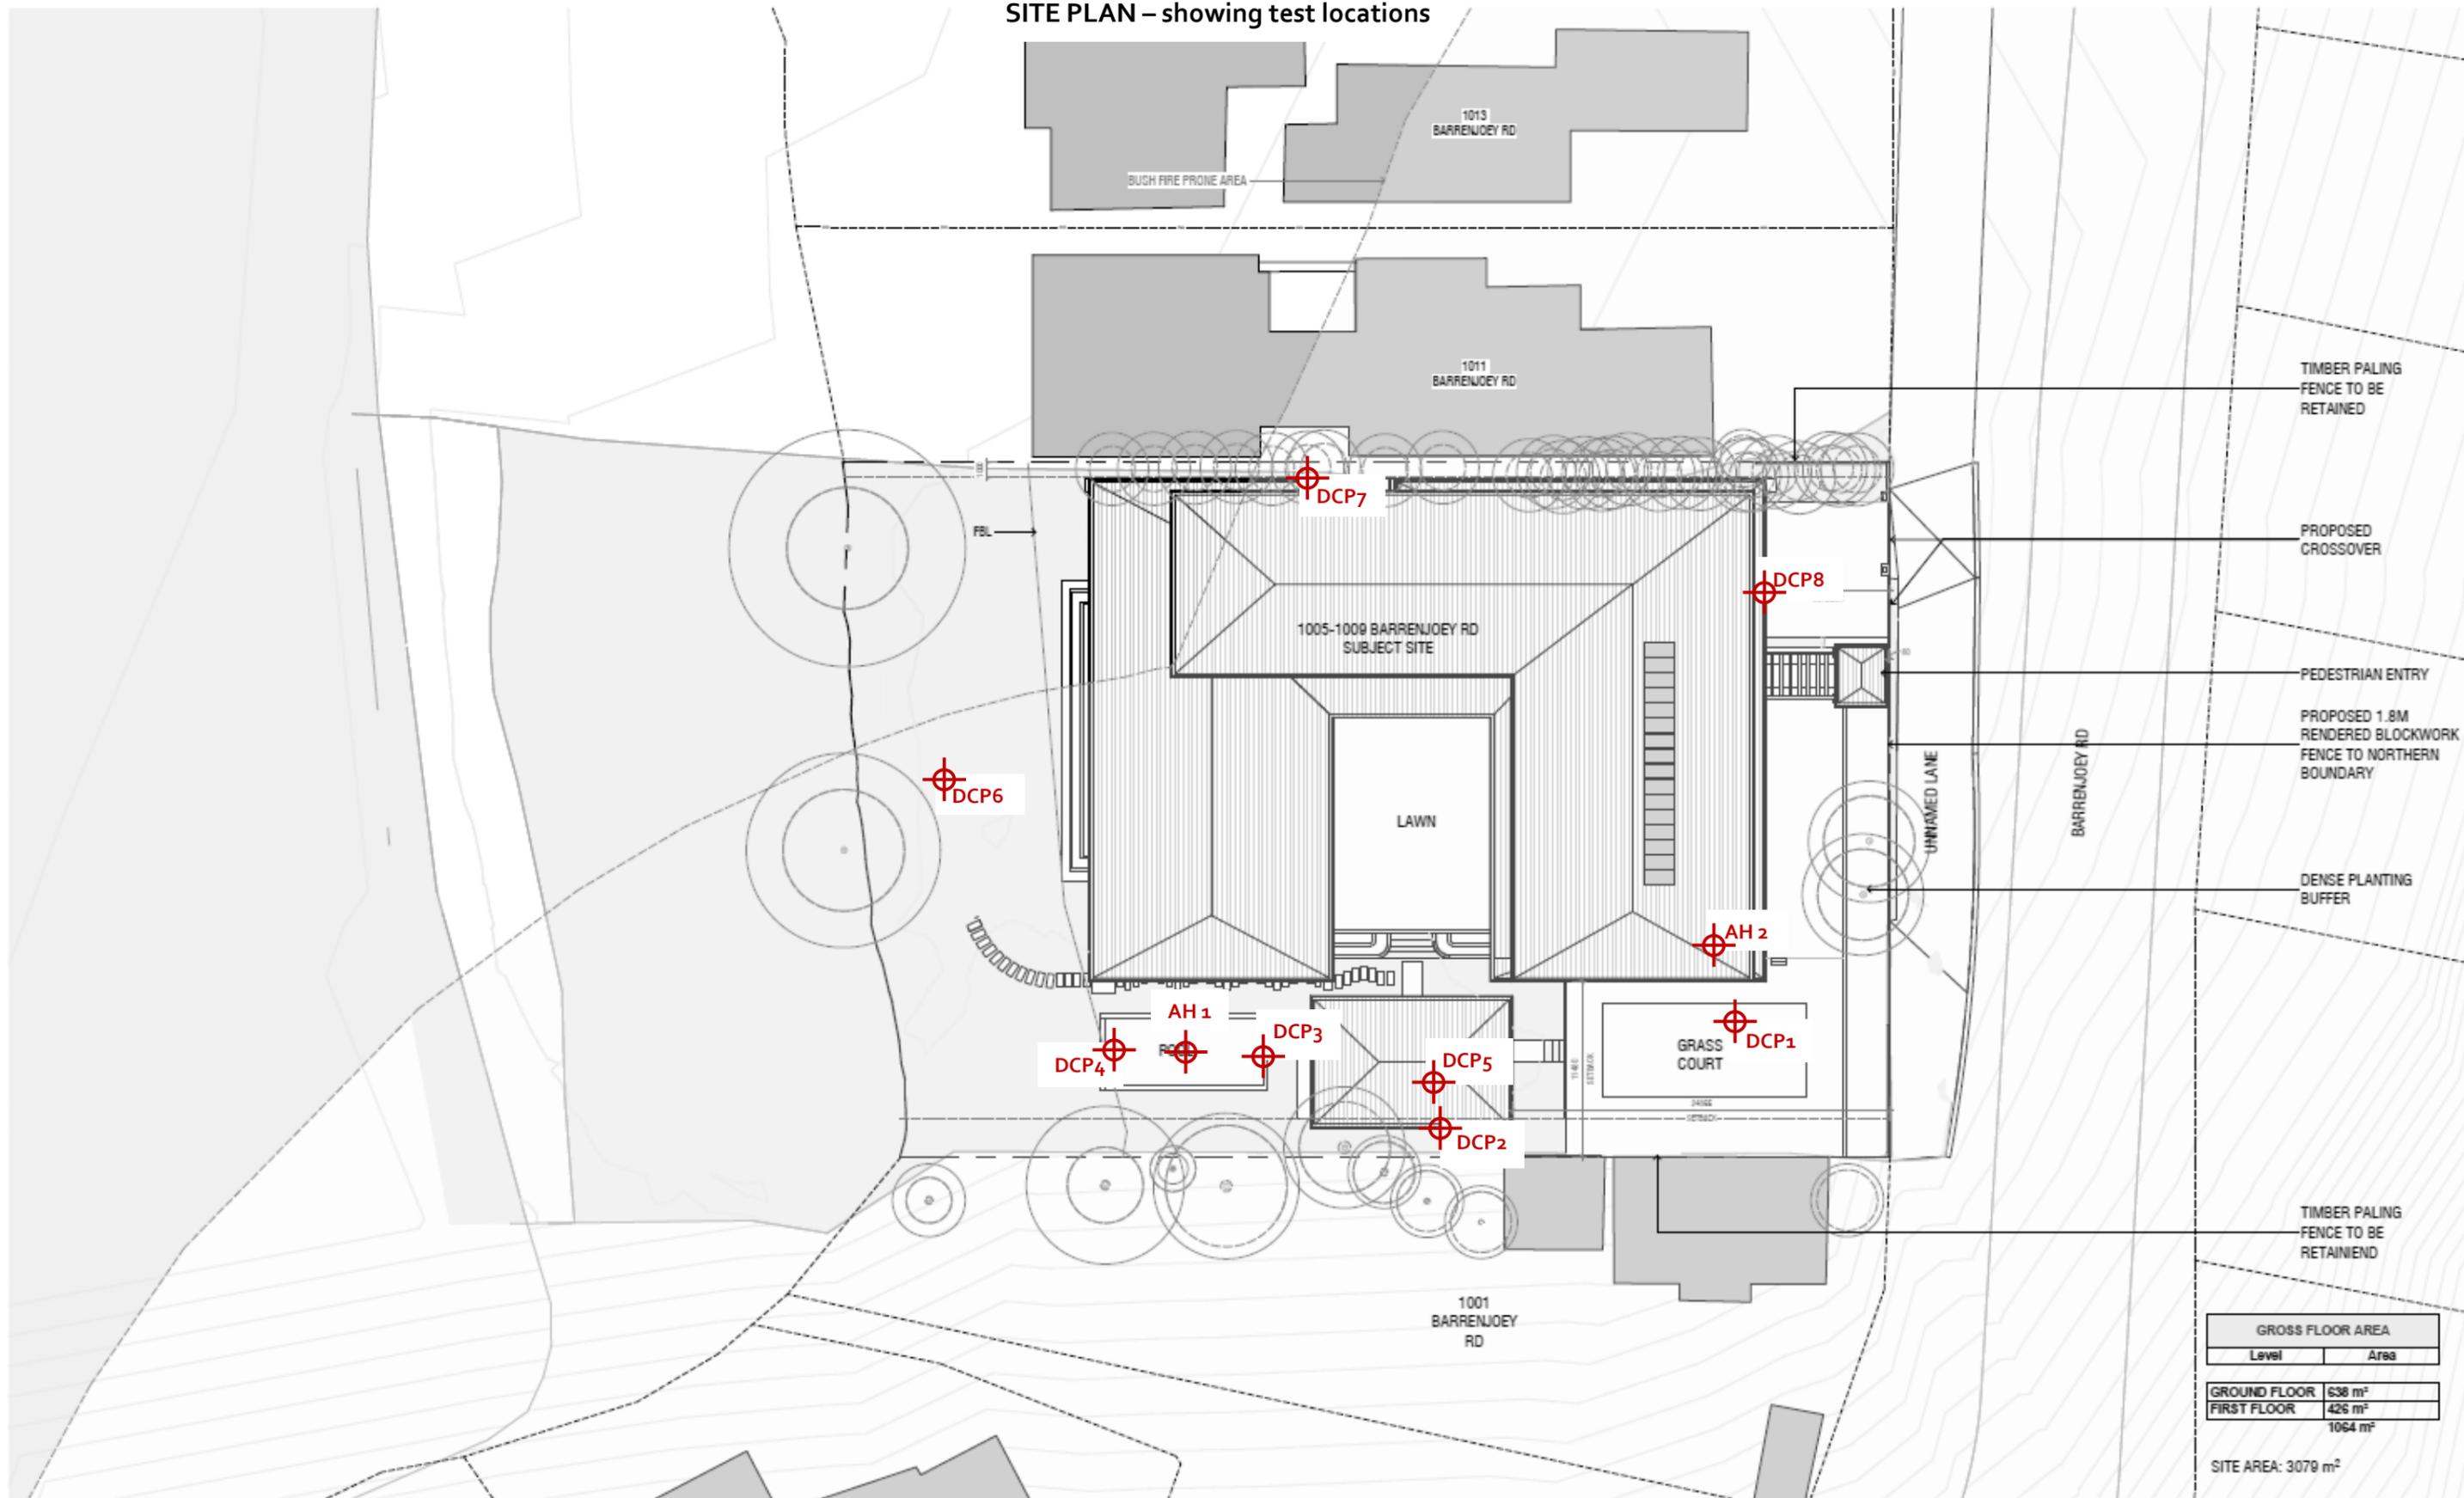
SITE PLAN – showing test locations

Two hand Auger Holes (AH) were put down to identify the soil materials. Eight Dynamic Cone Penetrometer (DCP) tests were put down to determine the relative densities of the sands throughout the profile. The locations of the tests are shown on the site plan attached. It should be noted that a level of caution should be applied when interpreting DCP test results. The test will not pass through hard buried objects so in some instances it can be difficult to determine whether refusal has occurred on an obstruction in the profile or on natural rock surface. This is expected to have occurred for DCP test 4. But due to the possibility that the actual ground conditions vary from our interpretation there should be allowances in the excavation and foundation budget to account for this. We refer to the appended "Important Information about Your Report" to further clarify. The results are as follows:

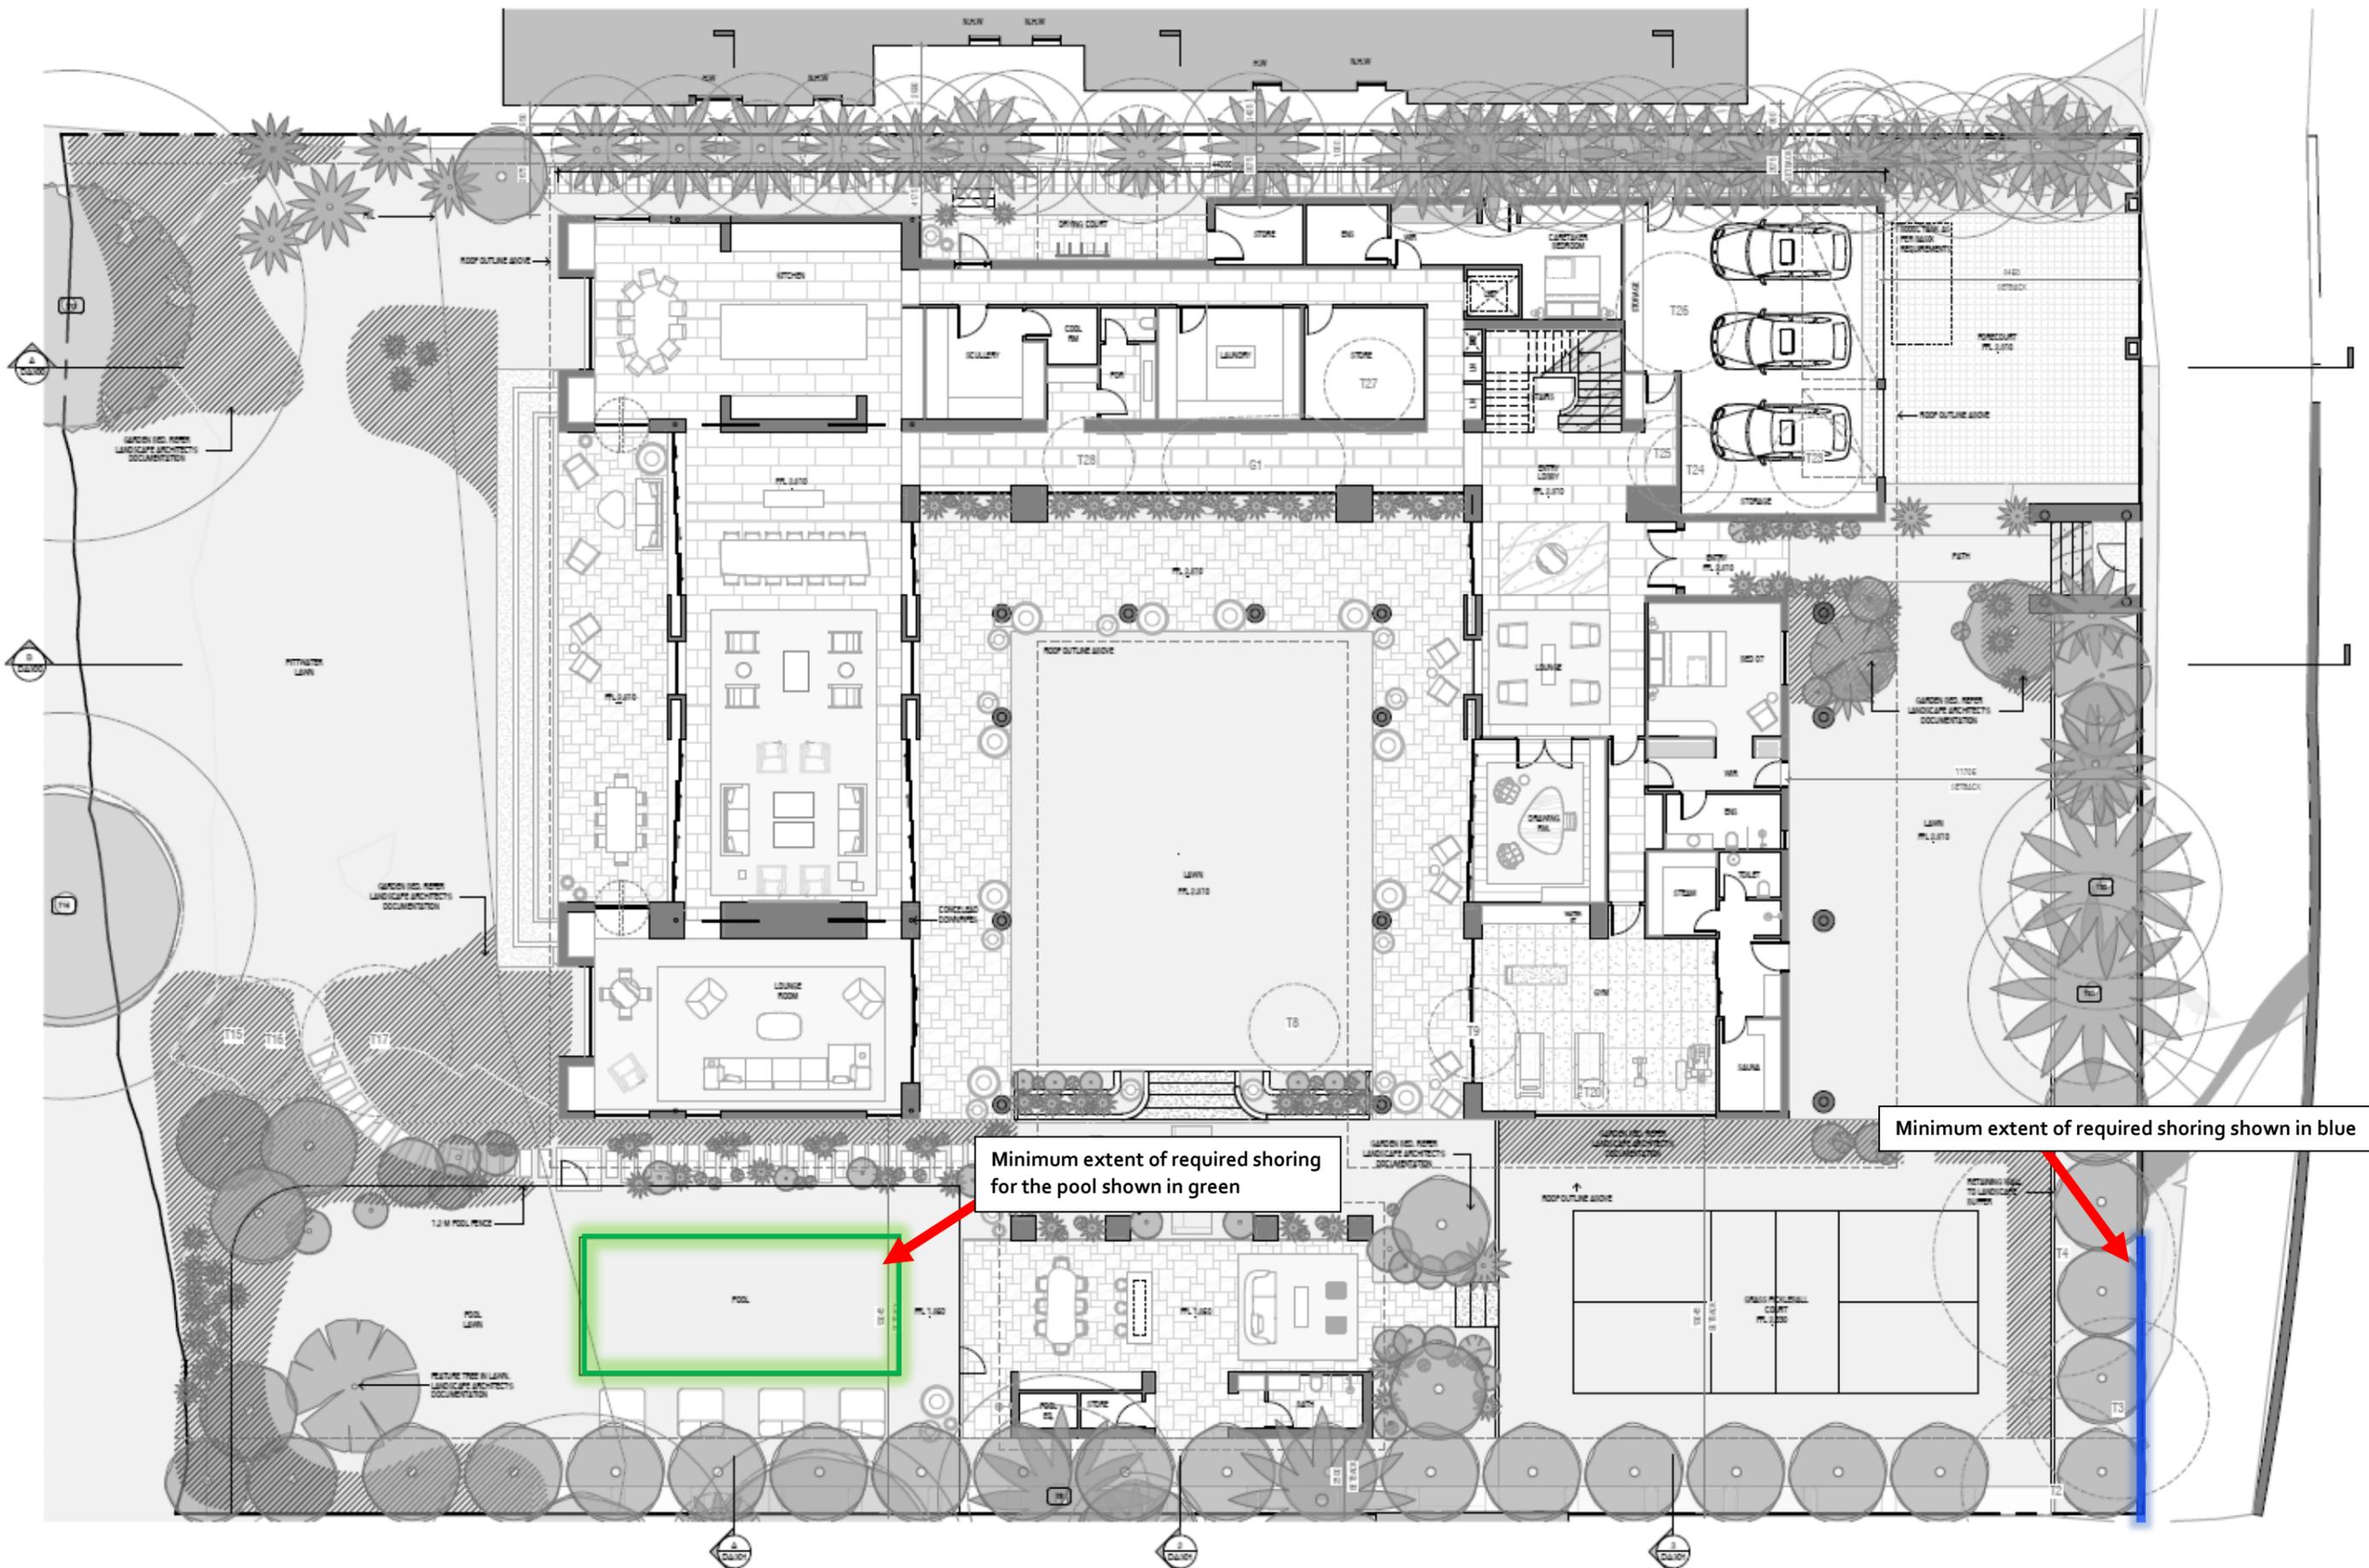
Minimum extent of required shoring for the pool shown in green

Minimum extent of required shoring shown in blue

The excavation is expected to encounter groundwater seepage at an approximate depth of 1.3m. Seepage at this level will likely undercut the excavation and cause the cut batter to slump / collapse. As such, temporary support around the perimeter of the pool excavation will be required to maintain stability until the pool shell is in place. See the site plan attached for the minimum extent of the required shoring shown in green.

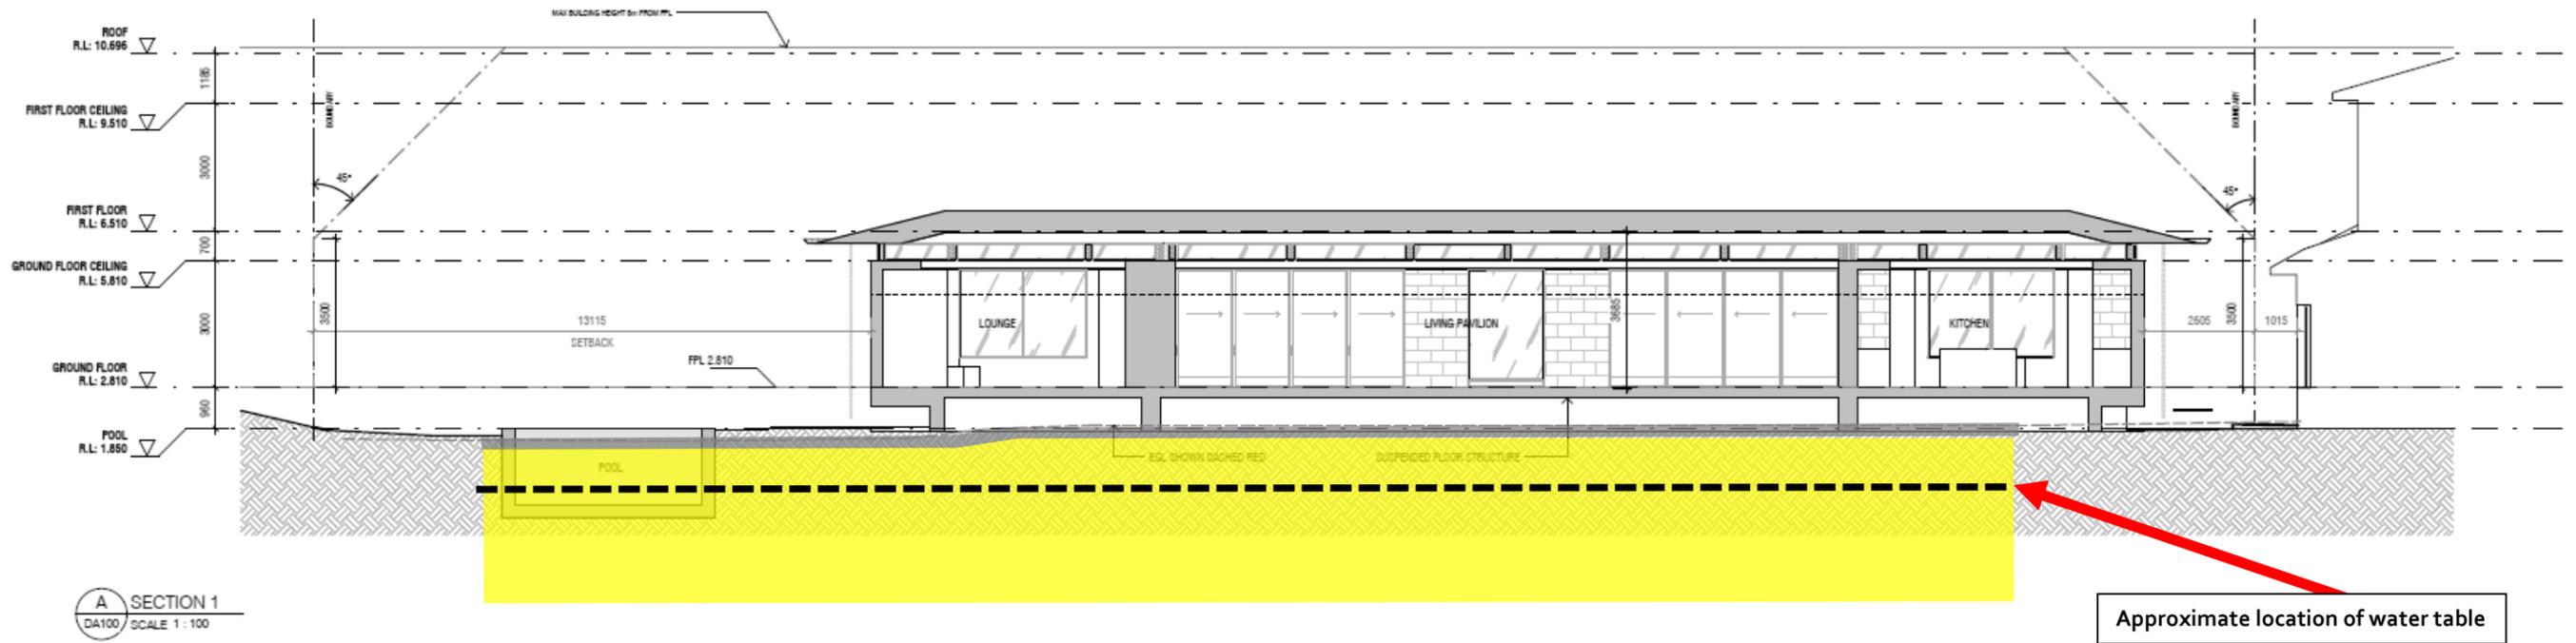
TYPE SECTION – Diagrammatical Interpretation of expected Ground Materials

Across the majority of the property, the site is underlain by a sandy topsoil and sands that extend to the depth of the testing. Filling to a height of ~0.4m has been placed across the property for landscaping. To summarise the test results, below the fill, a Loose to Medium Dense sandy topsoil occupies the top ~0.7m of the profile, that overlies sands of variable density that range from Loose to Medium Dense to the extent of the testing at ~4.8m. See the Type Section attached for a diagrammatical representation of the expected ground materials. The contact of Narrabeen group rocks is shown to extend across the E corner of the property, DCP test 1 which was taken in this location was terminated at ~2.7m due to a very high blow count. It is interpreted that the test was terminated in Extremely Low Strength Rock or better. The rock in this location quickly drops away to the W and is not thought to have been encountered by the other tests.

Approximate location of water table
