Geotechnical Assessment

Project: Alterations & Additions
72 Cooyong Road, Terrey Hills NSW

Ref: AG 24030
13 February 2024

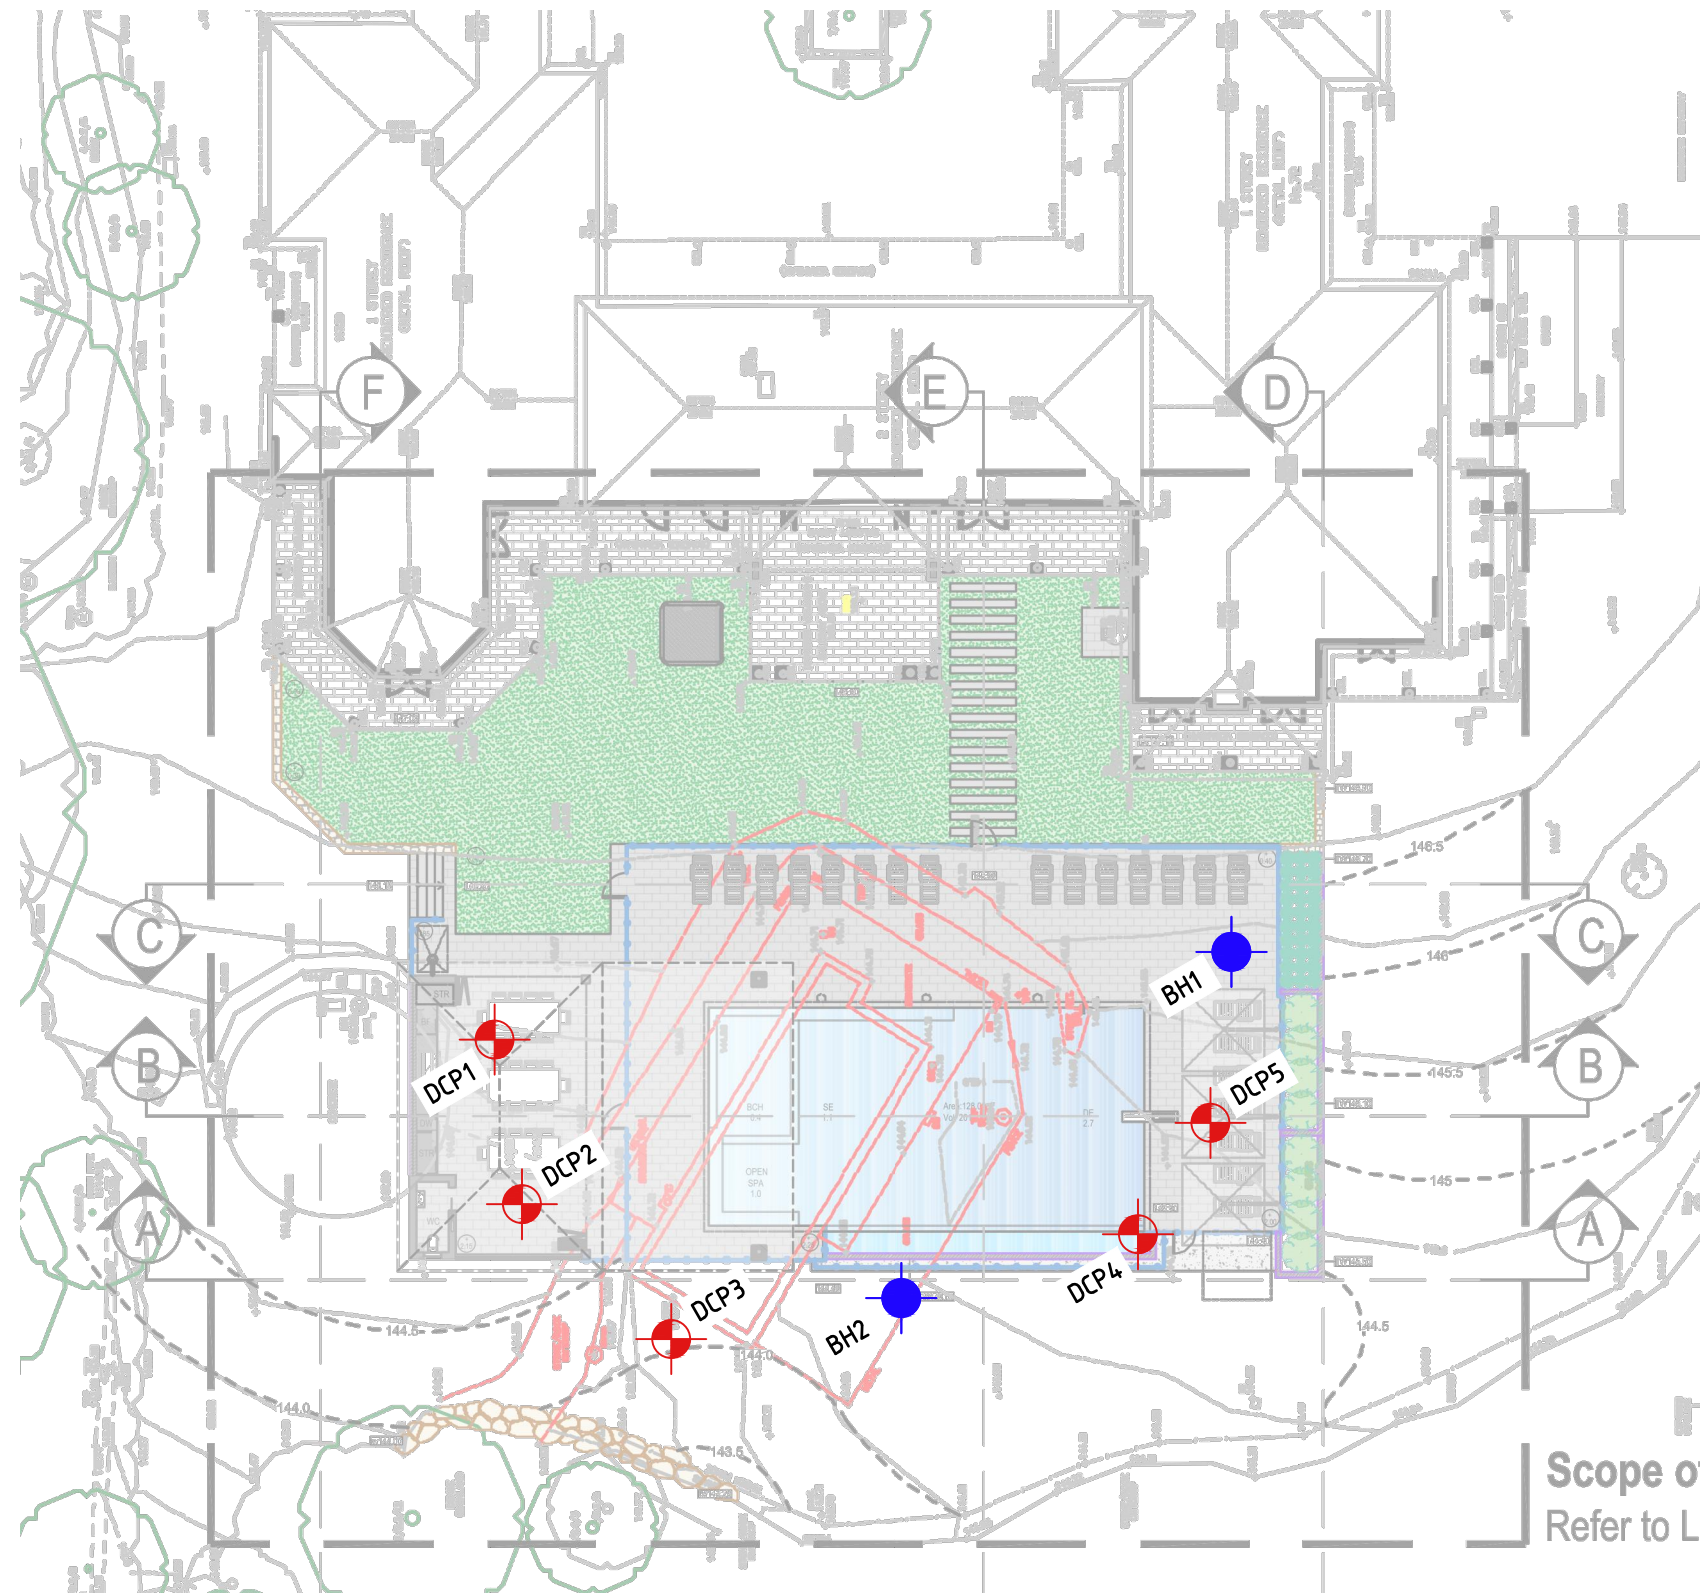
SITE PLAN/GROUND TEST LOCATIONS
SCALE NTS

Test	Summary
DCP 1	Refusal @ 0.3m Bouncing on bedrock. White sand on dry tip.
DCP 2	Refusal @ 0.3m Bouncing on bedrock. White / grey sand on dry tip.
DCP 3	Refusal @ 0.4m Bouncing on bedrock. White / grey sand on moist tip.
DCP 4	Refusal @ 0.3m Bouncing on bedrock. White sand on dry tip.
DCP 5	Refusal @ 0.4m Bouncing on bedrock. White sand on dry tip.

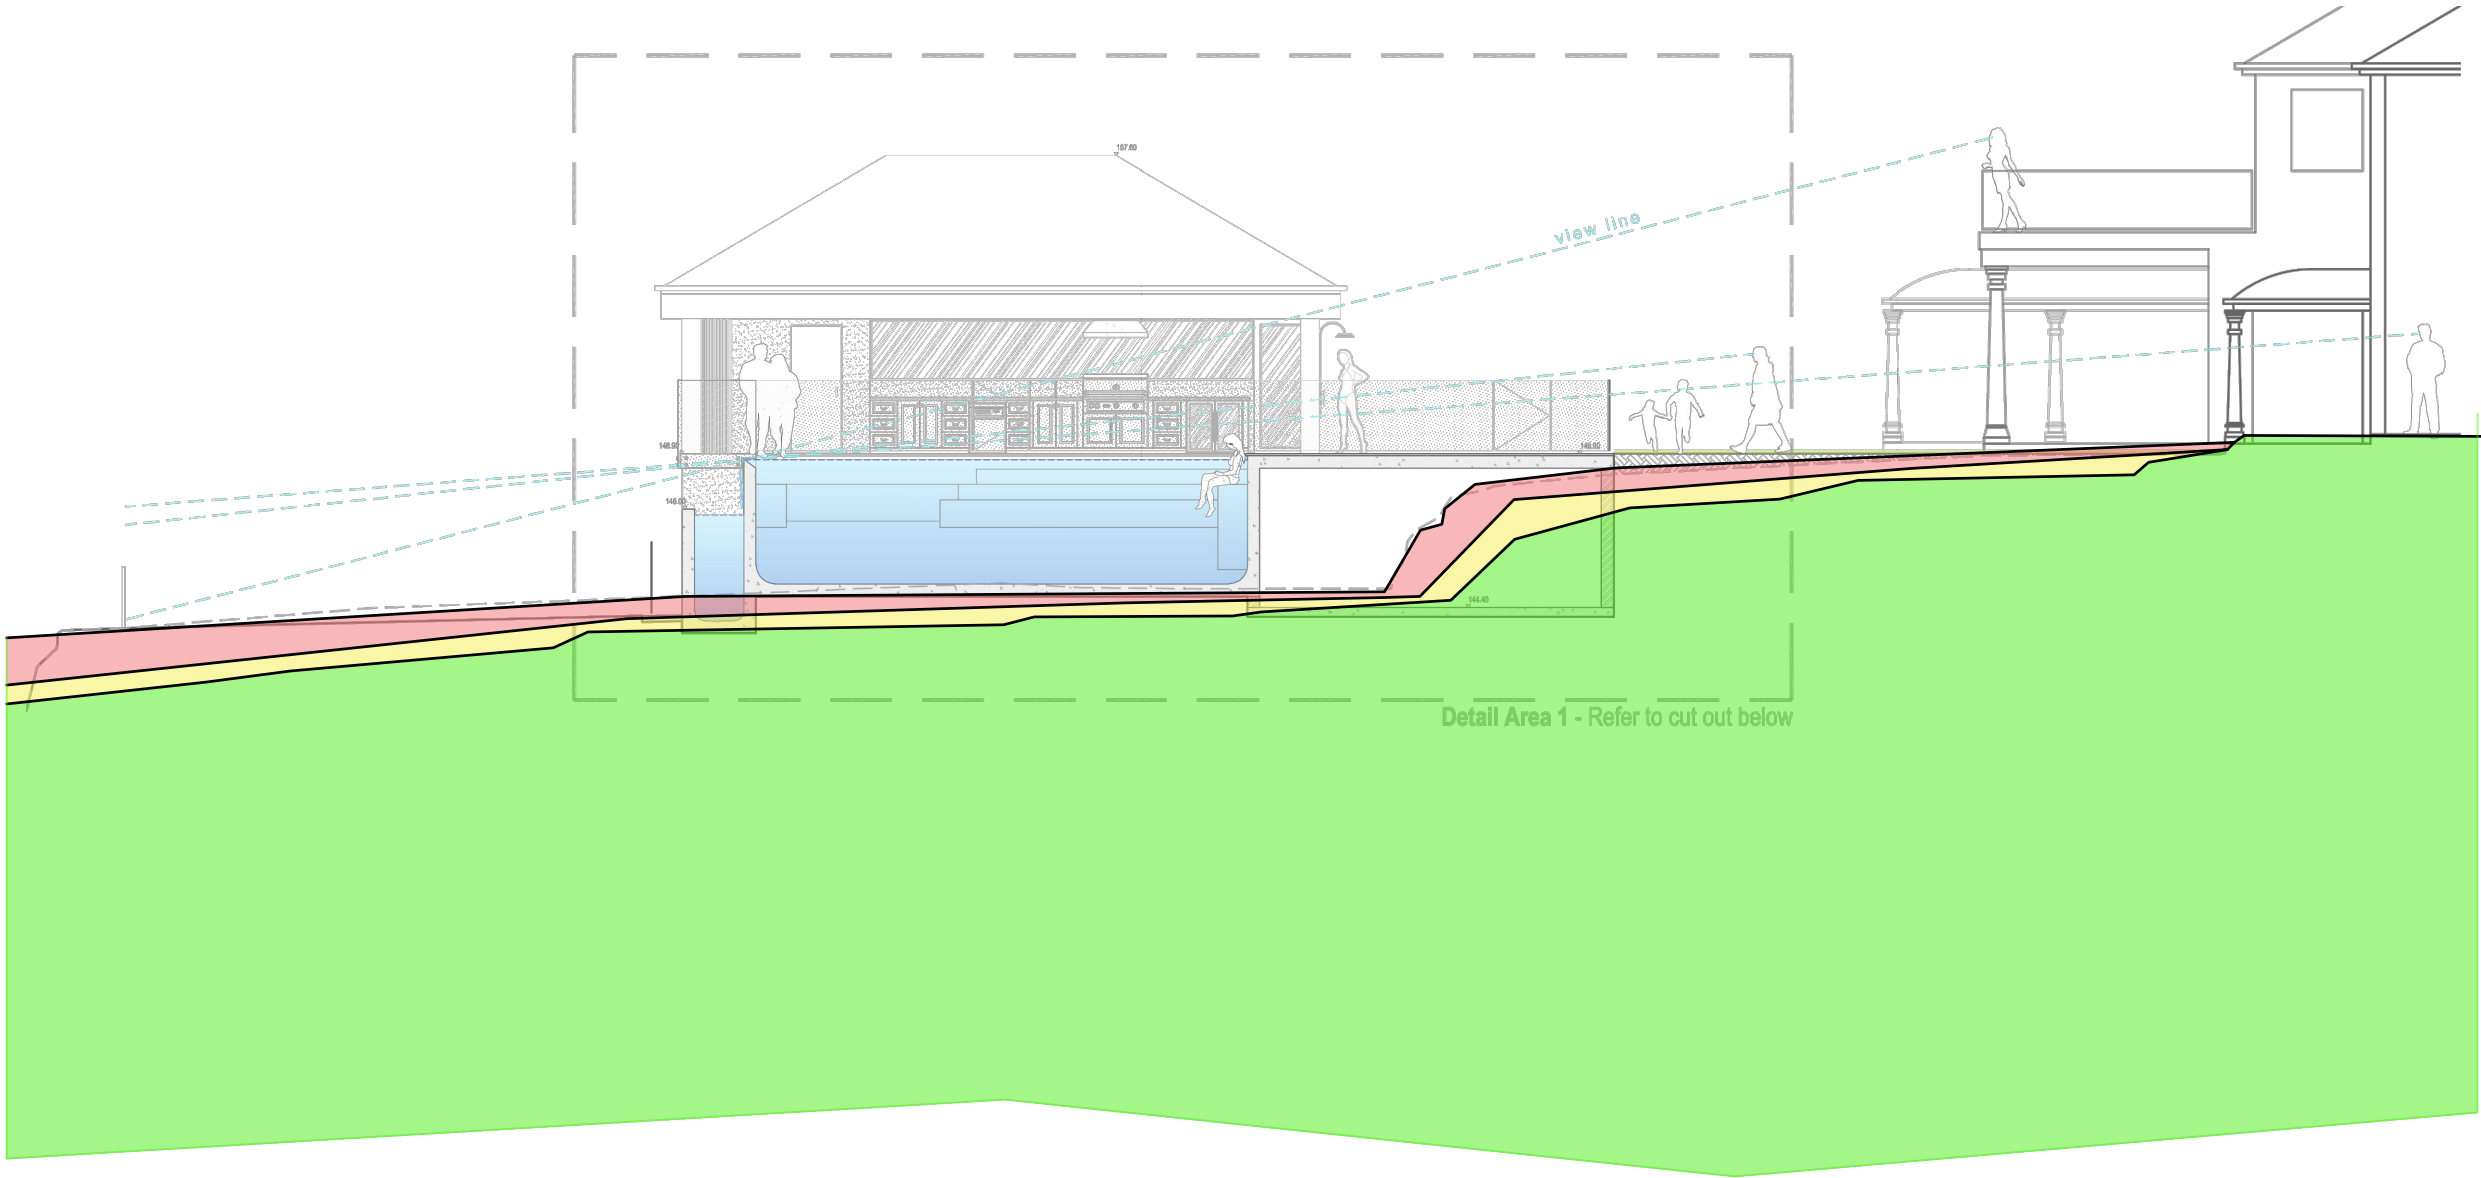
INFERRED GEOLOGICAL SECTION
SCALE NTS

Unit	Material Type	Material description
1	Topsoil/Fill	Paved, tiled & asphalt areas. Silty Sand topsoil.
2	Silty Sand	Fine grained silty sand.
3	Class V-IV* Sandstone	Extremely weathered low strength sandstone bedrock. Typically occurring near the uppermost metre or so of bedrock although thickness varies. Closely to moderately spaced defects resulting in blocky weathering.
5	Class III* Sandstone	Mainly medium strength, massively bedded sandstone. Exposed in rock faces across the north of the residence and south of the sandstone block walls and pool, below Class V-IV sandstone.

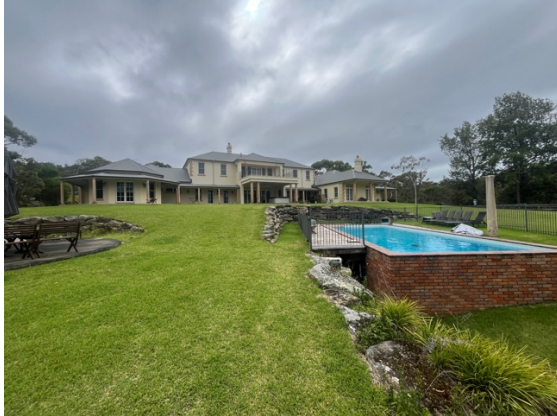
Photo 1: Swimming pool looking towards southern side of the residence & area of the proposed works

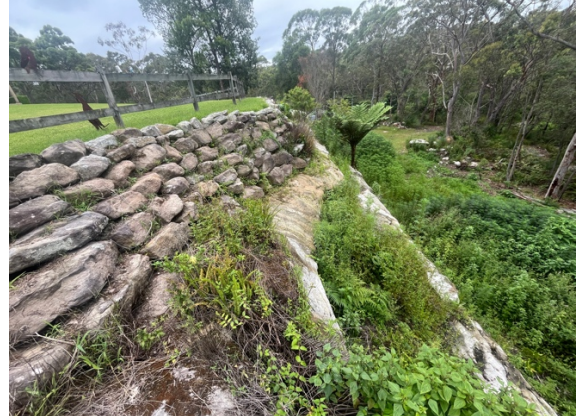
Photo 2: Sandstone bedrock outcropping to the south of the area of the proposed works

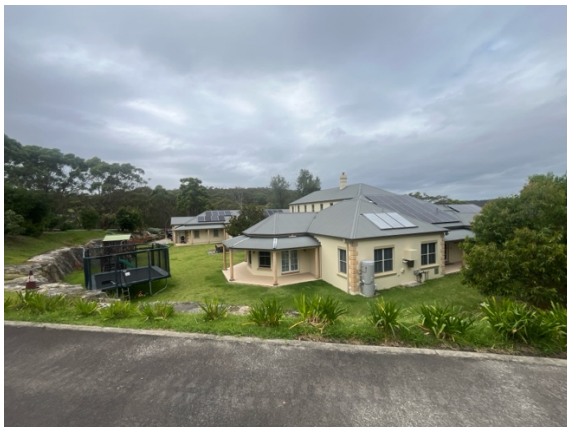
Photo 3: North-eastern corner of the residence

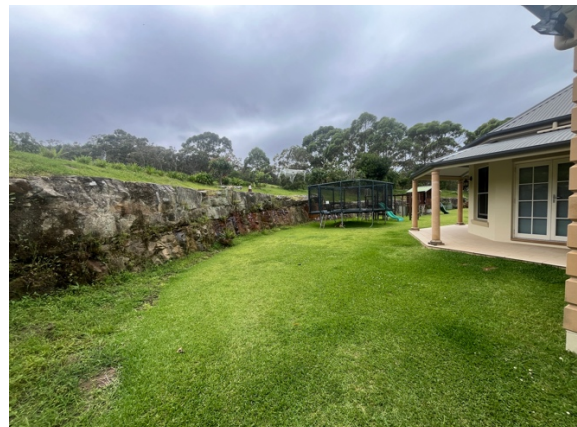
Photo 4: Outcropping rock to the north of the residence

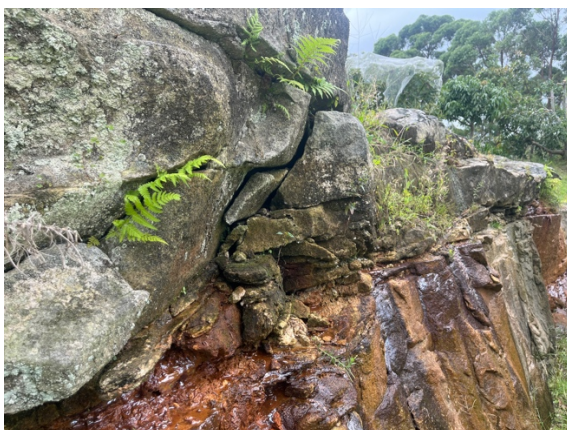
The outcropping rock to the north of the residence contains limited areas of blocky fracturing within the upper portions of the outcrop (photos 5 & 6) with the potential to fall within proximity of children's play equipment or be mobilised by children climbing the rock face.

- **Hazard One:** Failure of the proposed excavations.
- **Hazard Two:** Failure of blocky weathered rock in the outcropping bedrock to the north of the residence (Photos 5 & 6)

HAZARDS	HAZARD ONE	HAZARD TWO
TYPE	Failure of the proposed excavations	Failure of blocky weathered rock in the outcropping bedrock to the north of the residence (Photos 5 & 6)
LIKELIHOOD	'Possible' (10^{-3})	'Possible' (10^{-3})
CONSEQUENCES TO PROPERTY	'Minor' (5%)	'Insignificant' (0.1%)
RISK TO PROPERTY	'Moderate' (2×10^{-3})	'Very Low' (0.5×10^{-3})
RISK TO LIFE	5.3×10^{-4} /annum	3.2×10^{-5} /annum
COMMENTS	Following implementation of the recommendations outlined in Section 3.7, the above risk levels would reduce to 'Acceptable' levels within the site.	Following implementation of the recommendations outlined in Section 3.7, the above risk levels would reduce to 'Acceptable' levels within the site.

Photo 5: Fractured rock within the outcropping bedrock to the north of the residence

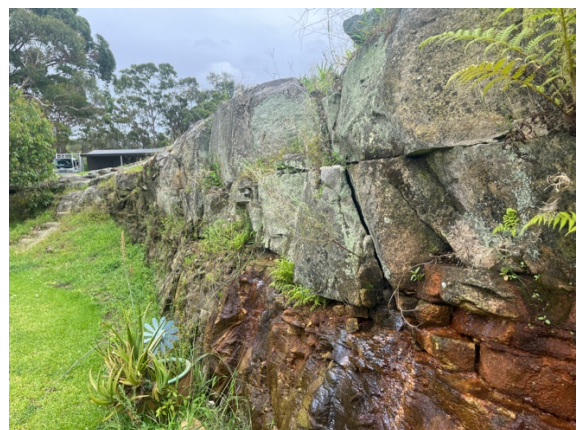
Photo 6: Fractured rock within the outcropping bedrock to the north of the residence
