Address of site 316 Hudson Parade, Clareville

Report Date: 1/12/22

GEOTECHNICAL INVESTIGATION:

Alterations and Additions at 316 Hudson Parade, Clareville

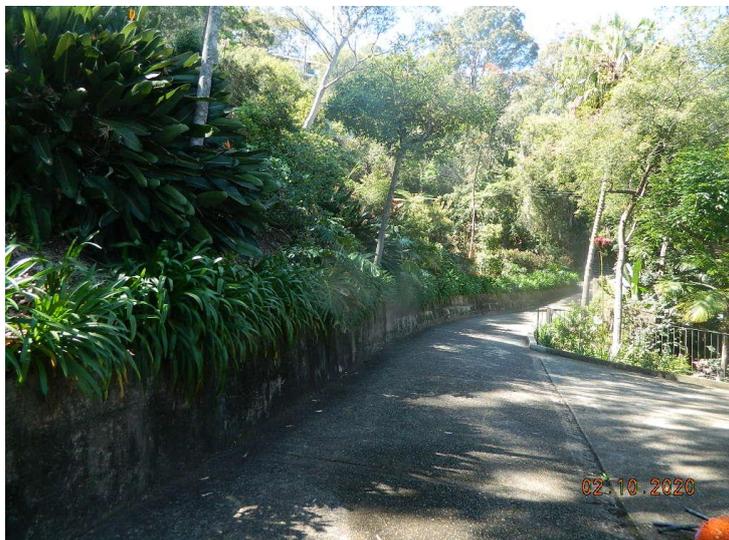
Photo 1

2.3 At the road frontage a steeply graded slope falls to the uphill side of the subject house (Photos 1 & 2). No significant signs of movement were observed in this area. Vehicular access to the property is provided by a shared driveway from the S that cuts across the slope and runs to the existing house and a detached brick garage/studio beside the house (Photos 2 & 3). On the downhill, external supporting wall of the detached garage a vertical crack runs through the supporting concrete footing and brick wall (Photo 4). No deflection was measured in the wall. The structure is currently considered stable and will be demolished as part of the proposed works. Below the detached garage/studio is a sandstone flagging retaining wall that is estimated to be battered back at an angle of $\sim 40^\circ$ from vertical (Photo 5).

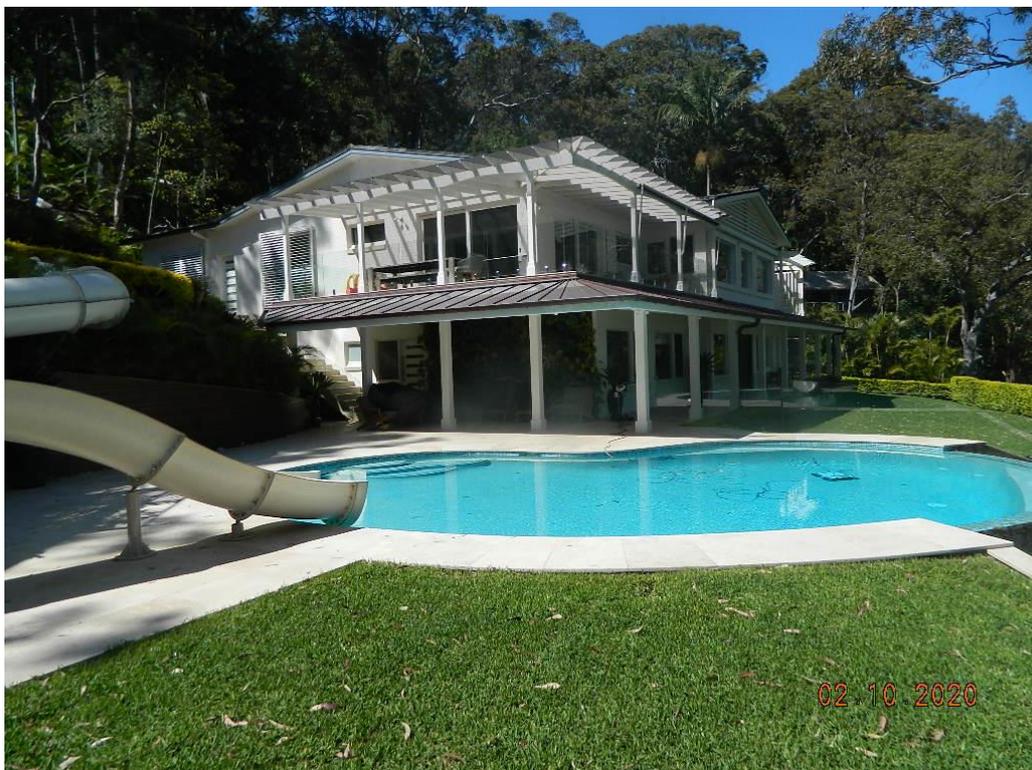
Photo 6

The two storey brick house displays no significant movement in the external supporting walls that could be associated with slope instability (Photo 6). A concrete pool is located below the N side of the house. The pool shell displays no visible signs of movement. The area below the house and beside the pool has been filled for a level lawn area. From visual observations on site the fill reaches a maximum height of $\sim 5.0\text{m}$ on the S side and reduces to $\sim 1.4\text{m}$ on the N end. The S side of the fill is supported by

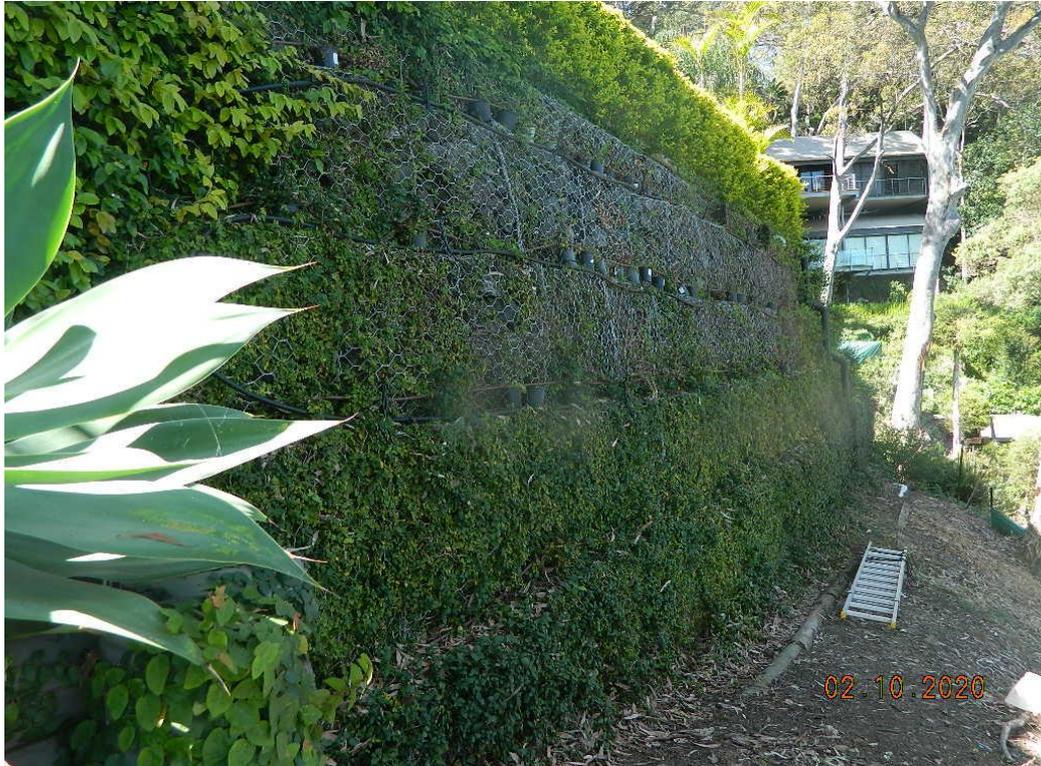
Photo 7

a gabion basket retaining wall (Photos 7 & 8). Where the wall lines the S common boundary the baskets are slightly bulging. To ensure the ongoing stability of the wall into the future the recommendation in **Section 16** are to be followed. The remaining areas of the wall show no obvious bulging. The N side of the fill is supported by a concrete crib retaining wall that is obscured by thick vegetation (Photo 9). From what could be seen of the wall it appears stable.

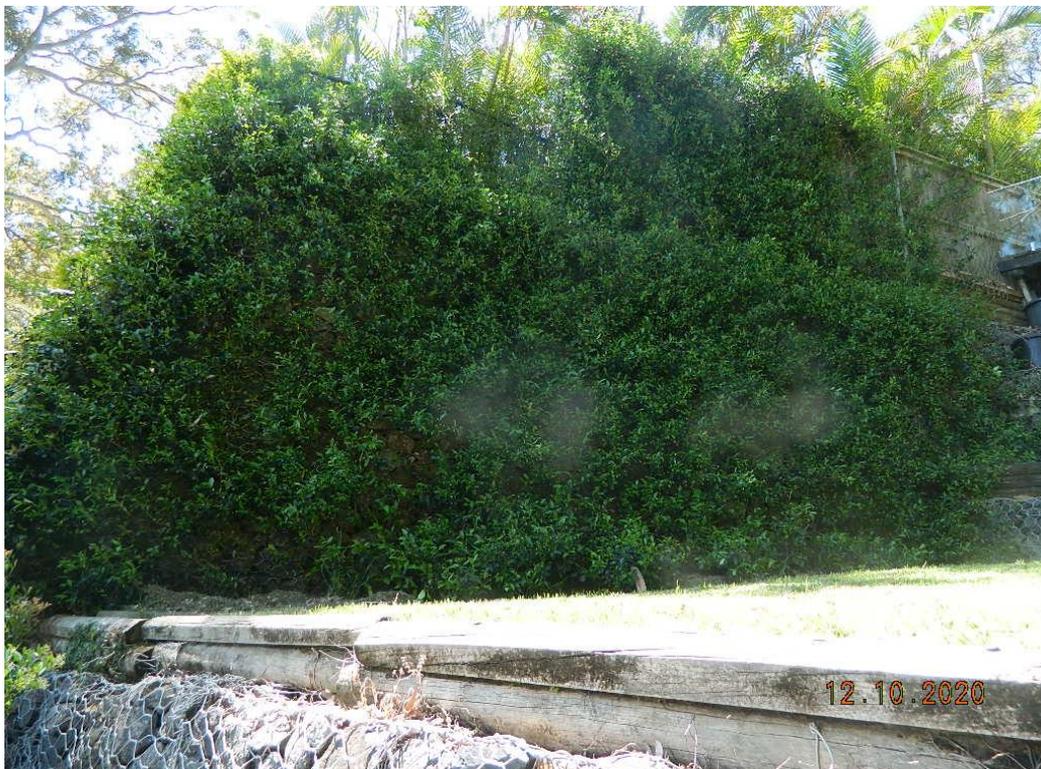
Photo 8

The proposed excavations are a potential hazard until retaining structures are in place (**Hazard Two**). The portion of the gabion basket retaining wall that lines the S boundary is a potential hazard (**Hazard Three**).

The S side of the gabion basket retaining wall is slightly bulging (Photo 8). This structure is currently considered stable but to ensure the ongoing stability into the future we recommend they be inspected by the owners on a biennial basis or after heavy prolonged rainfall, whichever occurs first. A photographic record of the inspections is to be kept. Should further movement be observed the Geotechnical Consultant is to be engaged to assess the structure and provide remedial advice should it be required.

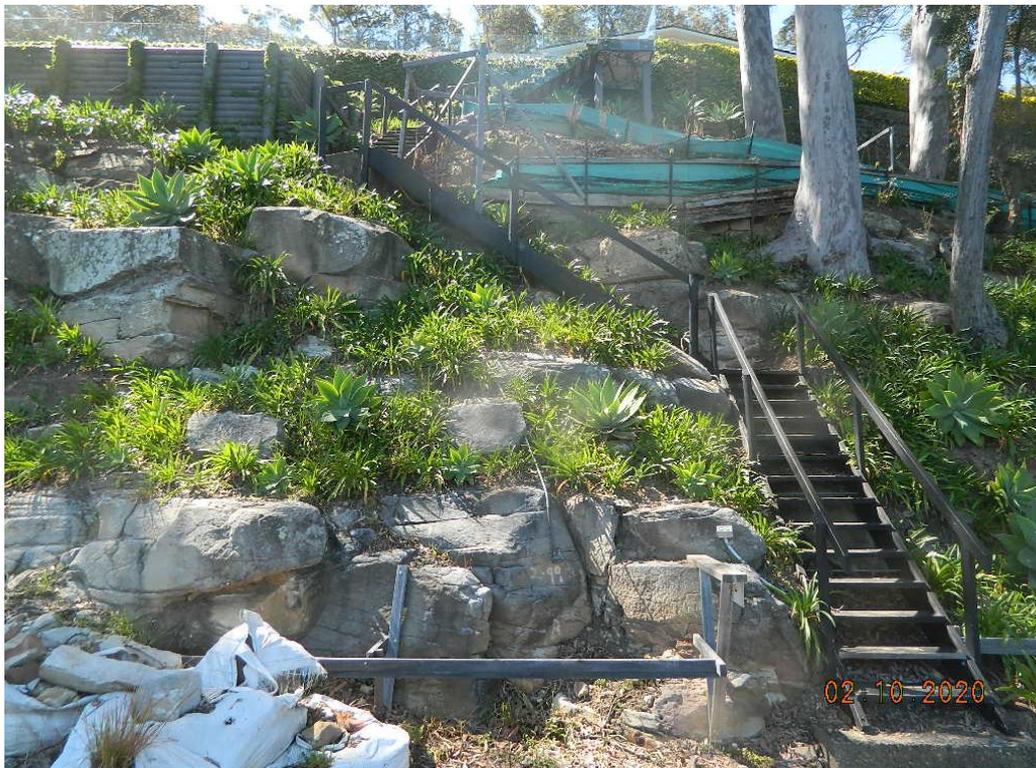
Photo 10

2.4 The area below the property has been partly terraced with treated pine retaining walls that appear well constructed. Below the walls the slope falls steeply to the waterfront. Bands of medium strength sandstone outcrop in this area (Photo 10). The exposed sandstone is fractured and is relatively thinly bedded. The exposed rock does not display any significant undercutting or geological defects that could lead to a significant failure that could impact the retaining walls or house above.

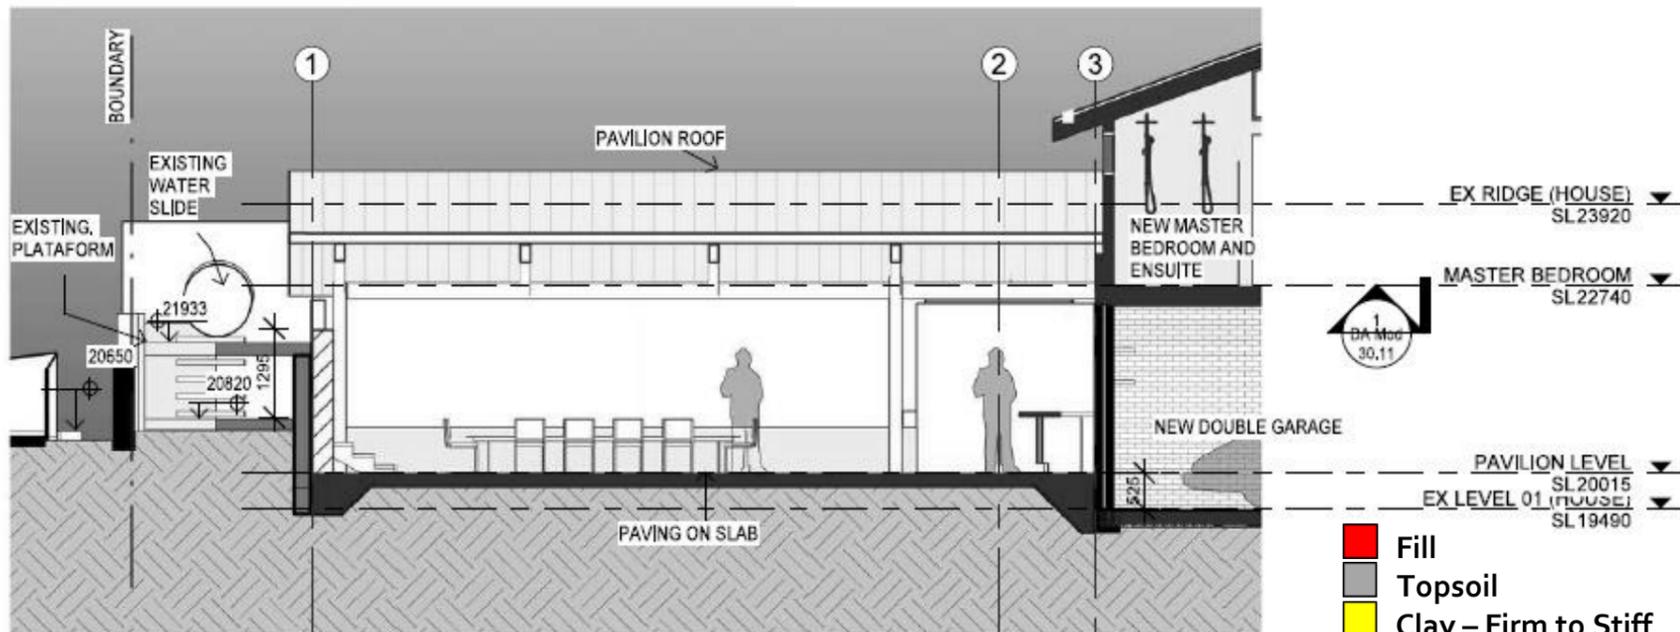
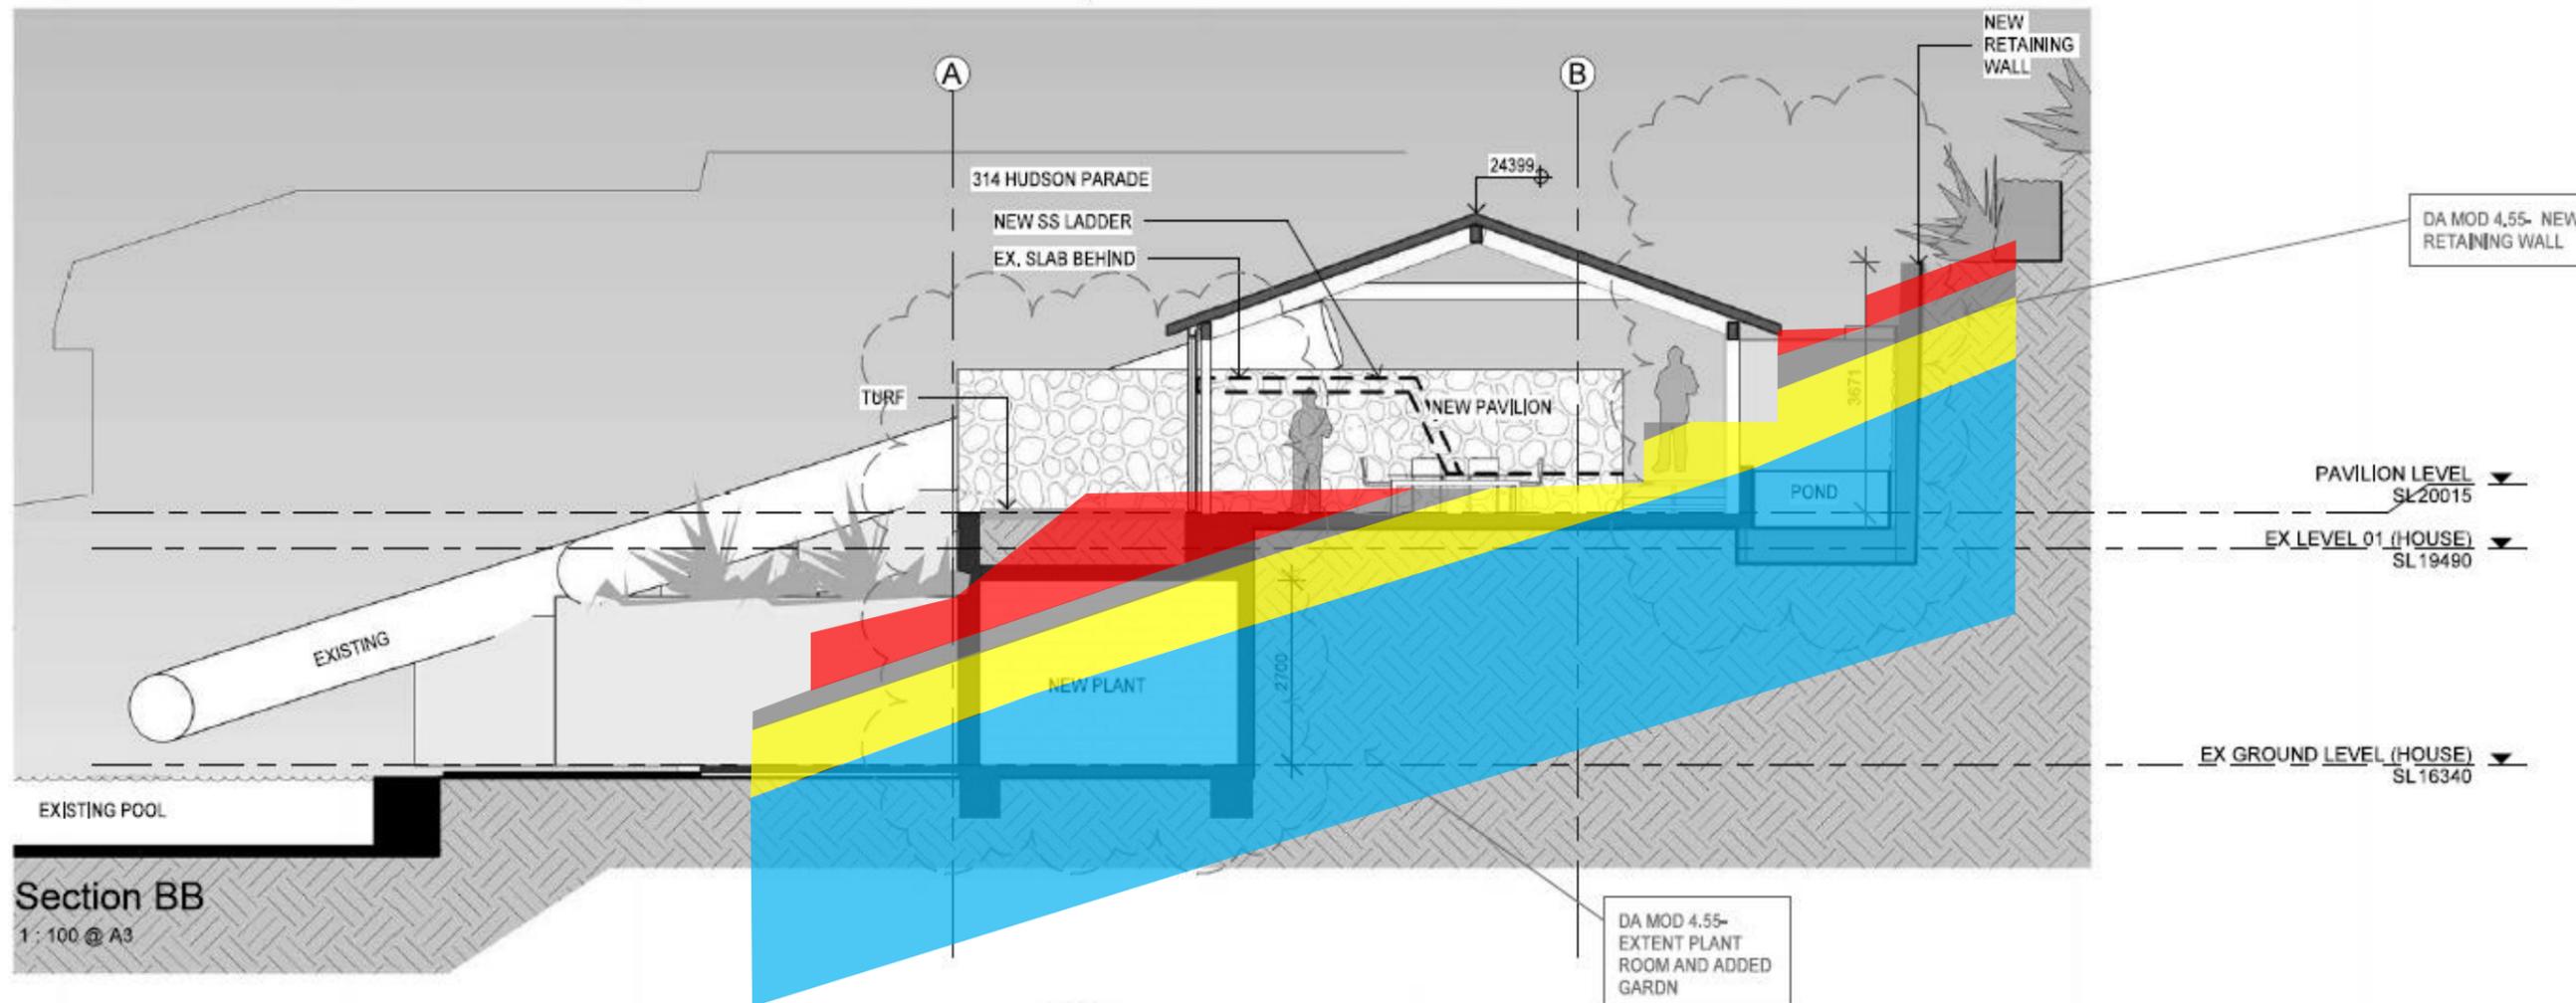
TYPE SECTION – Diagrammatical Interpretation of expected Ground Materials

The slope materials are colluvial at the near surface and residual at depth. In the test locations, the ground materials consist of fill and a thin sandy topsoil over firm to stiff clays. Fill to a maximum depth of ~5.0m provides level platforms for lawn, garden and paved areas across the property. In the test locations, the clays merge into the weathered zone of the underlying rocks at depths of between ~0.7m to ~2.4m below the current surface, being deeper in the filled area (DCP7). The weathered zone of the underlying rock is interpreted as Extremely Low to Low Strength Rock. It is to be noted that this material is a soft rock and can appear as a mottled stiff clay when it is cut up by excavation equipment. See Type Section attached for a diagrammatical representation of the expected ground materials.

- Fill
- Topsoil
- Clay - Firm to Stiff
- Narrabeen Group Rocks - Extremely Low to Low Strength Rock - after being cut up by excavation equipment can resemble a stiff to hard clay.
