Geotechnical Assessment

Project: Swimming Pool
145 McCarrs Creek Road, Church Point NSW

Prepared for:
Luke Anglicas

Ref: AG 24182
15 May 2024

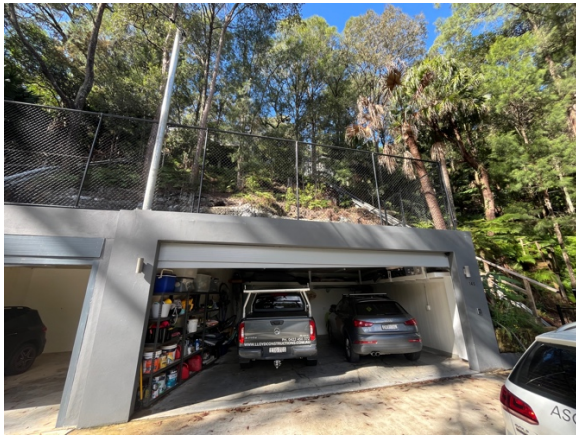
Photo 1: Garage at site frontage

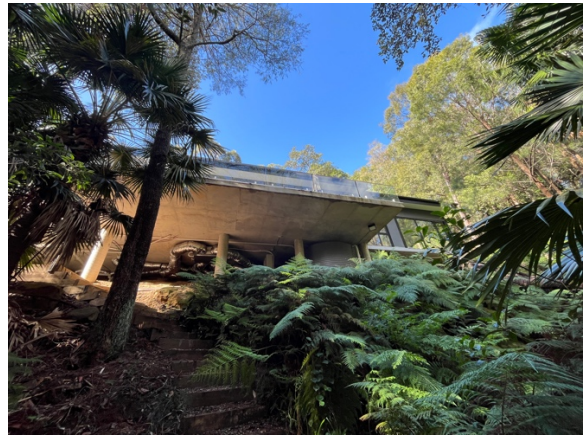
Photo 2: Residence frontage

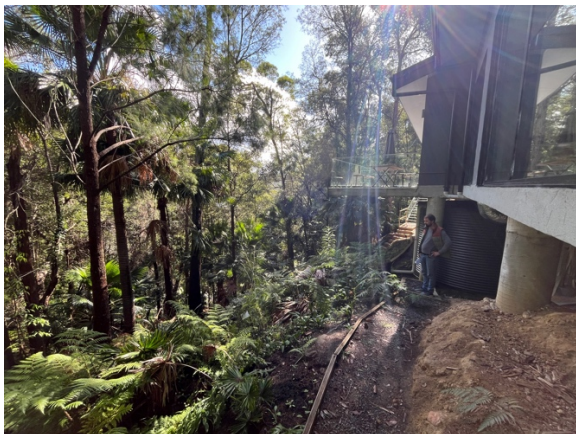
Photo 3: Residence frontage and location of the proposed pool

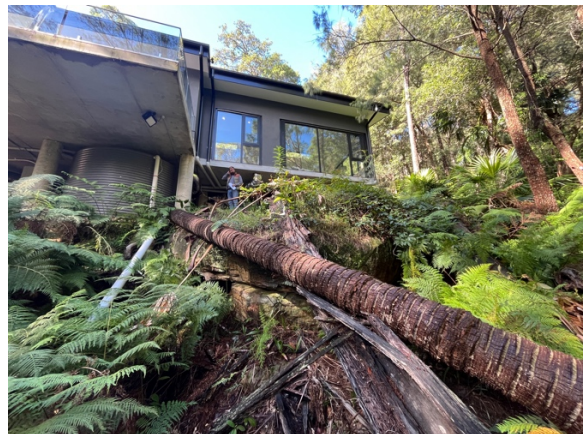
- **Hazard One:** The potential mobilisation of the large sandstone boulder in the location of the proposed pool.
- **Hazard Two:** The steep slope that falls across the property, and continues above, failing and impacting on the property.

Photo 4: Large sandstone boulder (behind tree trunk) in the location of the proposed pool

Recommendation	Description
	<p>may not be achievable. As such, lateral bracing of the pool structure to the existing structure, may be required.</p> <p>No footings or loads are to be placed on, or downslope of, the boulder that is located at the downslope side of the proposed pool. AscentGeo should be contacted regarding pier locations in relation to the boulder if there is any uncertainty.</p> <p>Pier footings should be of sufficient diameter to enable effective base cleaning to be carried out during construction. Small diameter piers that cannot be cleaned should be designed for shaft friction, resulting in a longer rock socket.</p> <p>To mitigate the risk of differential settlement, it is essential that all footings are founded on material of similar consistency.</p> <p>It is essential that the foundation materials of all footing excavations be inspected and approved before steel reinforcement and concrete is placed. This inspection should be scheduled while excavation plant and operators are still on site, and before steel reinforcement has been fixed or the concrete booked.</p>

Recommendation	Description
	of the large sandstone boulder that is located on the downslope side of the proposed pool area.
Inspections	It is essential that the foundation materials of all footing excavations be visually assessed and approved by AscentGeo before steel reinforcement and concrete is placed. Failure to engage AscentGeo for the required hold point/excavation/foundation material inspections will negate our ability to provide final geotechnical sign off or certification.
Conditions Relating to Design and Construction Monitoring	<p>To comply with Northern Beaches Council conditions and enable the completion of Forms 2B and 3, as required by Council's Geotechnical Risk Management Policy, it may be necessary at the following stages for Ascent to:</p> <ul style="list-style-type: none">● Review the geotechnical content of all structural engineer designs prior to the issue of Construction Certificate – Form 2B.● Complete the abovementioned excavation hold point and foundation material inspections during construction to ensure compliance to design with respect to stability and geotechnical design parameters.● By Occupation Certificate stage (project completion), AscentGeo must have inspected and certified excavation/foundation materials. A final site inspection will be required at this stage before the issue of the Form 3.
