**GEOTECHNICAL RISK MANAGEMENT POLICY FOR PITTWATER  
FORM NO. 1 – To be submitted with Development Application**

Address of site 96-104 Cabarita Road, Avalon Beach, NSW

Report Title: Geotechnical Assessment for Proposed Subdivision at 96-104 Cabarita Road, Avalon Beach, NSW

Report Ref No: 31842BMrpt Rev2

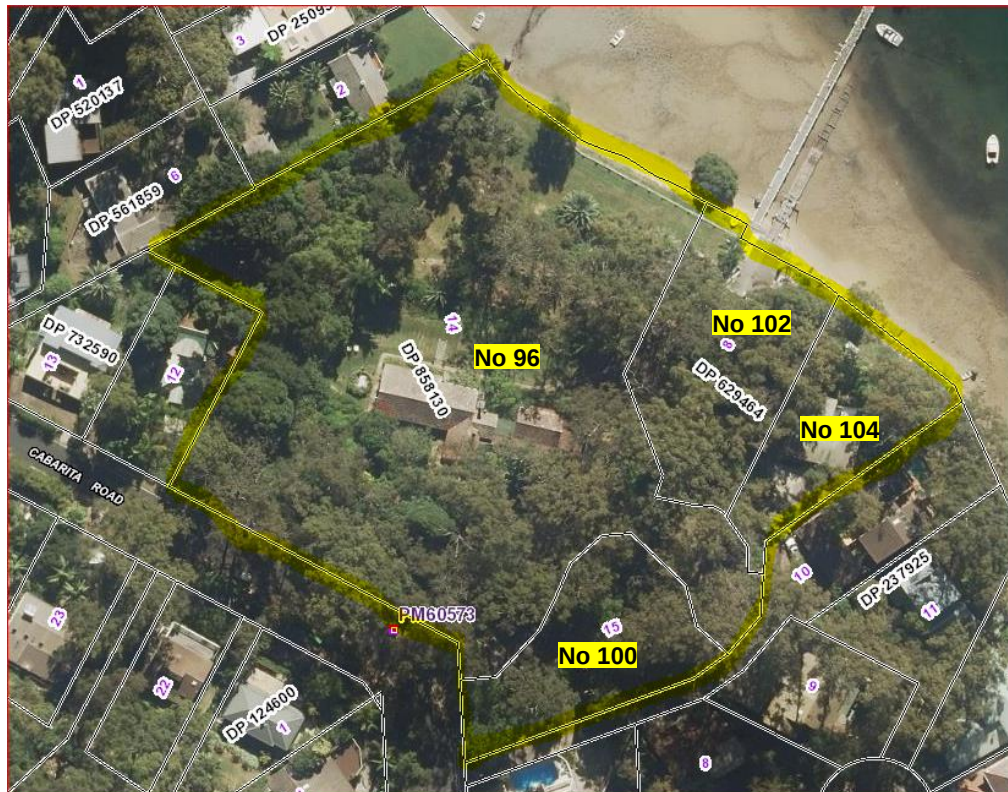
At the time of the site walkover, previous structures within No 96 and No 100 had been cleared except for a few small concrete slabs, numerous low height retaining walls and some stone paved paths. The majority of the trees shown on the survey remained interspersed across the entire site. A snaking vehicular access track had been formed where the house of No 96 once was present. Between the tracks were batter slopes of about 30° and up to about 2m in height, and minor unsupported cuttings to the south of this area. The cuttings exposed thick topsoil fill over gravelly sandy fill. The central portion of No 96 had remnants of a previous house.

Sloping down (from a bend in Cabarita Road) at about 12° was a concrete driveway which looped around (within No 100) but also provided access to Nos 104 and 96. Within the loop was a rounded hillock with a few sandstone exposures at the ground surface although it was not clear if these were outcrops or boulders. The lower, looping portion of the driveway was retained a stone block wall just two-to-three courses high but was in a state of disrepair. A couple of metres downslope was a properly constructed stone masonry retaining wall about 1m high on a concrete footing. Downslope of this wall was a grass slope.

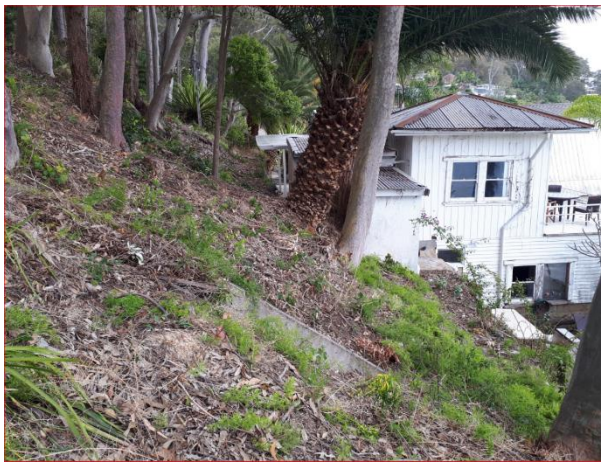
As shown to the left, a longer wider slope of about 35° was located at the north-eastern end of Nos 102 and 104. The crest of this slope was about 5m downslope (northwards) of the existing house at No. 104. The slope was generally densely vegetated, but beside some timber steps there was a small exposure of hard residual clayey soil, about 1m height. The toe of the slope was supported by a retaining wall of about 1.6m in height. This slope and the retaining wall extended

about 35m from the bayside pavilion to the boatshed within No. 102. The retaining wall was inclined at about 70° and appeared to be in good condition. Below the retaining wall was a flat garden and patio retained by a sandstone sea wall of about 1m height. Refer to photograph below.

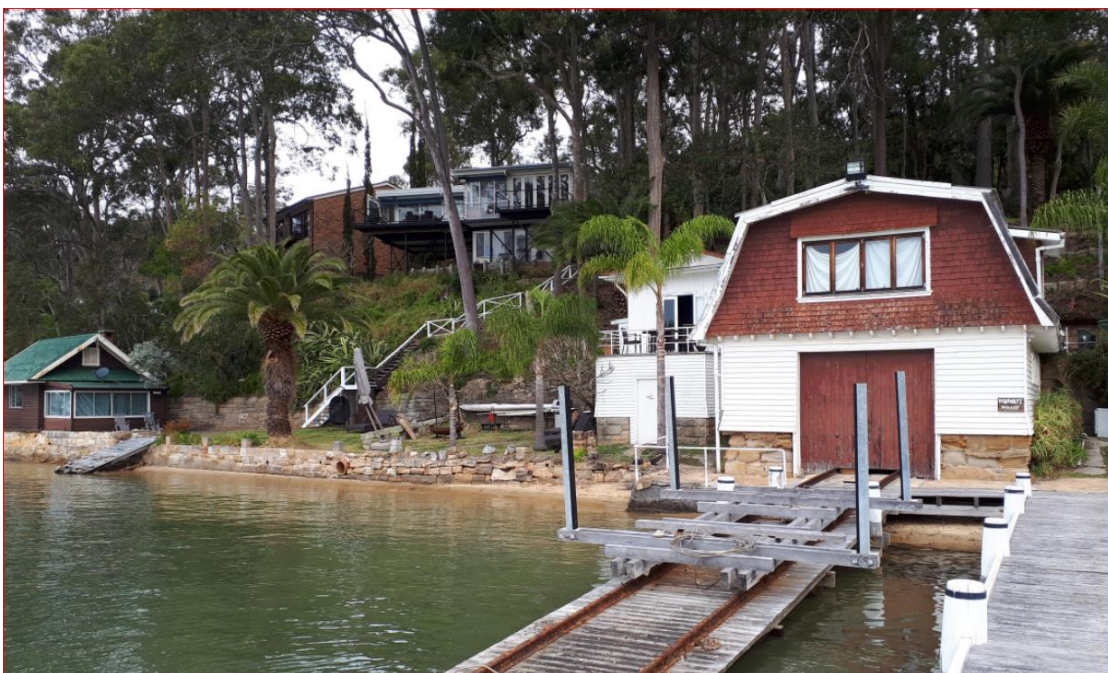
The boat house was a one-to-two storey building of timber clad construction on sandstone block foundation walls. It had a boat ramp and an adjacent jetty. To the north-west of the boat house was the natural toe of the hillslopes and flatter land beside the sandy beach.

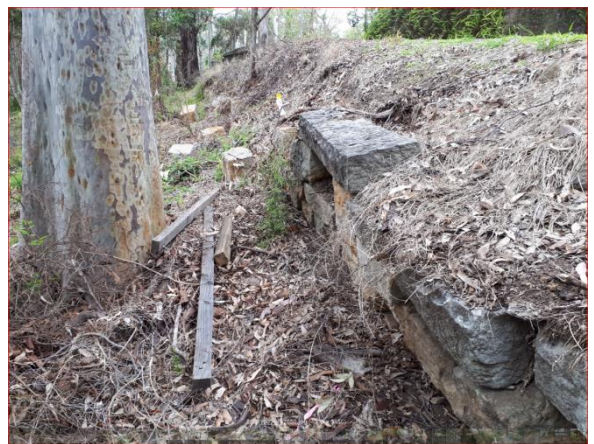
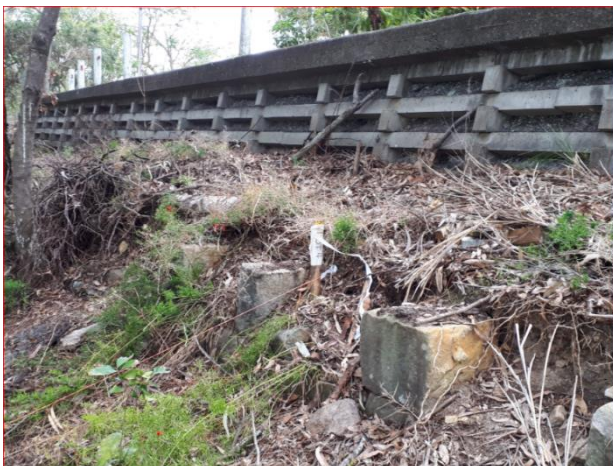
The south-western boundary of No. 96 is set back about 2m from the kerb line of Cabarita Road. Along most of this boundary was an old stone wall of about 0.6m in height, which had soil at its crest forming a gently sloping roadside verge. Where it was still intact, the stone wall was significantly tilting. Further along the wall, the upper courses of stone had failed and/or the wall was not evident.

About 1m upslope of the old wall remnants, was a crib-lock wall of about 1m in height supporting a concrete footpath. The path and crib-lock wall was limited to a length of about 20m. The wall, path and asphaltic concrete road appeared to be in good condition with no signs of movement.

The 0.6m to 1.0m high stone wall along the southern boundary of No. 96 is in a state of failure. We expect it was formerly a free standing 'fence' and soil, from road related works, has been pushed up against it. Notwithstanding, the survey shows this wall to be on the property boundary the embankment beyond is therefore council property. Failure of the wall (which it already has in some portions) will result in batters regressing towards the kerbside but they are unlikely to reach the roadway. Failure does not therefore present a road related hazard to the subject property, provided the road verge is maintained by council in due course. In this regard it would appear the crib-lock wall was constructed and has performed successfully on an adverse bend.

- 7.1.1 The existing retaining wall along the road side (south-western) boundary with No. 96 is leaning over, and in some sections fallen. Even though this risk assessment has shown that the risk from the hazard is acceptable we recommend that it be replaced as part of the subdivisional works. Since this wall extends across several of the proposed allotments it would be much easier to reconstruct the wall as part of the subdivision rather than within each individual lot. Retaining wall design parameters are provided below. Stone block gravity, or reinforced block retaining walls will be suitable subject to further investigation of the depth to rock along the wall alignment. Gabion and crib-lock walls, and reinforced earth walls, are also feasible structures provided they are founded on rock with sufficient space to form temporary batters.

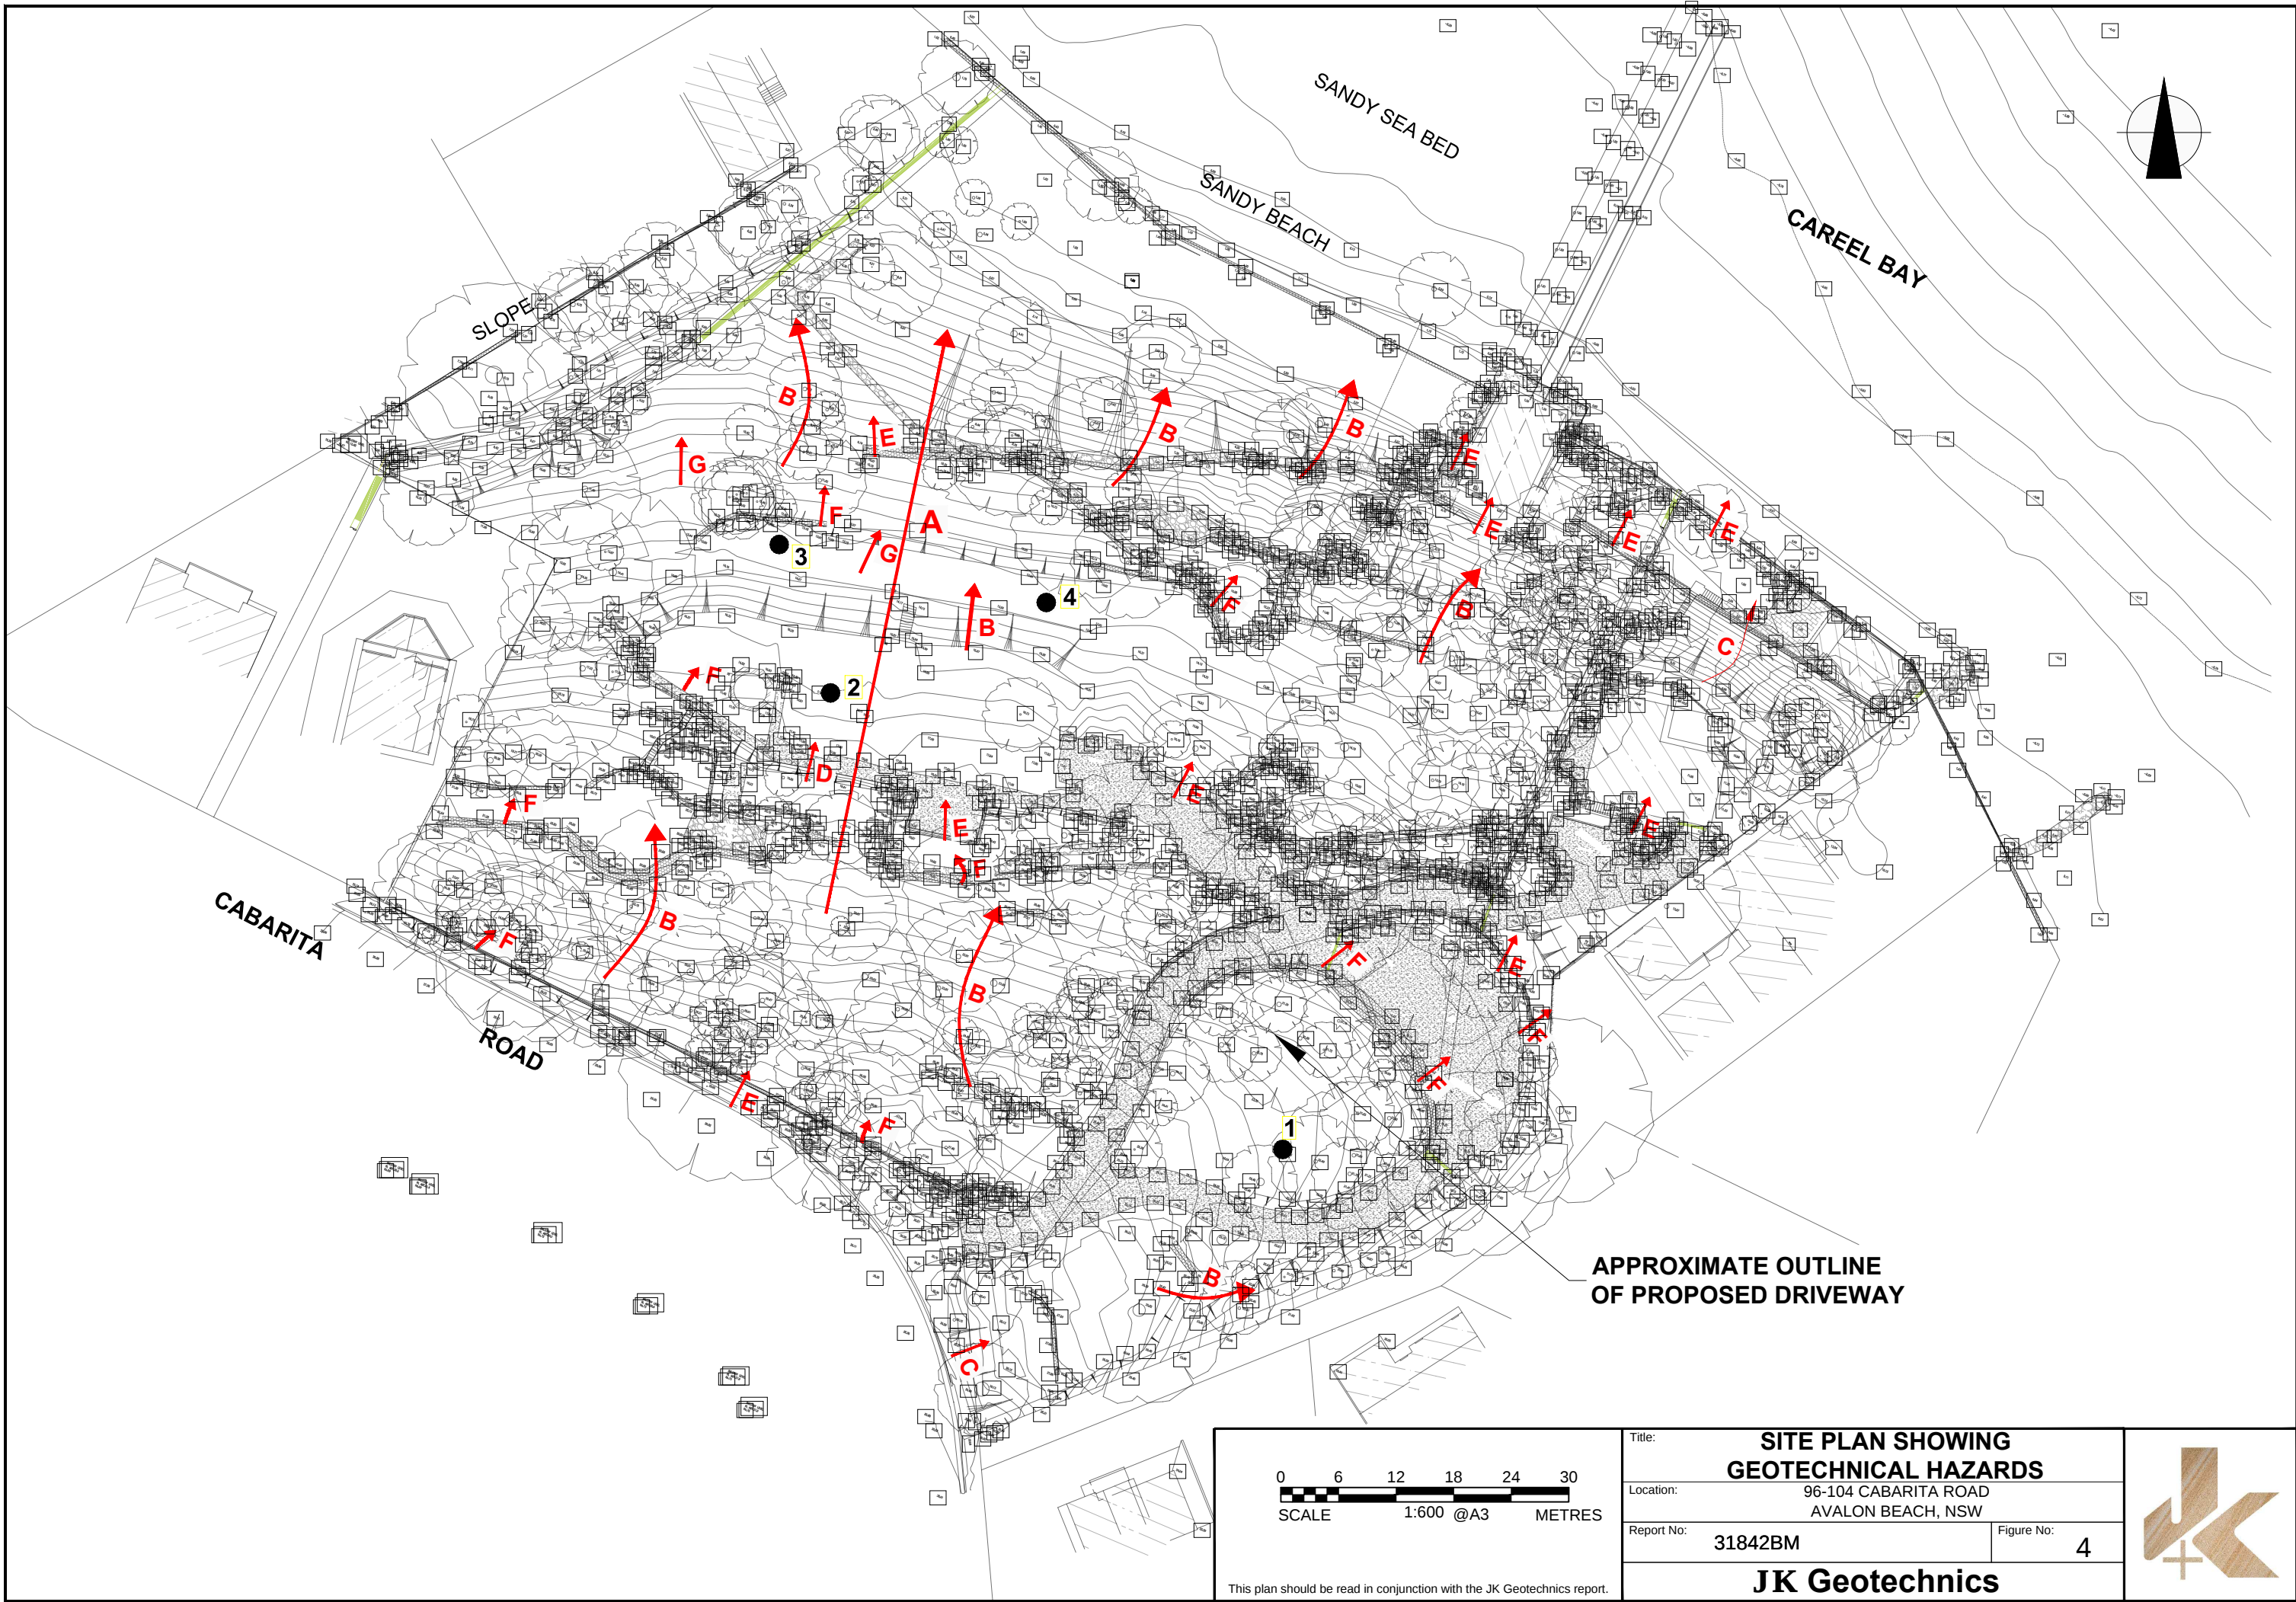
**FIGURE 4: SITE PLAN SHOWING GEOTECHNICAL HAZARDS**

- A. Overall slope failure, slopes typically 10° to 20°.
- B. Localised slope failure of slopes of less than or equal to 30°.
- C. Failure of the steep vegetated slopes of 35° located downslope of No. 104, and upslope of No. 100.
- D. Unsupported cuts in soil greater than or equal to 45° and less than 1.5m in height.
- E. Failure of the existing crib-lock wall at Cabarita Road and other properly constructed walls of less than 1.6m in height
- F. Failure of existing stone walls of less than 1.5m in height
- G. Proposed engineered retaining walls and cut & fill for the access driveway.
- H. Proposed engineered retaining walls for new houses
- I. Local slope failure beneath the new houses

These potential hazards are indicated in schematic form on the attached Figure 4; some of them are also on Figures 5 and 6.
