Our Ref: 18EGO3T

07 June 2022

**Re: Project Arborist Services at
Lot 1 DP 1220196, 4-10 Inman Rd Cromer NSW 2099.**

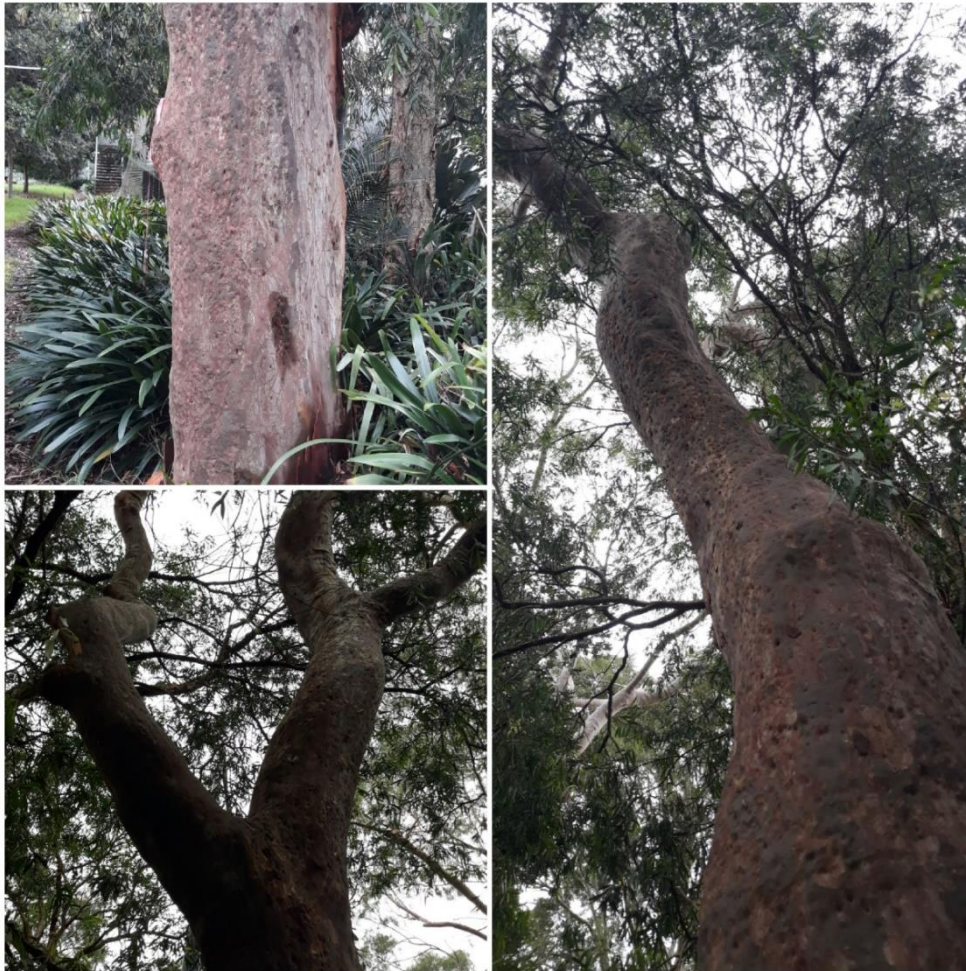
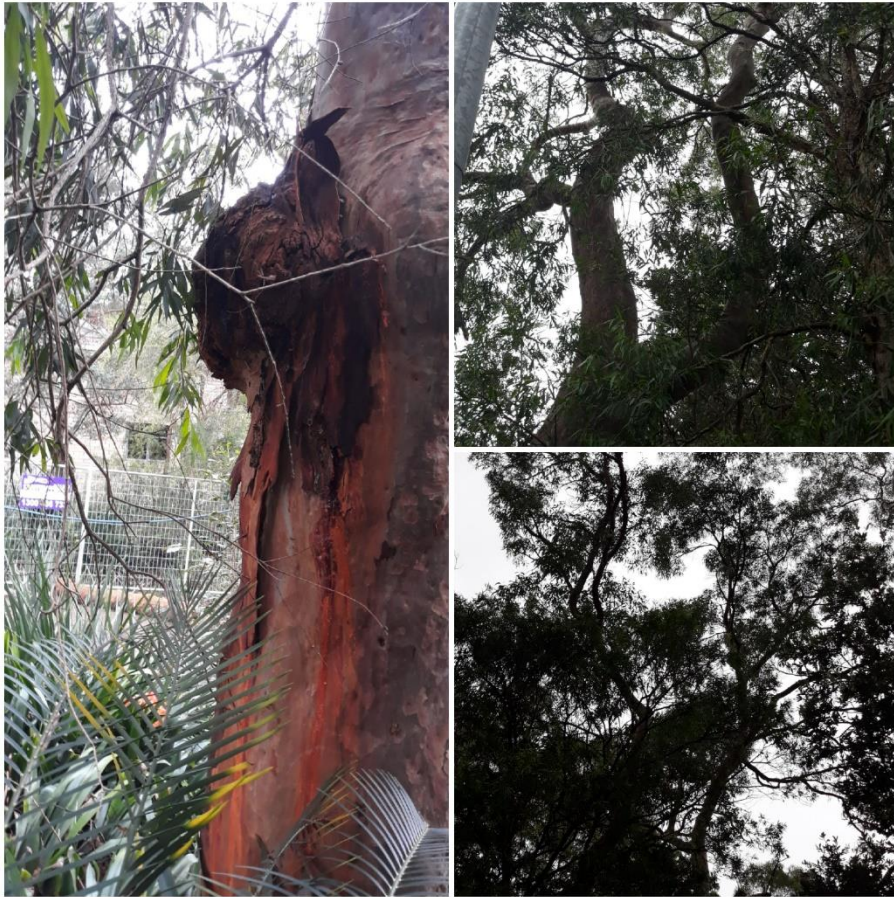
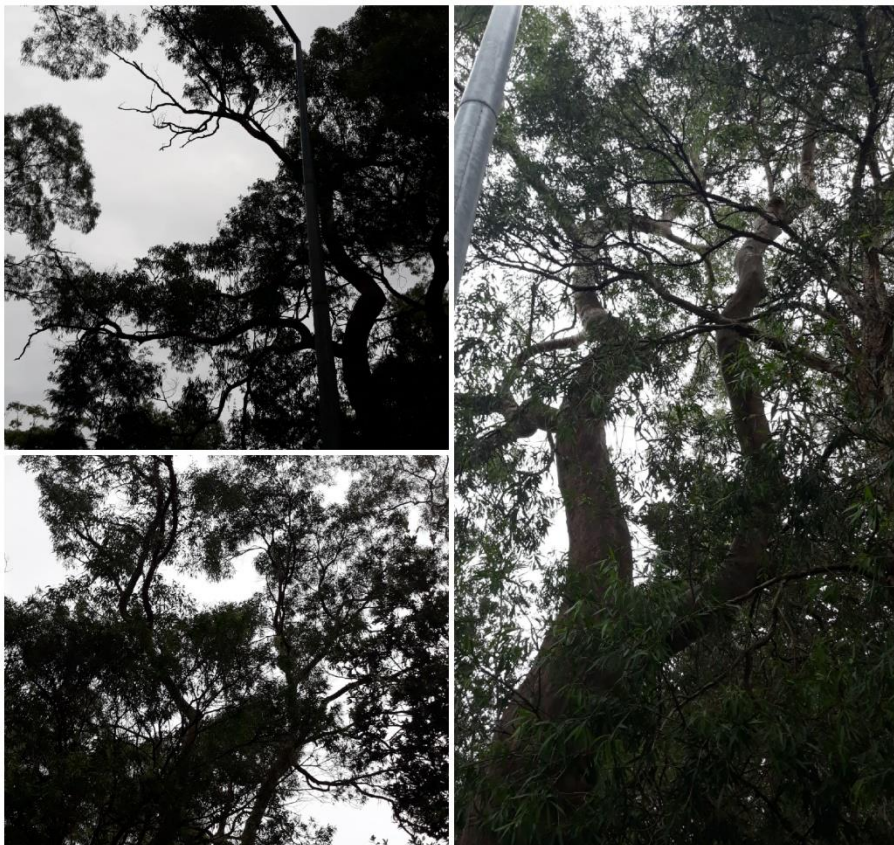
Tree 56

Species: *Angophora costata* (Sydney Red Gum)

Height: 13 metres

Canopy Width: 13 metres

Diameter at Breast Height (DBH): 60 cm

Deadwood (estimated percentage): 35%

Pests or disease observed: none

General Comments: Tree 56 presents in average condition and good vigour with normal foliage, good structure, codominant at base of crown and phototropic. Tree has an old wound on eastern side of trunk at 2m high with a small amount of kino exuding. Wound has occluded however bark is growing abnormally similar to a burl. Some reaction wood has been put down. Tree has been pruned for adjacent ambience light. Tree is located in a garden bed adjacent a building and vehicular entrance road (and is now starting to grow into adjacent pebblecrete footpath), with an estimated useful life expectancy (ULE) of 40+ years.

Given the spatial constraints of the riparian corridor, the removal of Tree 56, Tree 57 and Tree 58 is required to enable the removal and reinstatement of the drainage channel/waterway. Deep excavations and installation of batters will be undertaken within the location of Trees 56, 57 and 58 and their removal is required to facilitate the proposed plans.

Six (6) additional trees should be planted to off-set the removal of Trees 56, 57 and 58 elsewhere within the site. A suitable location would be within the planting area closest to the riparian corridor: 2 x *Melaleuca quinquinervia* (Broad-leaved Paperbark), 2 x *Bursaria spinosa* (Blackthorn) and 2 x *Tristaniopsis laurina* (Water Gum), minimum pot size 100L (dependent on availability). These species will provide valuable mid canopy habitat and potential connectivity.

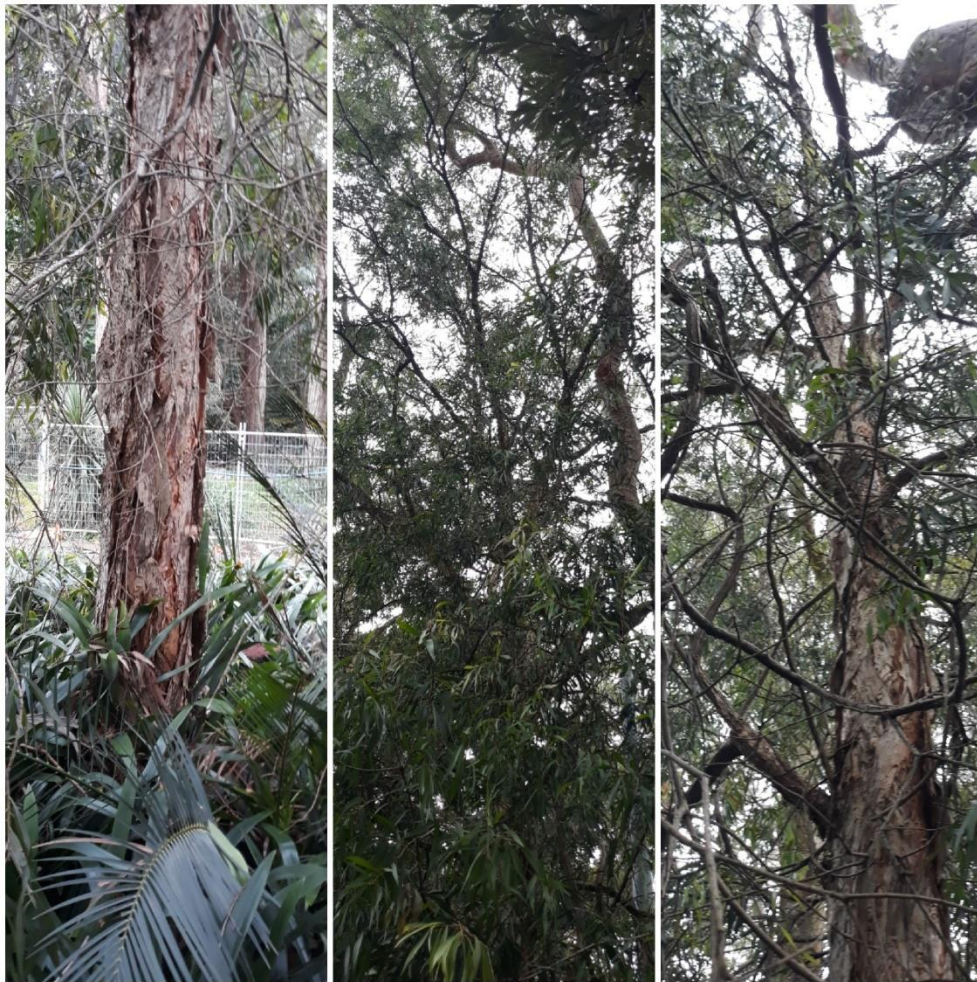
Figure 5: Tree 57

Tree 57

Species: *Melaleuca sp.* (Paperbark Tree)

Height: 9 metres

Canopy Width: 6 metres

Diameter at Breast Height (DBH): 40 cm

Deadwood (estimated percentage): 0%

Pests or disease observed: none

General Comments: Tree 57 presents in excellent overall health and condition with normal foliage, good vitality and very good structure. Tree is growing in a garden bed adjacent a building and vehicular entrance road, with an estimated useful life expectancy (ULE) of 40+ years.

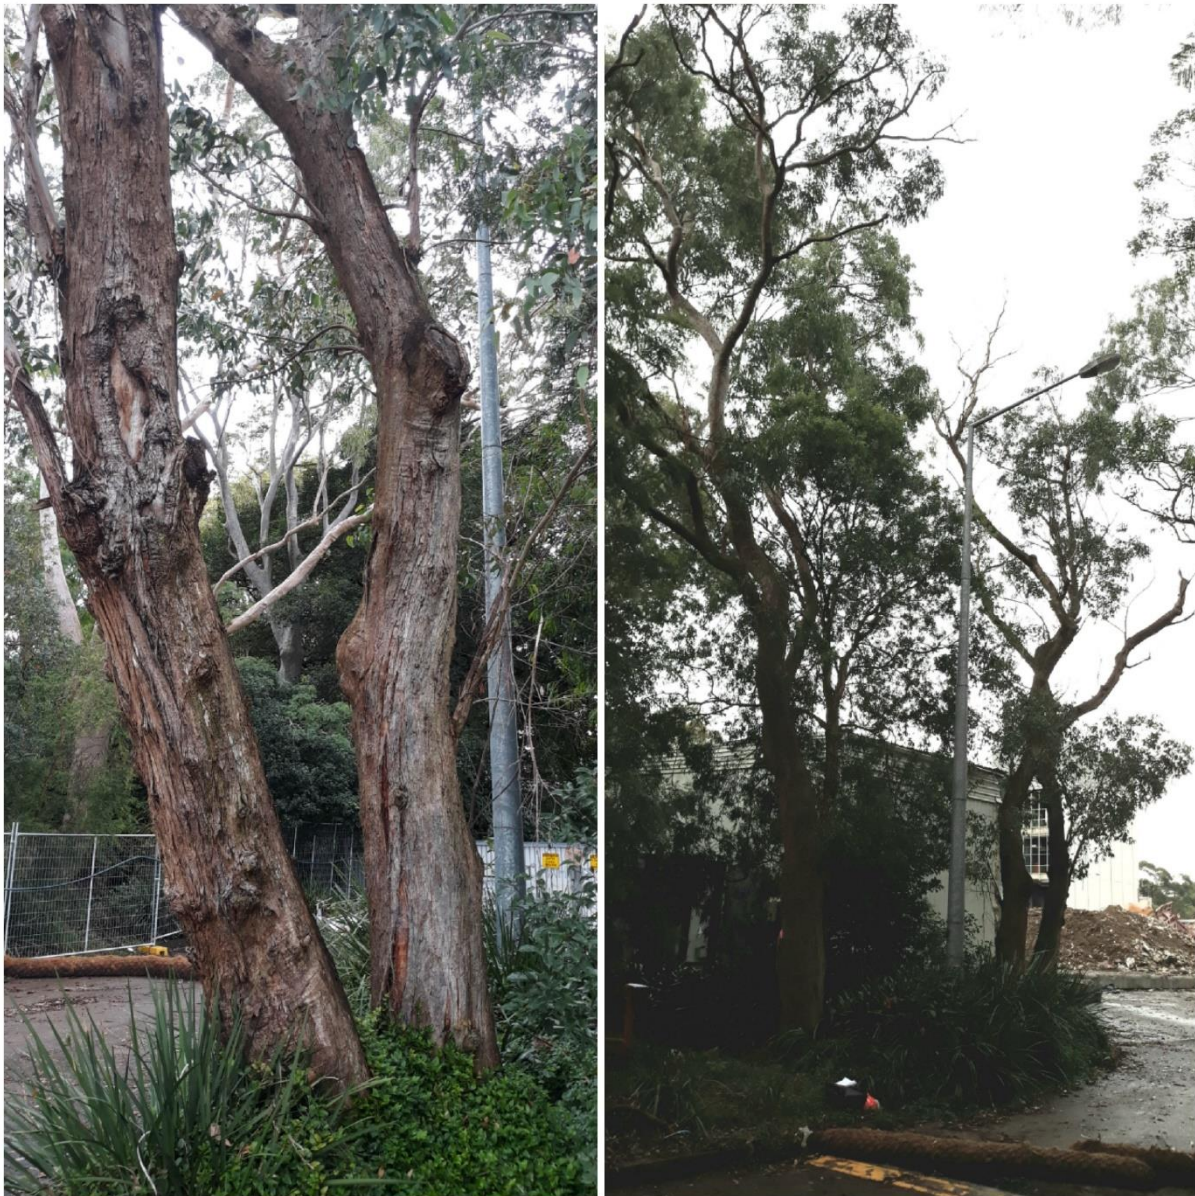
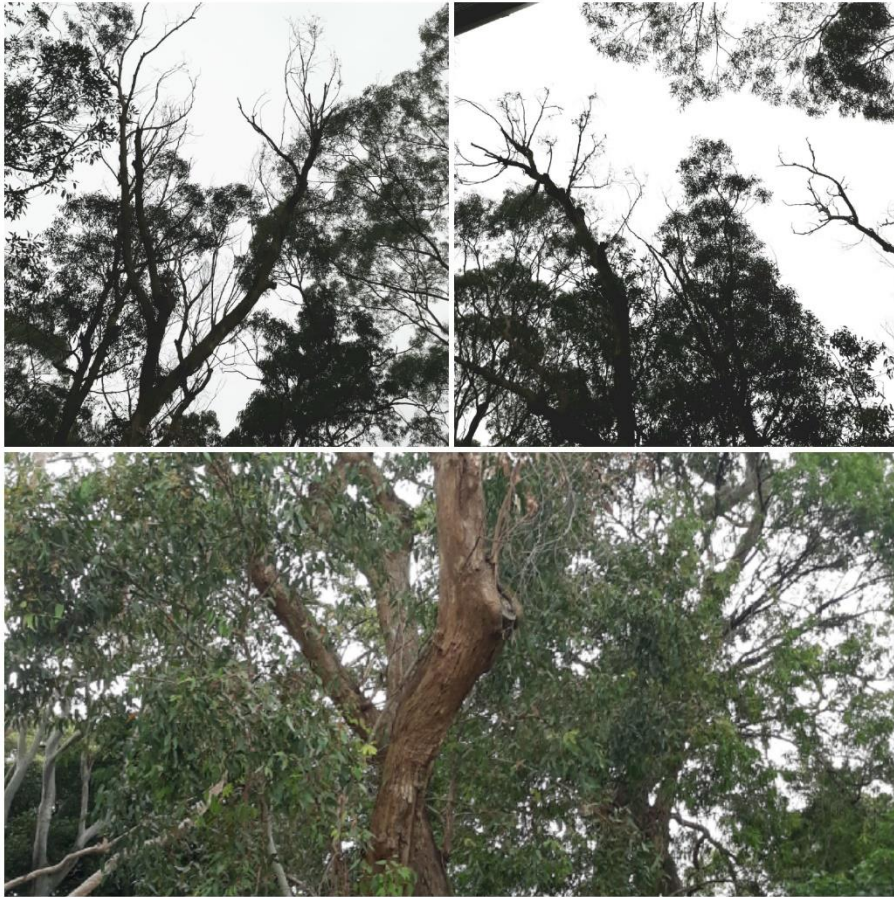
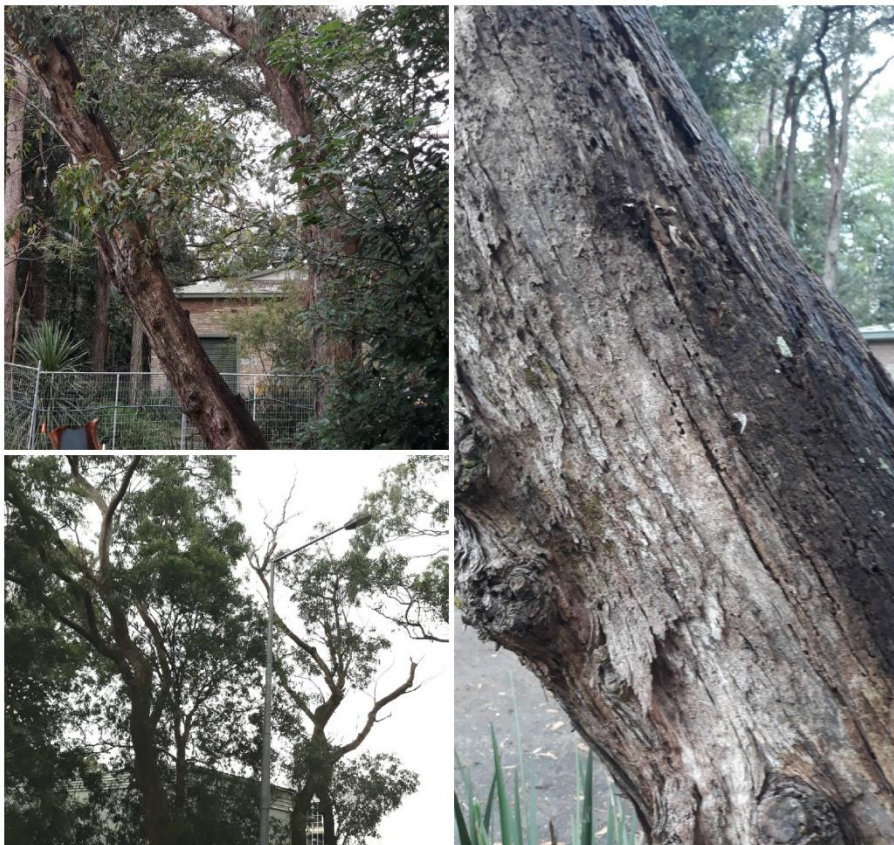
Tree 58**Species:** *Eucalyptus piperita***Height:** 13 metres**Canopy Width:** 10 metres**Diameter at Breast Height (DBH):** 54,49 cm**Deadwood (estimated percentage):** 70%**Pests or disease observed:** none

General Comments: Tree 58 is in spiral of decline. Dieback has established with only 15% vigour. There is an old tearout in the western leader. The northern leader has 3 epicormic shoots and the remainder of the foliage is dying or recently dead. The western leader has 1 scab that is of normal foliage and structure but dieback is starting at the tip and the remaining foliage is dead or dying. Tree has been pruned for building clearance with some good woundwood formed and some poor pruning/flush cuts. Tree has also been pruned for road and ambience light clearance. Tree is located in a garden bed adjacent a building and vehicular entrance road with an estimated useful life expectancy (ULE) of <5 years.

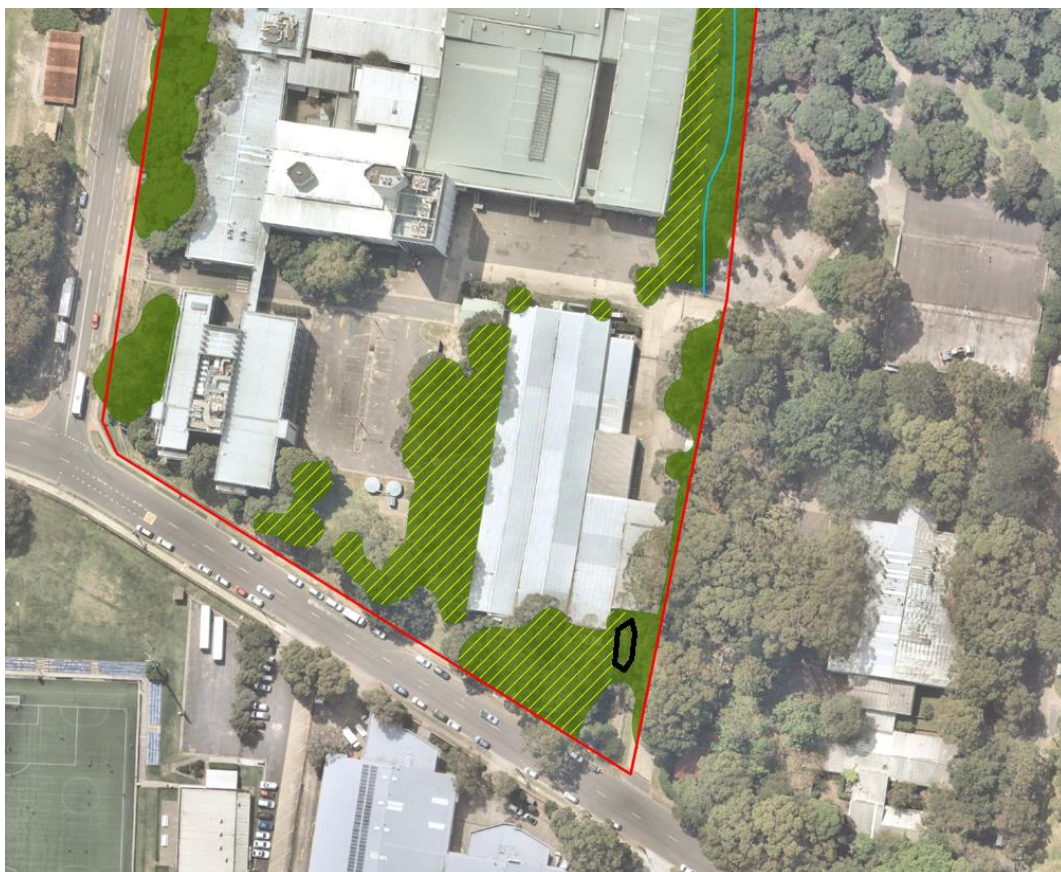
The proposal has been assessed and approved with a BDAR requiring credits for impacts on PCT 1841. The base of the 3 trees appear to occur adjacent to the area being offset or considered as part of the development footprint (see figure below) with some canopy overhang into the development footprint. The credits generated by the impact was 9 ecosystem credits for a 5,200m² impact. The addition of 100m² impact would not change the credit generation, it would need to be approximately 578m² in size to require an additional credit to be sourced. Based on this, we don't feel it necessary to provide an amendment to the BDAR or calculator.

Figure 9: Location of the 3 trees in relation to the development footprint in the BDAR (diagonal lines)
