## 63 Marine Parade, Avalon

### Geotechnical Comments for Section 4.55

## **GEOTECHNICAL INVESTIGATION:**

### **Alterations & Additions at 63 Marine Parade, Avalon**

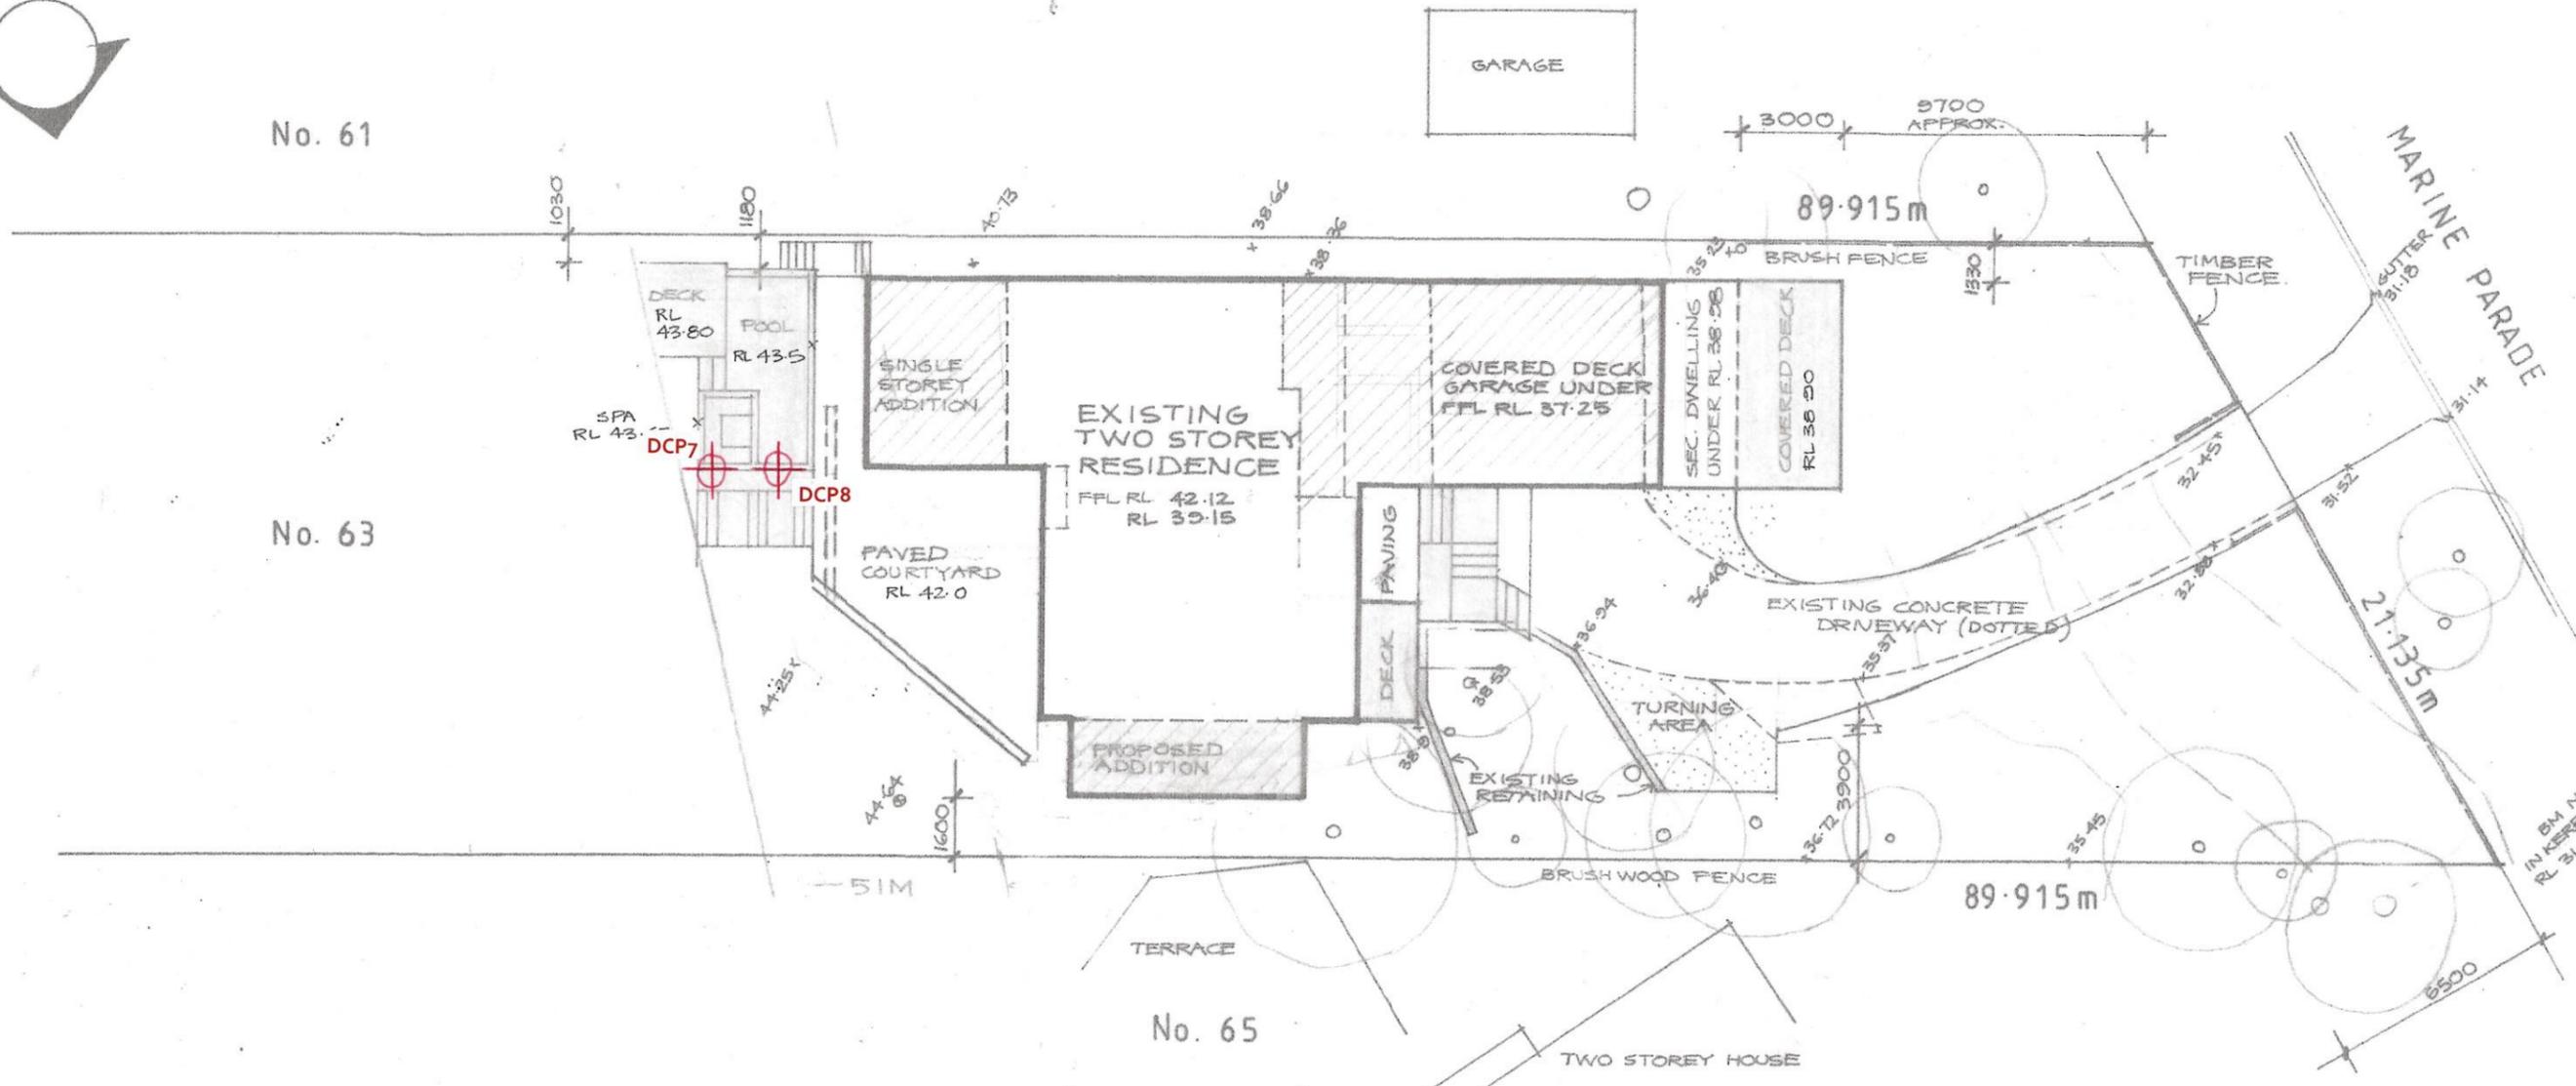
SITE PLAN – showing additional test locations

Two additional Dynamic Cone Penetrometer (DCP) tests were put down to determine the relative density of the overlying soil and the depth to bedrock in the location of the proposed pool. The locations of the tests are shown on the site plan below.

DCP7 – Refusal on rock @ 0.6m, DCP bouncing off rock surface, brown impact dust on dry tip.

DCP8 – End of test @ 0.9m, DCP still very slowly going down, brown impact dust on dry tip.

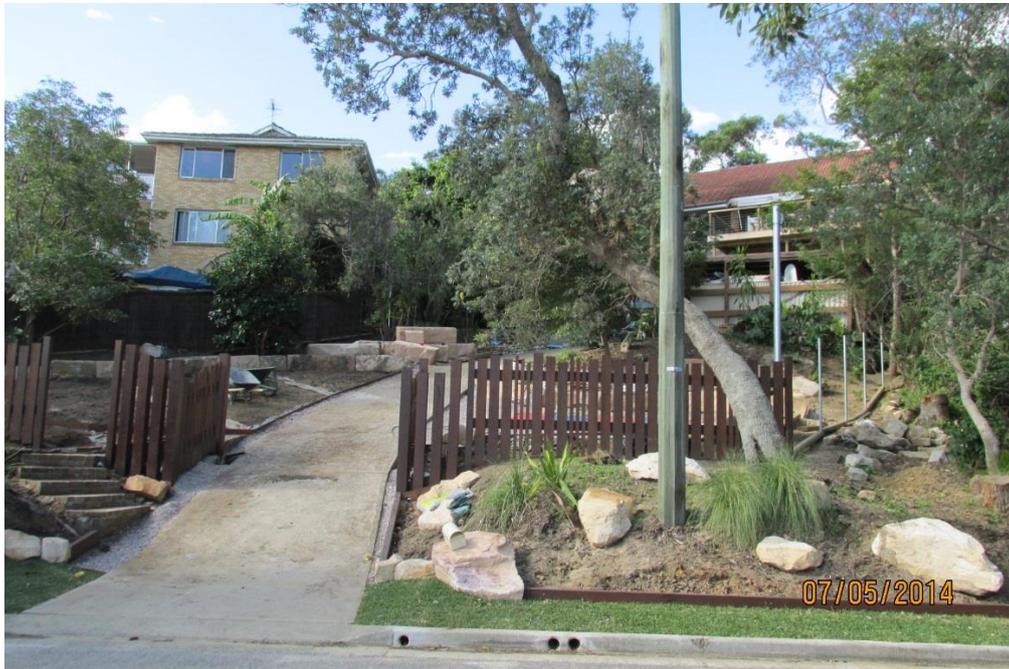
Photo 1

- 2.3 At the road frontage a concrete paved driveway climbs the slope to a brick carport below the house (Photo 1 & 2). The carport is constructed over a cut and fill in the slope. The cut is supported by a brick wall. The fill merges into the natural slope. The house is a two storey brick structure and has also been supported on a cut and fill. At the higher northern side sandstone bedrock is exposed in the cut. At the southern downhill corner some settlement is evident in the exterior supporting wall, where it is likely supported on the fill (Photo 3). On the uphill side of the house a cut has been made in the slope to provide a lawn area. The cut is supported by a brick wall that has cracked and tilted (Photo 4). This wall will be replaced as part of the works. Above the wall sandstone bedrock that caps the cliff outcrops and rises to the crest of the slope. At the crest the surface is level for ~10m before the cliff drops to the ocean (Photo 5). The top half of the face is horizontally bedded sandstone with shale beds forming the lower half (Photo 6). Some minor undercutting was observed through the upper sandstone beds but the majority of the face within the property contained no undercutting and is considered stable. The base of the cliff is protected from the erosive forces of wave action by the rock platform and boulders that have accumulated at the base of the cliff as part of the normal weathering process.

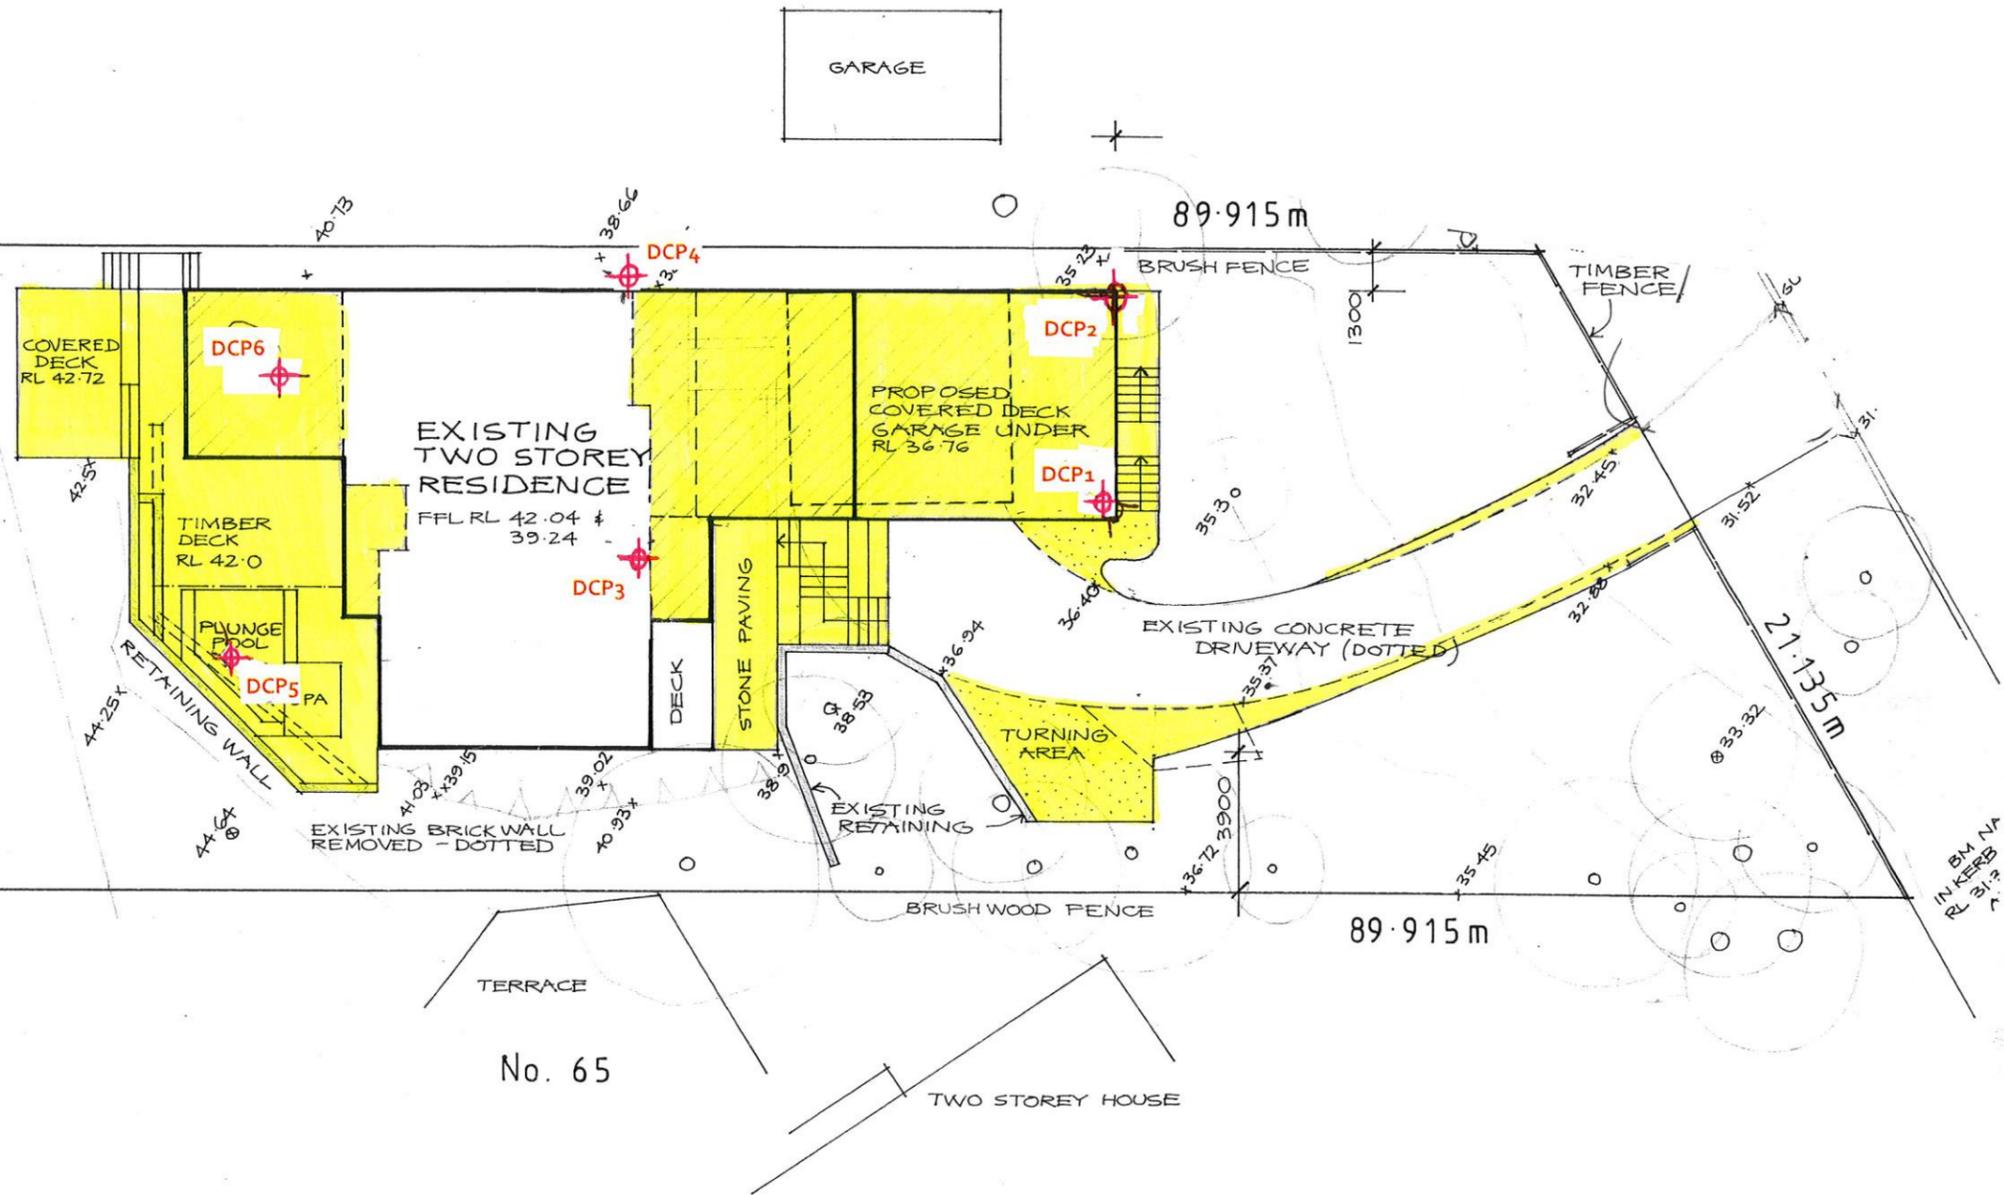
SITE PLAN – showing test locations

Five DCP (Dynamic Cone Penetrometer) tests were put down to determine the relative density of the overlying soil and the depth to bedrock. The location of the tests are shown on the site plan and the results are as follows:

DCP1 – end of test @ 1.2m, nothing on dry tip.

DCP2 – end of test @ 0.9m, nothing on dry tip.

DCP3 – end of test @ 0.6m, nothing on dry tip.

DCP4 – end of test @ 0.1.8m, nothing on dry tip.

DCP5 – refusal @ 0.6m on rock, orange impact dust on dry tip.

DCP6 – end of test @ 0.9m, light brown impact dust on dry tip.

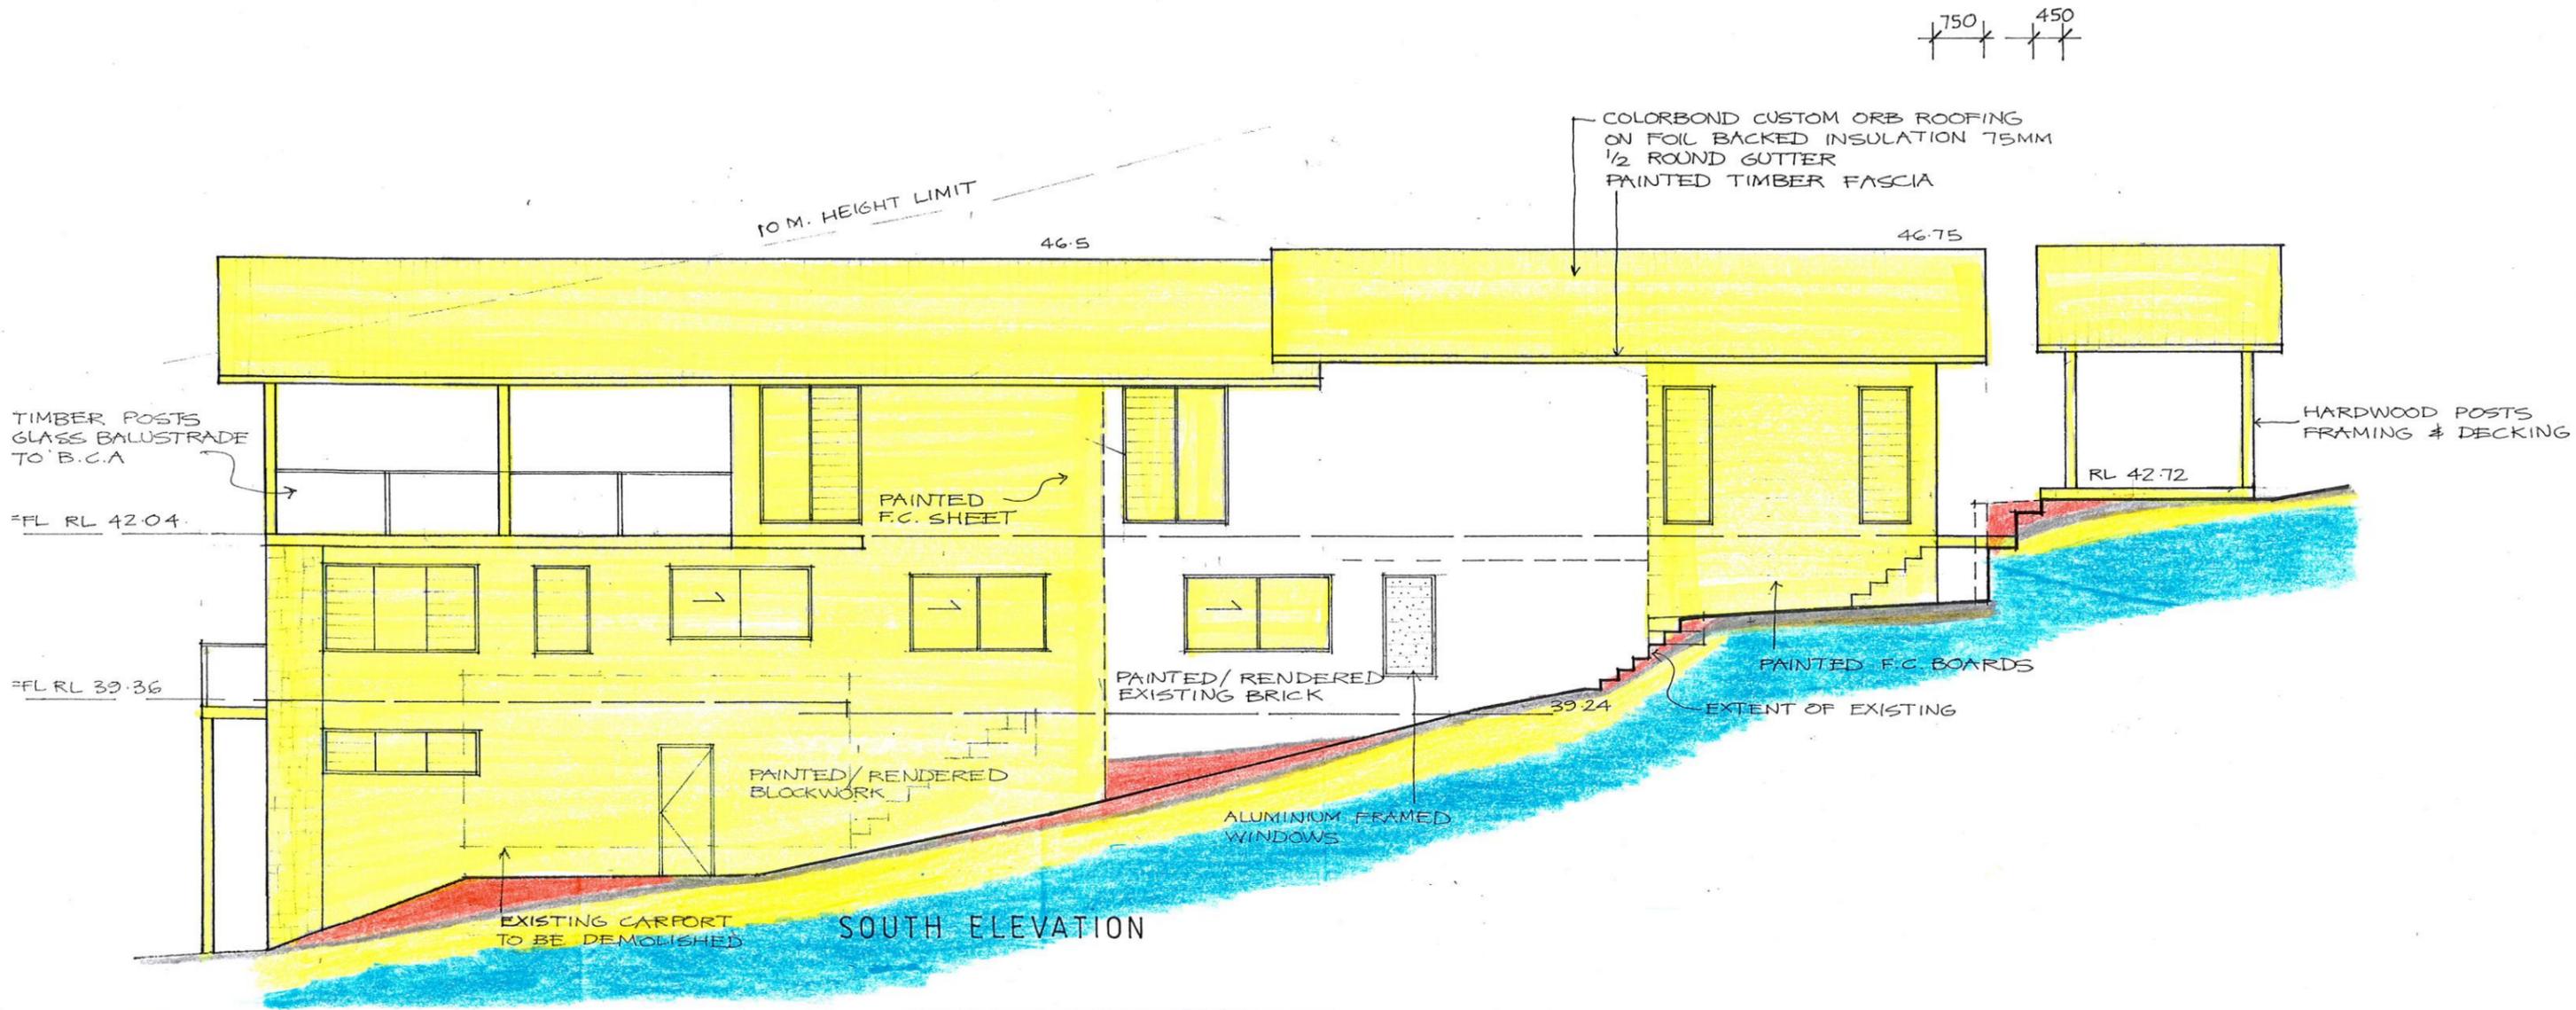
Type Section  
 63 Marine Parade, Avalon  
 J0152  
 Scale 1 :100

The slope materials are colluvial at the near surface and residual at depth. They consist of sandy clays and clays with rock fragments throughout the profile. The sandy clays and clays merge into the weathered zone of the underlying rocks at depths expected to be in the range 0.6 to 1.5m. The weathered shale can appear as a mottled maroon to light grey stiff clay when it is cut up by excavation equipment. Fill is expected at the southern downhill corner of the house, behind the brick retaining wall on the downhill side of the house and below the downhill side of the garage.
