From: [Gerry Lenihan](#)
To: [Planning Panels - Northern Beaches](#)
Cc: [REDACTED]
Subject: DDP Meeting 3 December 2025 - Regarding DA2025/0167 - Geotechnical report
Date: Thursday, 27 November 2025 4:06:24 PM
Attachments: [image003.wmz](#)
[image001.wmz](#)
[image002.png](#)
[2025-11-25 - White Geotechnical Group - 10 Capua Pl, Avalon Assess SW.pdf](#)
Importance: High

10 Capua Place, Avalon.

Comments on proposed neighbouring stormwater system

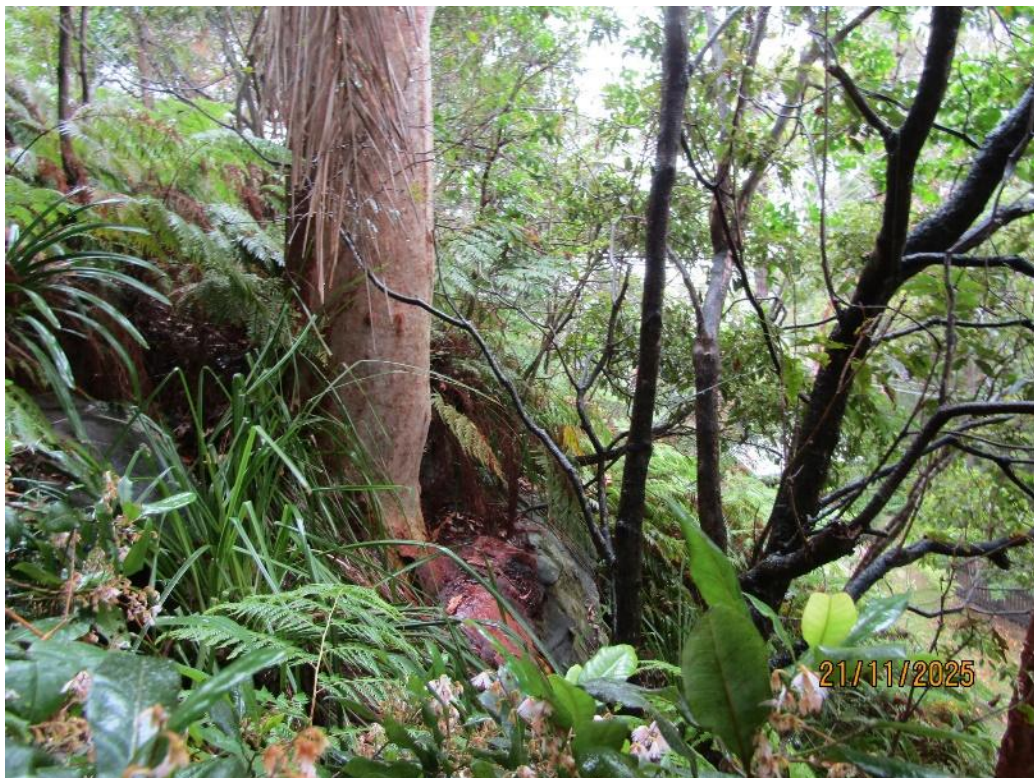
The slope immediately below the proposed spreader drops steeply at angles of 40 degrees (Photo 1). Foundations dug on the adjoining property (10 Capua Pl) for an extension in 2021, meters from Photo 1 on this slope, found the soil overlying the rock was 1.1 to 1.3m deep. The soil slope terminates at a sandstone cliff face that drops some 5m to the driveway of 10 Capua Pl. (Photo 2). The cliff face is considered stable in terms of a mass failure but does have some cracking through the bedding planes that could result in small isolated rockfalls (Photo 3).

Photo 1 – grade of soil slope immediately below spreader and immediately above the rock face.

In our opinion a spreader pipe is not a suitable stormwater solution for this site primarily because of the very steep grade, (40° from horizontal) and the depth of the soil overlying the slope (1.1 to 1.3m deep) immediately below the spreader. Adding additional stormwater flows to a slope this steep could result in slope stability issues during heavy or prolonged rainfall events. Additionally, the spreader is shown on the plans to be only 1.2m wide so the discharged stormwater will be concentrated onto the slope over a width of only 1.2m (See Stormwater Plan Appended). We do not consider this width is adequate to spread the water across the slope, rather, it is concentrating it to only a width of 1.2m. Concentrated stormwater flows can cause stability issues on very steep soil slopes.

The steep slope that the spreader discharges onto is immediately above the driveway of 10 Capua Place so any soil failure that occurs as a result of the stormwater system will likely impact the driveway. This is a risk to life and property on 10 Capua Place.

The proposed spreader system for the secondary dwelling at 45A Riviera Avenue, Avalon Beach is not a suitable stormwater disposal system due to the steep soil slope and the 5m cliff face immediately below. A suitable solution is to pipe the stormwater from the proposed secondary dwelling to the Council Stormwater System for the road below.

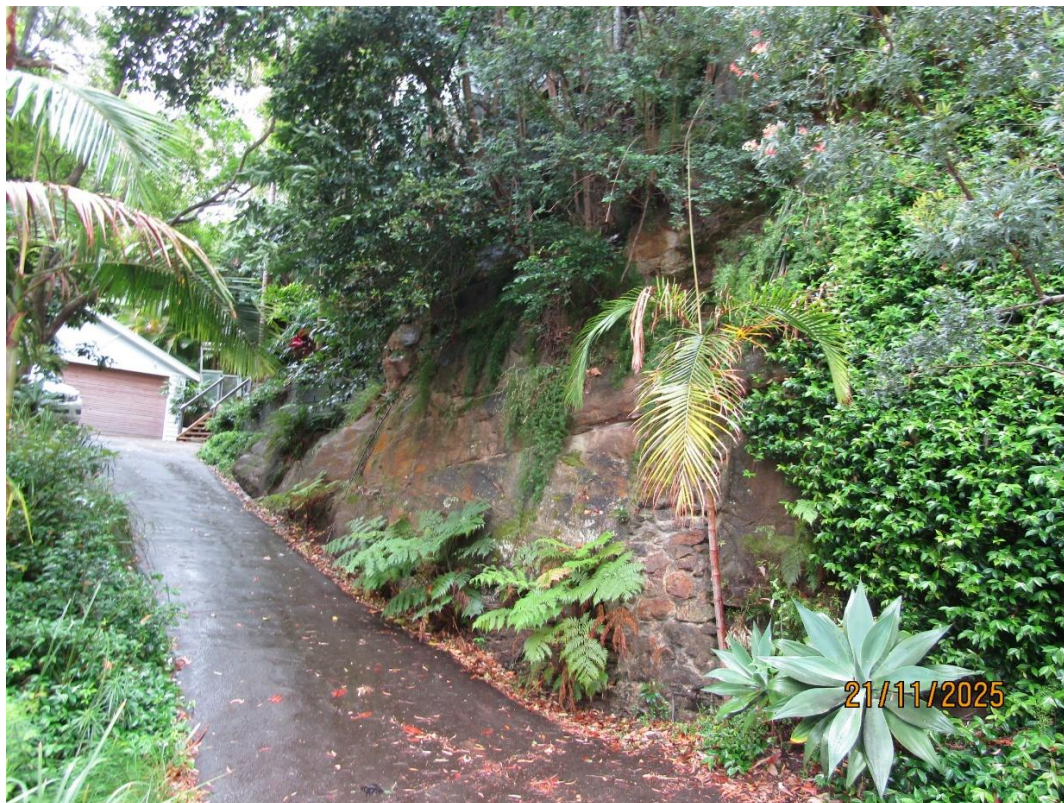
Photo 2 – cliff face below proposed spreader and driveway for 10 Capua Pl.

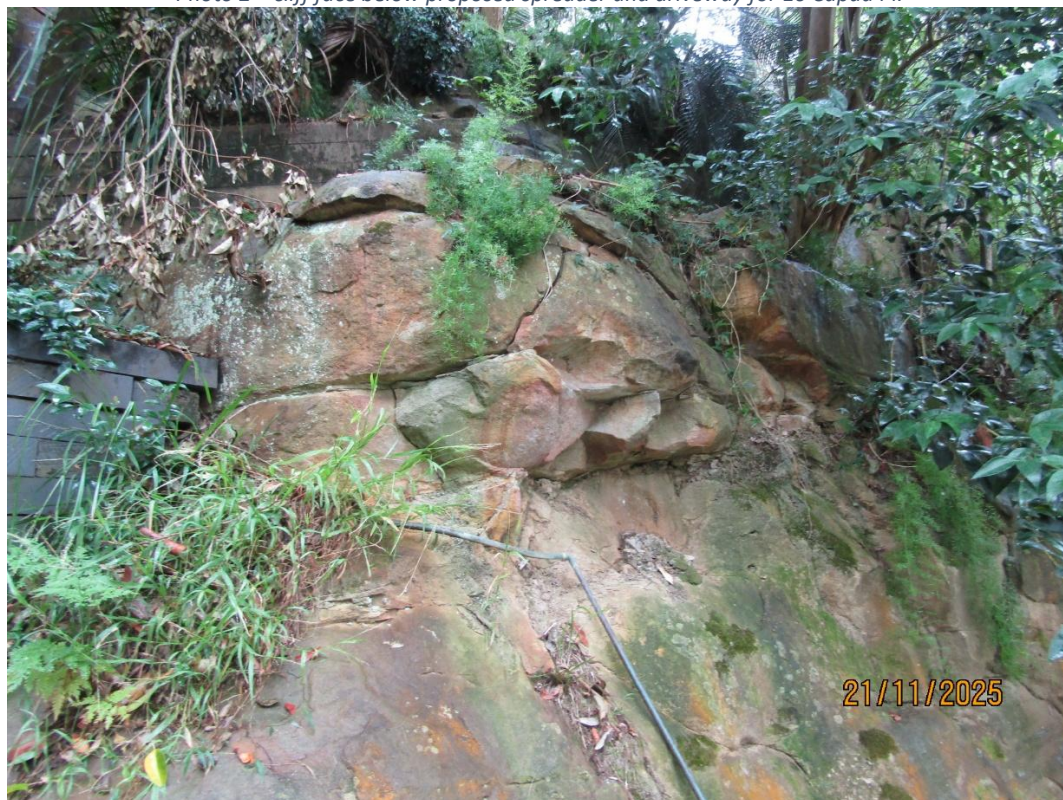
Photo 3– close up of cliff face below proposed spreader, showing cracking.
