Geotechnical Assessment

Project: Alterations & Additions
8 Cecil Road, Newport NSW

Ref: AG 25314
26 July 2025

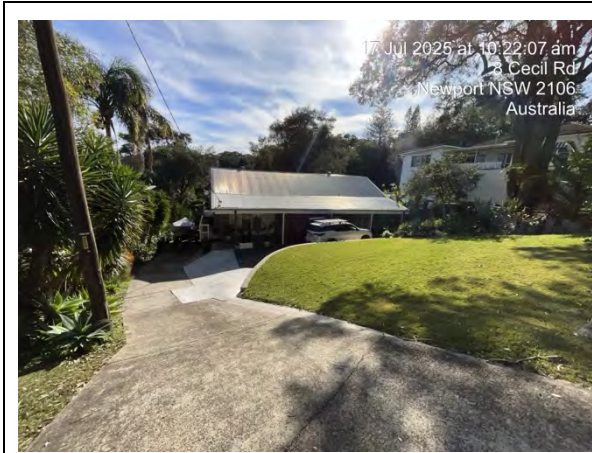
Photo 1: Residence frontage

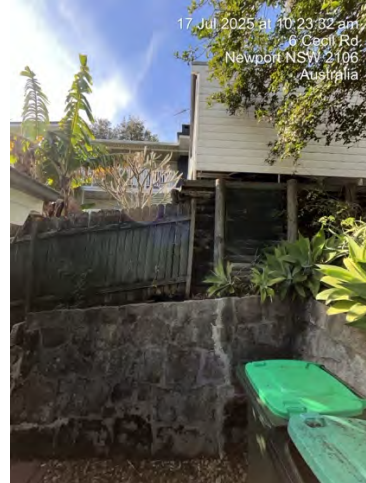
On the eastern boundary, near the southwestern corner of the house, a sandstone flagging wall is visibly displaced and contains a vertical crack, extending the full height of the wall, and which has been patch repaired.

Photo 2: Sandstone flagging wall downslope of adjoining structure footings on the eastern boundary of the subject site

Recommendation	Description
	<p>geotextile fabric (i.e. Bidim A34 or similar) to prevent the clogging of the drainage with fine-grained sediment.</p> <p>We recommend that the sandstone flagging wall at the southeastern corner of the house (Photo 2) be replaced with a retaining wall designed by a structural engineer. The sandstone flagging wall is not adequate to retain the slope or soil materials long term and failure of this wall has the potential to impact upon the footings of the garage structure of the adjoining site to the east, immediately upslope of this wall.</p>
<p>Footings</p>	<p>A maximum allowable bearing pressure of 400kPa can be assumed for footings on low strength shale bedrock. It should be noted that this material is a soft rock and a rock auger will cut through it, so the builders should not be looking for refusal to end the footings.</p> <p>As the bearing capacity of clay and shale reduces when wet, we recommend the footings be dug, inspected and poured in quick succession (ideally the same day if possible). If the footings get wet, they must be drained and the soft layer of clay/shale on the footing surface is to be removed before concrete is poured.</p> <p>If a rapid turnaround from footing excavation to the concrete pour is not possible, a sealing layer of concrete may be added to the footing surface after it has been cleaned. All footings should be taken below the zone of influence of adjacent excavations which is a theoretical 45° (1 Horizontal to 1 Vertical) line from the base of the proposed excavation towards the proposed footings.</p> <p>It is essential that the foundation materials of all footing excavations be inspected and approved by AscentGeo before steel reinforcement and concrete is placed. This inspection should be scheduled while excavation plant and operators are still on site, and before steel reinforcement has been fixed or the concrete booked.</p>

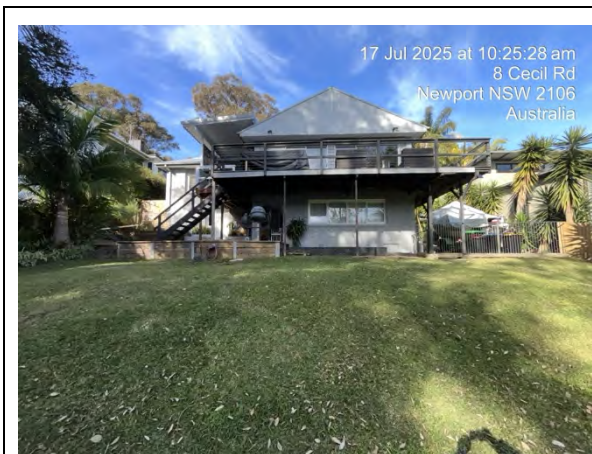
Photo 3: Rear of the residence

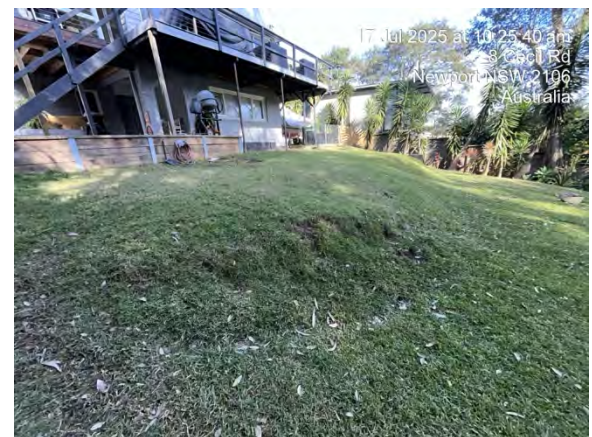
The existing building at the site is a two-storey house with a grassed front yard and larger grassed backyard areas. The rear yard displays terrace mounded soil, inferred to be the result of the placement of excavation spoil materials from the original clearing and construction of the existing dwelling. Neighbouring buildings are mostly double storey dwellings that appear to be in good condition.

Photo 4: Mounded fill materials in the rear yard
