GEOTECHNICAL ASSESSMENT

PROPOSED ALTERATIONS AND ADDITIONS

76 ALAMEDA WAY WARRIEWOOD, NSW

Project No.: 2019-137

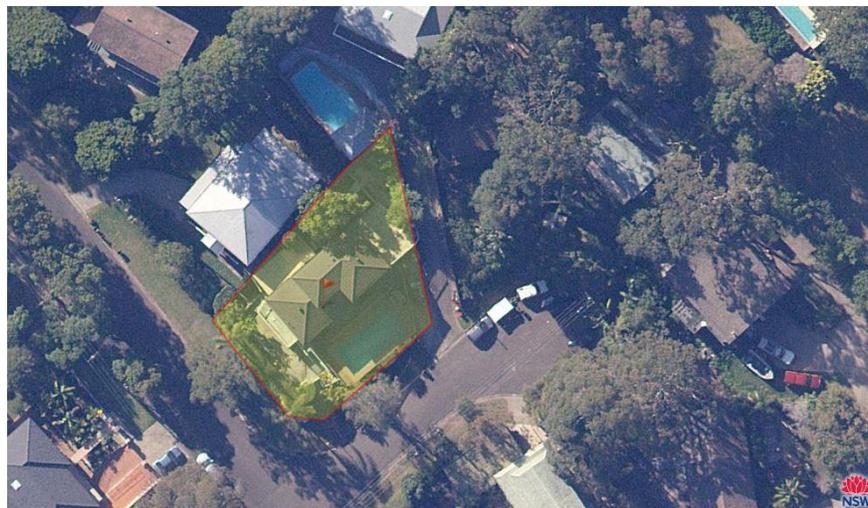
Photograph: 1 – View of site and surrounds

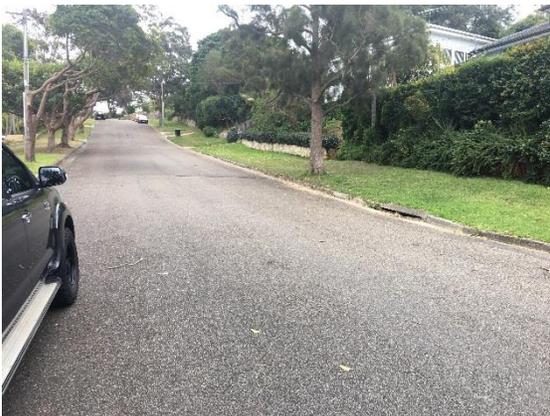
Photograph: 1 □ Alameda Way, □ site □ to right

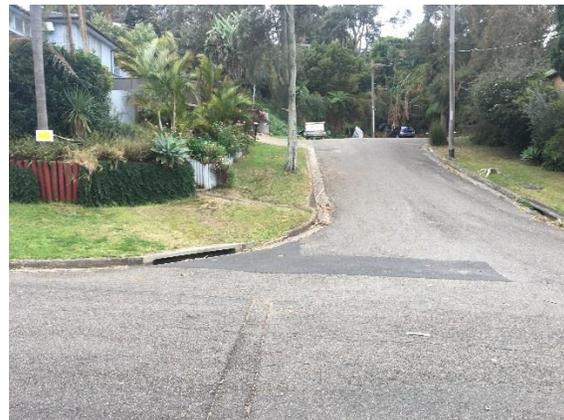
Photograph: 2 □ Iramir Place, □ site □ to left

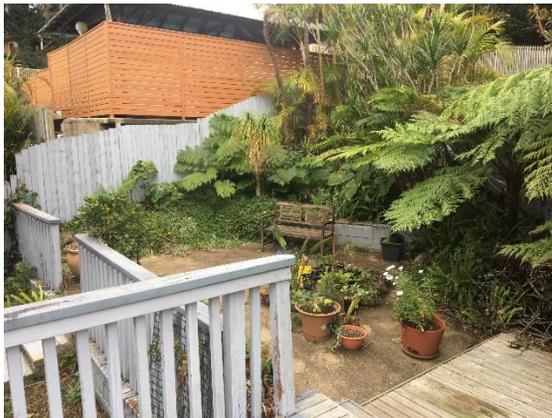
The north-east corner of the site contains gently sloping terraces with garden surrounds that are stepped down to the west and retained by low timber, concrete block and sandstone rock retaining walls along the rear northern side of the house. A garage structure is formed at the eastern end of the house, at Ground Floor level, with a timber deck above at First Floor level. The garage is considered to be an addition to the original house and appears to have involved excavation into the hill slope, which is now retained by a 3.0m high concrete retaining wall. The low garden support walls show some cracking and deterioration however there were no indications of instability in garden beds or terraces whilst the garage's concrete retaining wall is in good condition with no signs of movement, excess cracking or deterioration.

Photograph: 3 - Gardens, terrace north-east corner

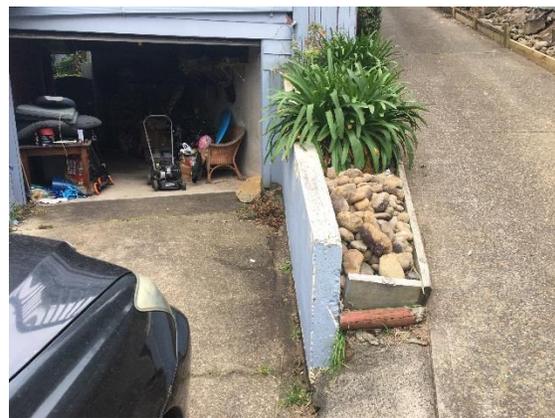
Photograph: 4 □ Garage at east end of site

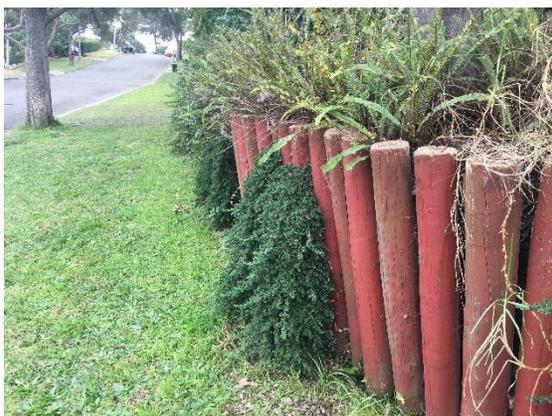
The western end of the site contains a narrow, gently sloping garden bed that rises up from the crest of a series of vertical 100mm diameter timber posts that have been formed along the sites western boundary and retain the garden bed approximately 1.0m above the road reserve level. These posts are separated by approximately 50mm gaps and are interpreted to provide support via a cantilever method. At the crest of the garden slope is a steel fence line with a narrow garden on its eastern side that is retained approximately 400mm above a concrete terrace formed at the western end of the house. The timber log retaining wall system shows deterioration of the timber material due to age and is also rotated by approximately 10 deg, likely due to soil creep pressures and deterioration of the buried cantilever support portion.

Photograph: 5 □ Timber log retaining wall west bdy.

The existing timber post retaining walls supporting garden beds at the sites western and southern boundaries are deteriorating with age whilst the western wall shows signs of moderate rotation. This wall will be expected to continue to rotate with eventual collapse, however the resultant slope movement is considered to be limited to the adjacent garden area and is not considered to be a significant landslip hazard.

Hazard A was estimated to have a **Risk to Life** of up to **5.21×10^{-8} for a single person**, while the **Risk to Property** was considered to be **‘Low’**.

It is recommended that the footings for the new deck at the western end of the house be extended to found within residual soils to reduce any impact from movement in the soils retained by the log wall on the western boundary. It is also recommended that these log retaining walls be replaced before further significant deterioration or rotation occurs. This should be considered within a time line of approximately 10 years.

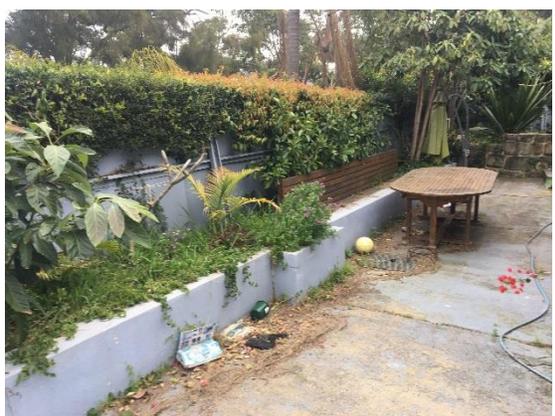
Photograph: 6 □ Concrete terrace west end of house
