**GEOTECHNICAL RISK MANAGEMENT POLICY FOR PITTWATER
FORM NO. 1 – To be submitted with Development Application**

Development Application for	<u>Niels and Lenore Walter</u> Name of Applicant
Address of site	<u>10 Taminga Street, Bayview</u>

**RISK ANALYSIS & MANAGEMENT
FOR
PROPOSED ALTERATIONS AND ADDITIONS
AT
10 TAMINGA STREET, BAYVIEW**

Job Number:
QY 00171
15th December, 2020
Page 13

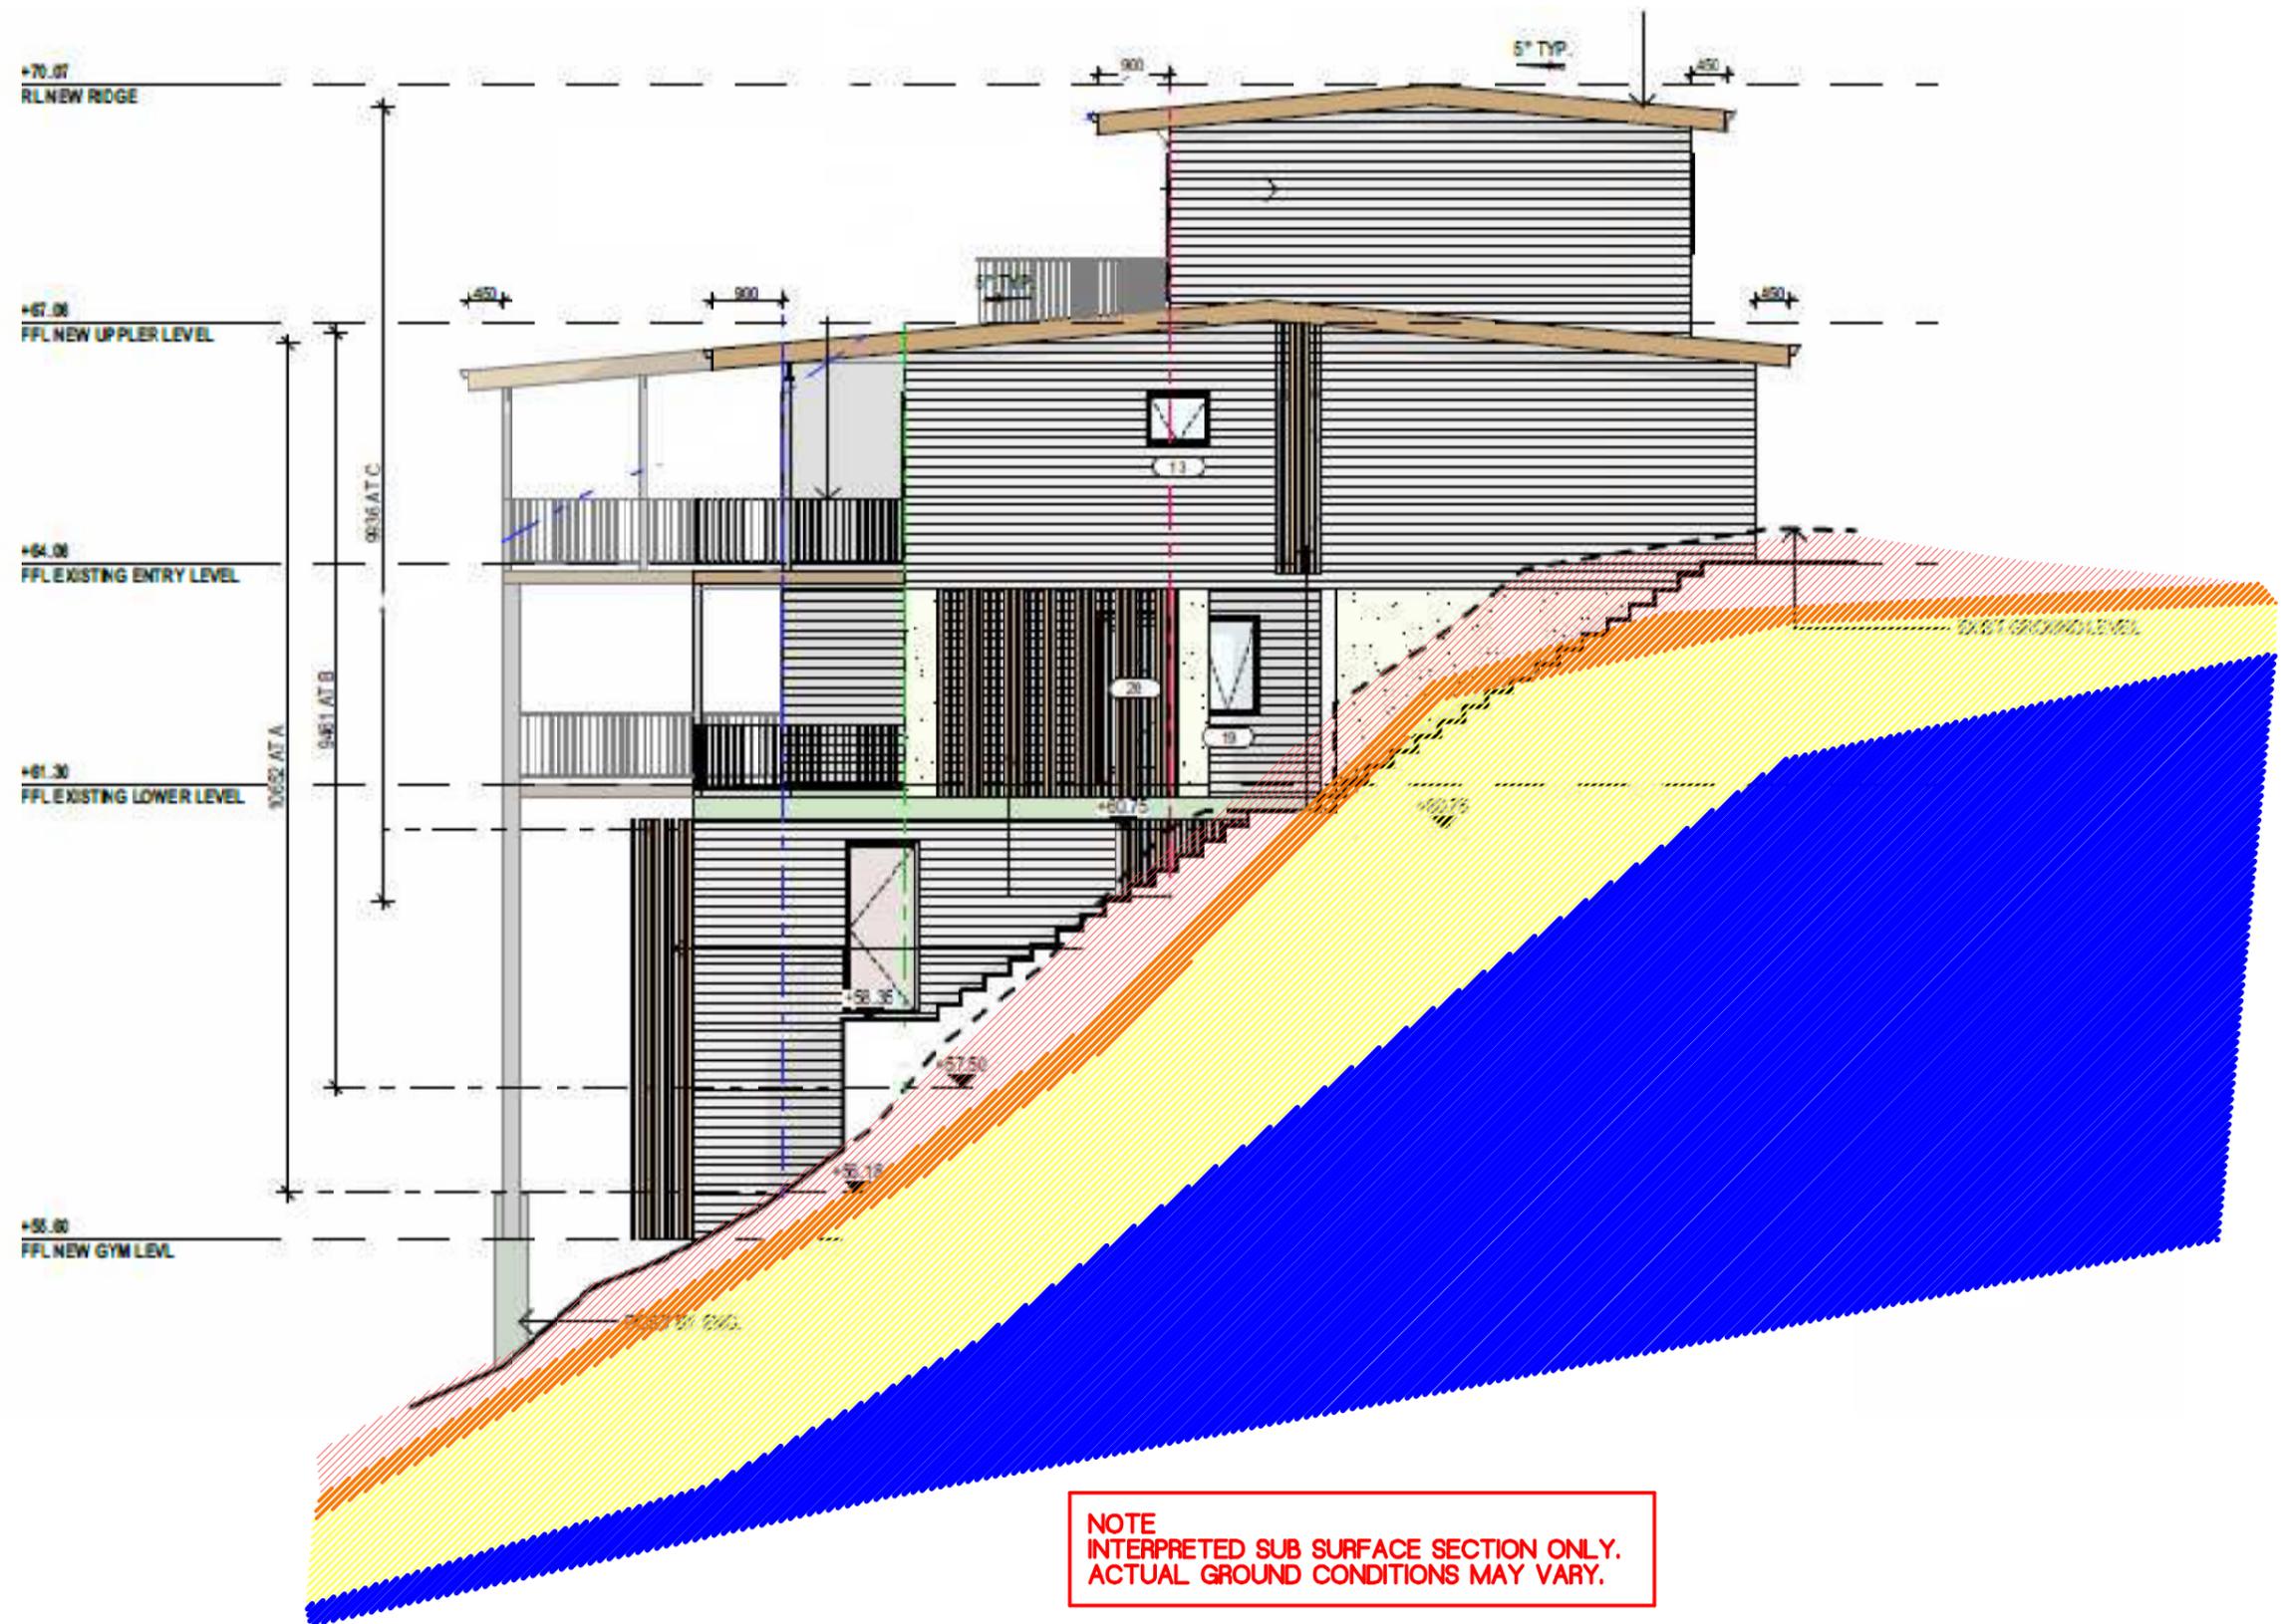
TYPE SECTION

4.2 The slope materials are colluvial in origin at the surface and become residual with depth. They consist of topsoil over sandy clays and clays that merge into the weathered rock at depths varying from 1.0 to 3.5 metres or deeper where filling has been carried out.
