TREE ASSESSMENT AND DEVELOPMENT IMPACT REPORT

DECEMBER 2018

96-104 CABARITA ROAD AVALON BEACH NSW 2107

Meraki Developments Pty Ltd

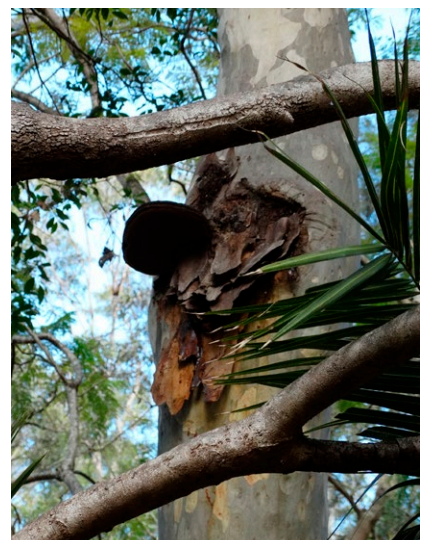
Fig. 31: 3G. Detail of *Phellinus* fruiting body

3G: *Corymbia maculata* (Spotted gum) is a mature to over-mature specimen in fair to poor health and vigour – see figure 30 (right). It has co-dominant stems at 6m and a thin and leggy habit due to the overshadowing of surrounding trees. There is a large *Phellinus* fruiting body emerging from a wound site 4m about ground on the north side of the trunk indicating possible substantial internal decay – see detail figure 31. The proposed lower level of dwelling on Lot 2 requires negligible excavation (1.3%) in the TPZ, while the mid-level slab floats above ground in a further 15.3% of the zone. While not envisaged, should any pier supports be required, they must be located flexibly to avoid any significant root disturbance within the TPZ. On this basis, and with due care, Tree 3G is considered not directly impacted by the development as currently specified.

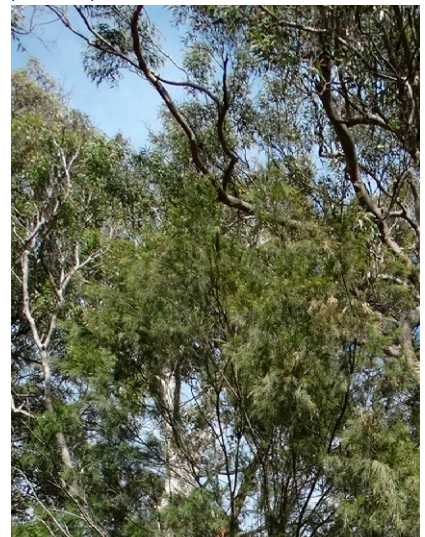
Fig. 49: **31.** *Corymbia maculata*

31: *Corymbia maculata* (Spotted gum) is an over-mature specimen showing fair to poor health and vigour – see figure 49. It has co-dominant stems at 1.2m and a thin canopy, predominantly in the north due to the overshadowing of neighbouring trees. There is evidence of deadwood up to 200mm diameter in up to 30% of the canopy, which represents a potentially significant hazard. The mid-level of the proposed dwelling on Lot 4 requires excavation of 14% in the TPZ, with the upper level slab floating above ground in a further 2.4%. However, the tree is located in a heavily disturbed ground profile with cut-and-fill terracing, and a 1m stone retaining wall to its north within 1.5m of its trunk, and it is possible that root growth is irregular in the zone due to the changed ground levels. In order for Tree 31 to be retained, a root investigation under supervision of the site arborist would need to demonstrate that excavation would not cause significant root disturbance within the TPZ, nor adverse impact to tree health.

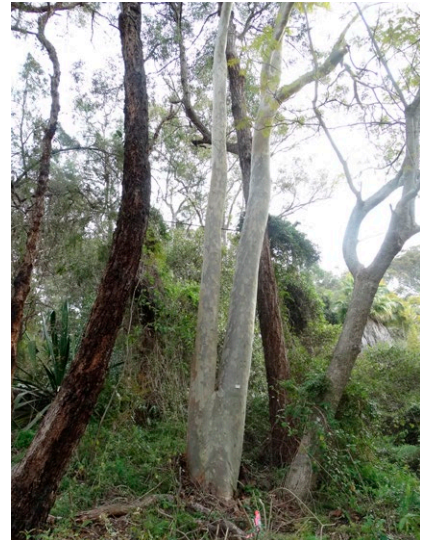
Fig. 52: **41.** *Corymbia maculata*

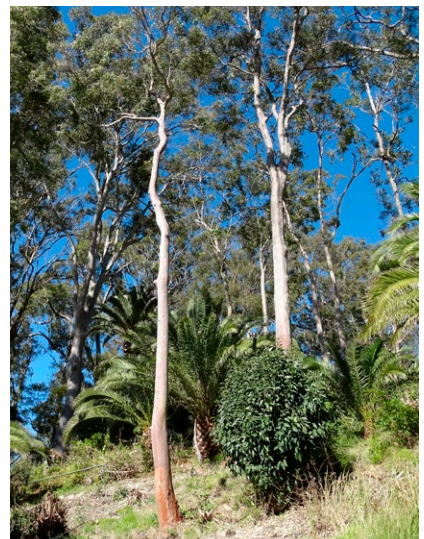
Fig. 82: **97. (L); 96 (R)** *Corymbia maculata*

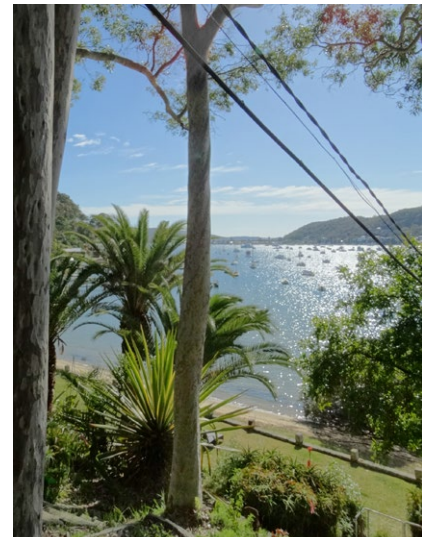
Fig. 91: **104A.** *Corymbia maculata*

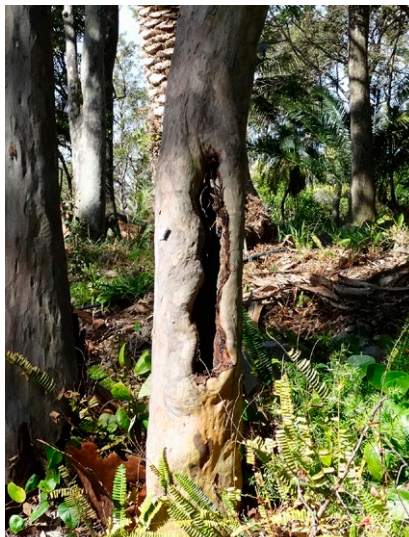
Fig. 93: **104D.** Detail of decay site

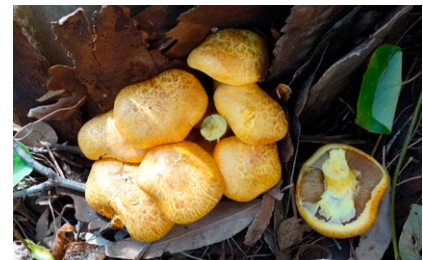
Of these, five trees (**40, 139B, 104, 104D and 104E**) are in very poor condition, and while considered not significantly impacted, due to senescence and, in the case of 104 and 104E, evidence of suspected pathogenic *Armillaria luteobubalina* fungal fruiting bodies, it is recommended that their ongoing condition be monitored with consideration of removal should their declining structure become hazardous.

Fig. 94: Detail of fungal fruiting bodies on **104 (top); 103 (left); 104E (right)**

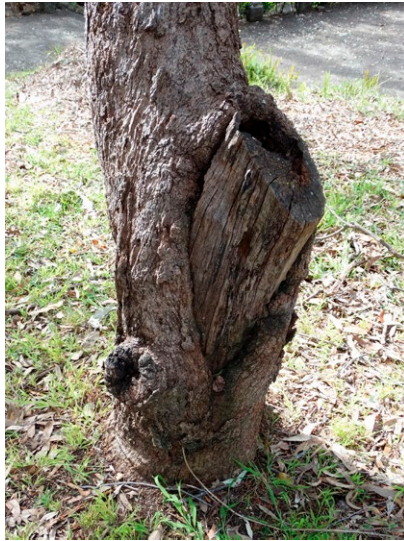
Fig. 105: **133.** Detail of decayed stump
