REPORT ON GEOTECHNICAL SITE INVESTIGATION

PROPOSED ALTERATIONS AND ADDITIONS

24 NORMA ROAD, PALM BEACH, NSW

Project No.: 2021-218

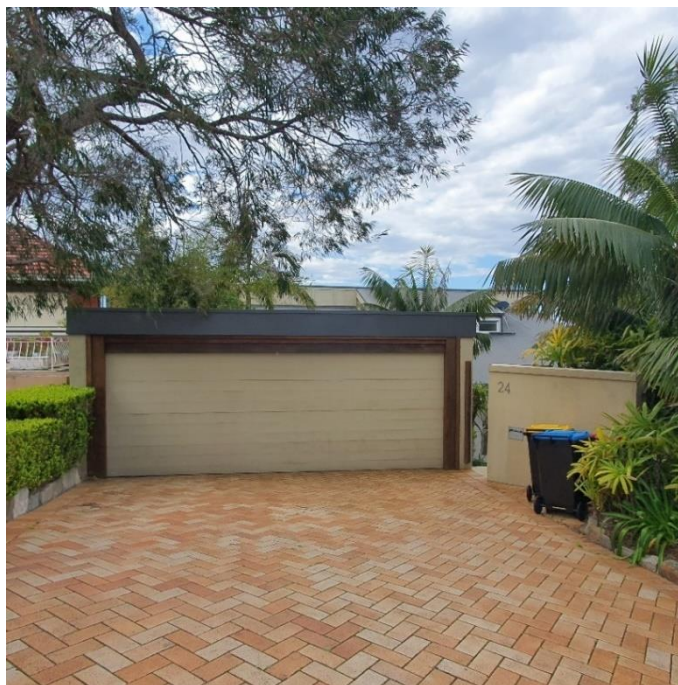
Photograph-2: Front of the site. View looking north.

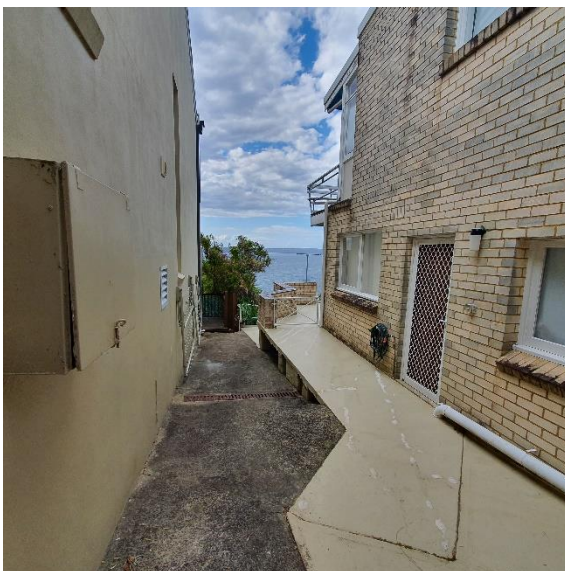
Photograph-3: Pathway along the eastern side of the site-dwelling. View looking north.

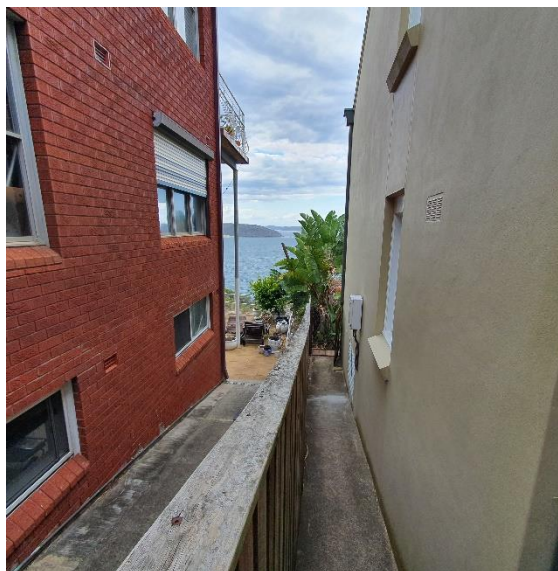
Photograph-4: Pathway long the western side of the site-dwelling. View looking north.

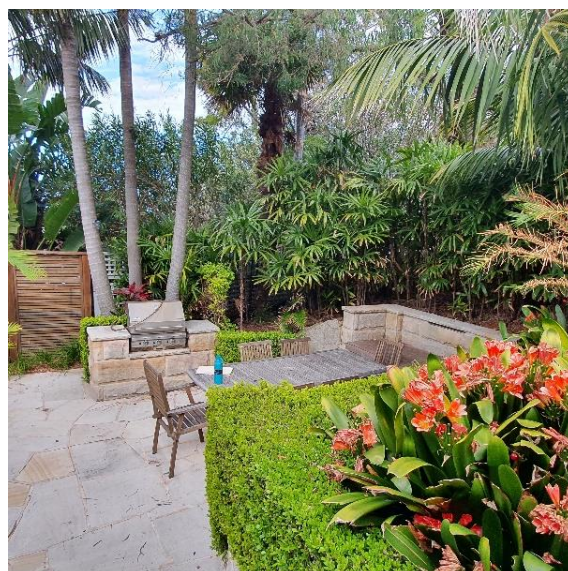
Photograph-5: Front site patio. View looking east.

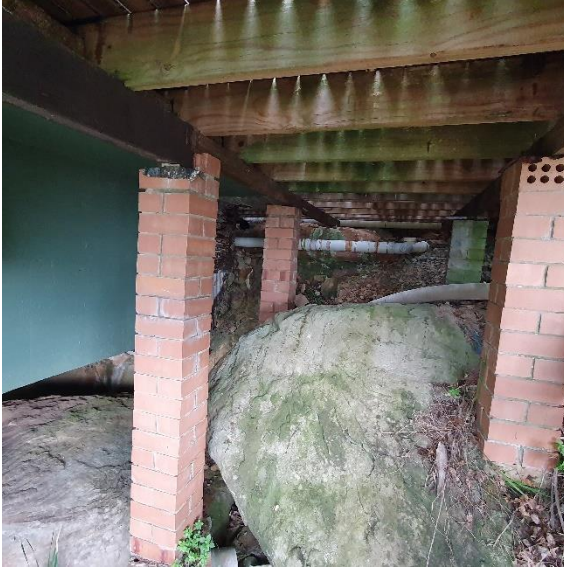
To the rear of the site-dwelling is a swimming pool with timber decking. The timber deck and concrete pool are supported by brick piers and concrete piers onto the crest of a sandstone bedrock cliff face outcrop. The cliff face is approximately 4m to 5m high and is characterised as fine to medium grained, low to medium strength and contains sub-horizontal bedding defects (Photograph-8). Signs of water leakage in the pool,

Photograph-6: Brick piers supporting the timber deck. View looking south.

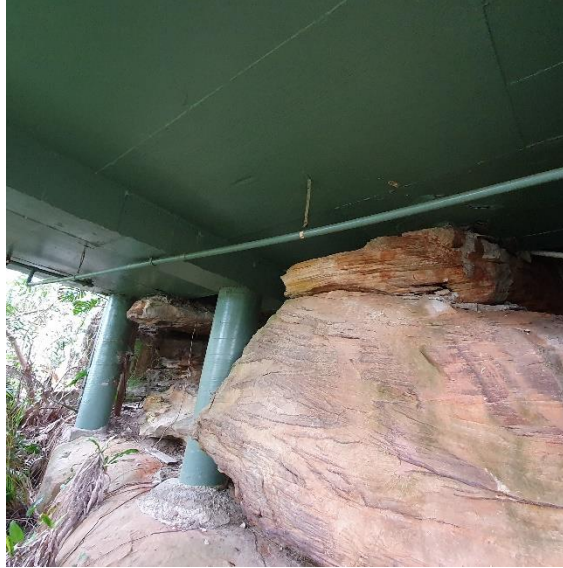
Photograph-7: Concrete piers supporting the pool. View looking up south-east.

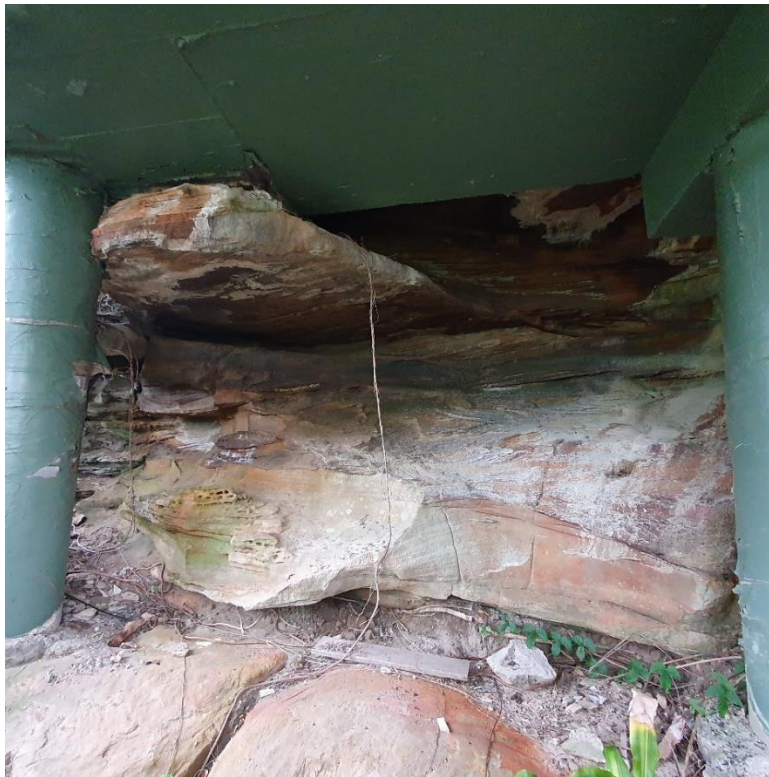
unfavourable defects, ground movement or underlying geotechnical issues were not identified in the observed sandstone cliff face and above structures.

Photograph-8: Sandstone bedrock cliff face below the pool displaying sub-horizontal bedding defects and minor undercutting. View looking south.

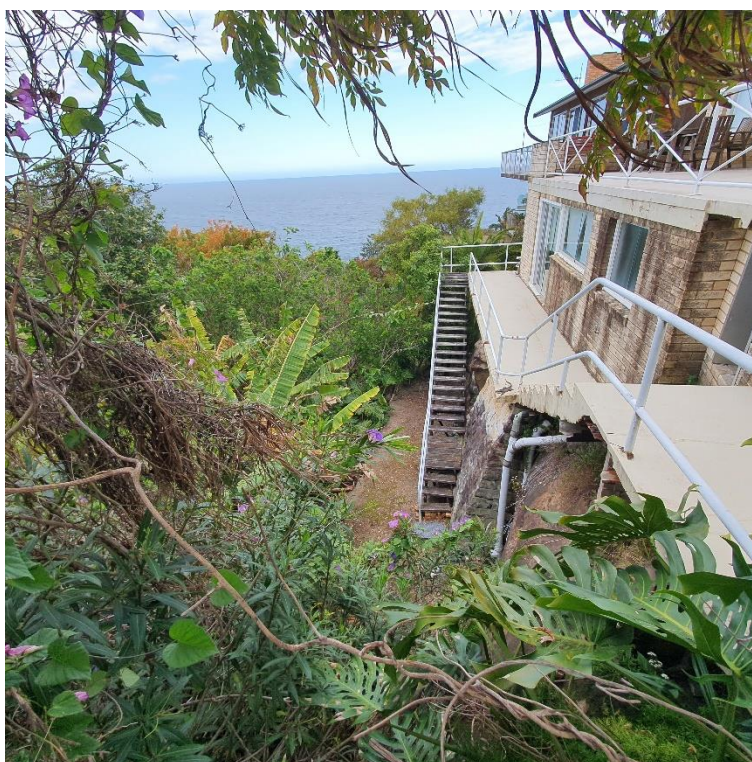
The neighbouring property to the east (No.26 Norma Road) is currently occupied by a two to three storey brick residence located within the southern portion of the block. The southern front of the property contains a carport within the western side and a concrete carpark within the eastern side. To the rear of the property dwelling the Ground Surface Level (GSL) drops approximately 4m and exposes the east-west striking sandstone cliff face through the centre of the property (Photograph-9). The neighbouring property is at similar GSL to the site along the common boundary. The property dwelling and carport are approximately 2.5m east from the common boundary. The northern half of the property contains overgrown vegetation. Signs of cracking, ground movement or underlying geotechnical issues were not encountered on the observed structures and appeared in good condition.

Photograph-9: Sandstone bedrock cliff. View looking down east to the neighbouring property.

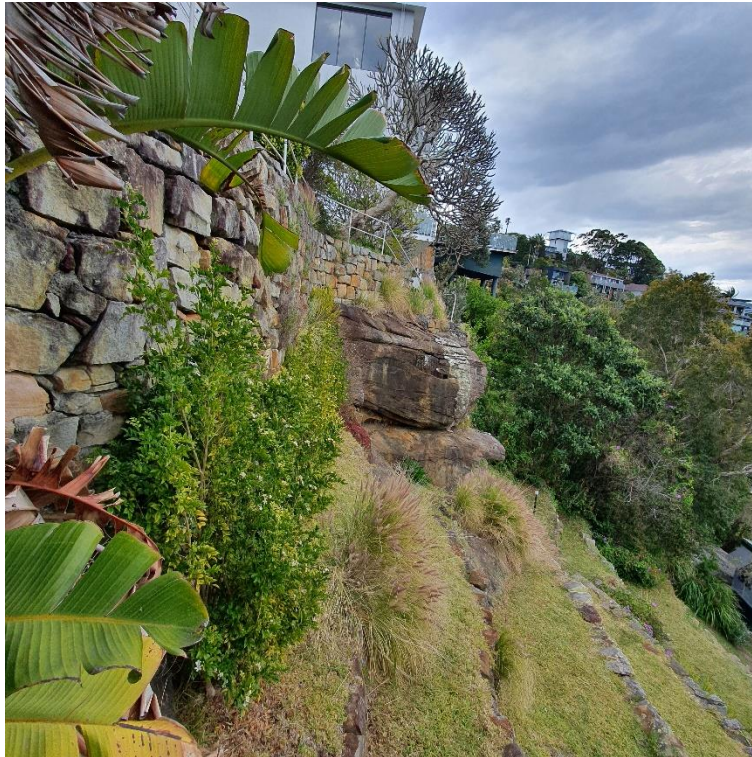
The neighbouring property to the west (No.22 Norma Road) is currently occupied by a two to three storey brick residence with a balcony to the rear located within the southern portion of the block. The southern front of the property contains a concrete carpark with a balcony above within the eastern side and a grass lawn within the western side. The ground to the rear of the property dwelling is supported by a dry stacked sandstone block wall retaining wall (Photograph-10) which appears to be partly founded on the crest of the sandstone bedrock cliff face. The ground to the rear of the sandstone bedrock cliff face comprises terraced gardens. The neighbouring property is at similar GSL to the site along the common boundary. The neighbouring house extends east to approximately 1.5m from the common boundary. Signs of cracking,

ground movement or underlying geotechnical issues were not encountered on the observed structures and appeared in good condition.

Photograph-10: Sandstone bedrock cliff and retaining wall. View looking west to the neighbouring property.
