## **INFILTRATION TESTING:**

For Proposed Infiltration Trench at **38 Hilltop Crescent, Fairlight**

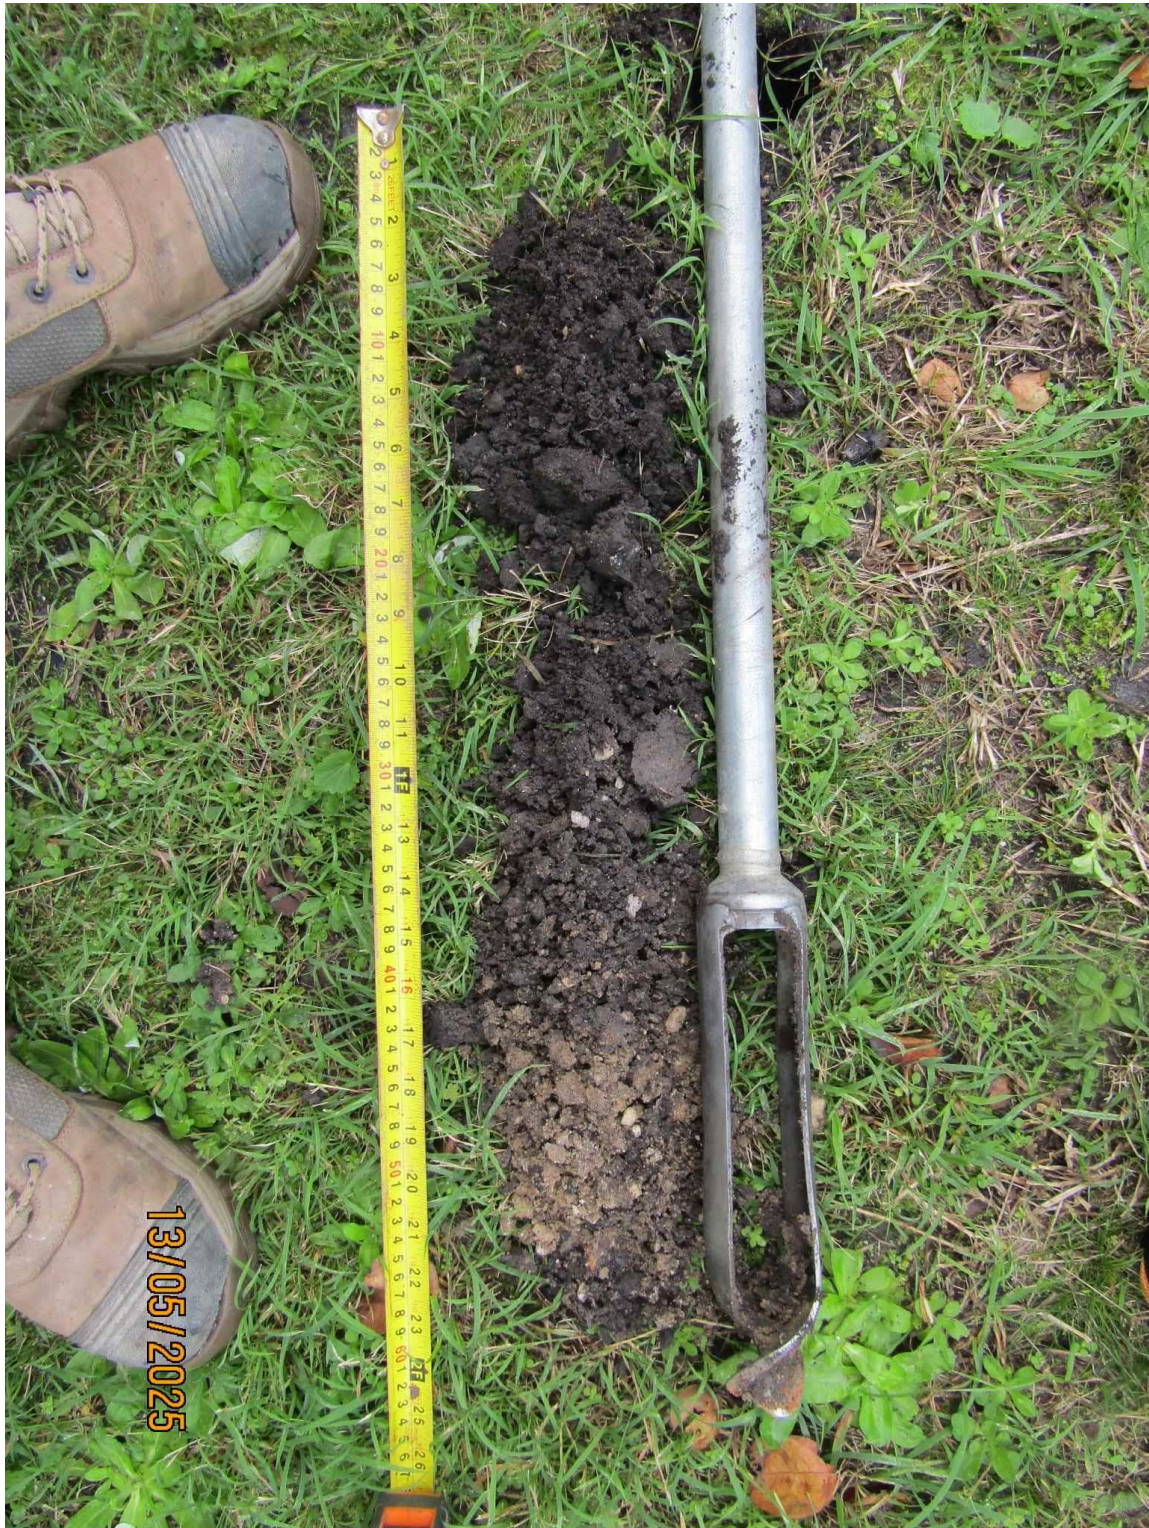
## AUGER HOLE 1 (~RL58.1) – AH1 (Photo 1)

0.0 to 0.6      **FILL**, sandy soil, with some rock fragments, dark brown, grey, white, orange, moist, fine to coarse grained.

Refusal @ 0.6m, auger grinding on rock. No water table encountered.

Photo 1: AH1 – Downhole is from top to bottom.
