## **73 Marine Parade, Avalon**

### Geotechnical Comments for Section 4.55

## **GEOTECHNICAL INVESTIGATION:**

### **New House and Pool at 73 Marine Parade, Avalon**

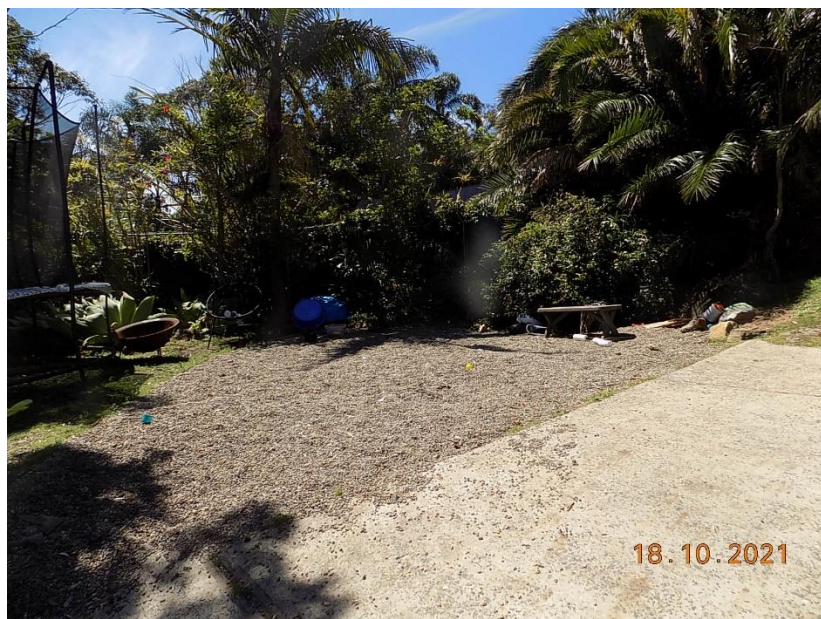
Photo 1

- 2.3** At the road frontage, a concrete driveway runs up the slope to a gravel parking area on the downhill side of the property (Photo 1) and to a garage on the lower ground floor of the house (Photo 2). The cut for the driveway is supported by stable mortared stack rock retaining walls that will be demolished as part of the proposed works (Photo 3). Between the road frontage and the house is a gently sloping lawn and garden area (Photo 4). The part two-storey brick house was observed to be

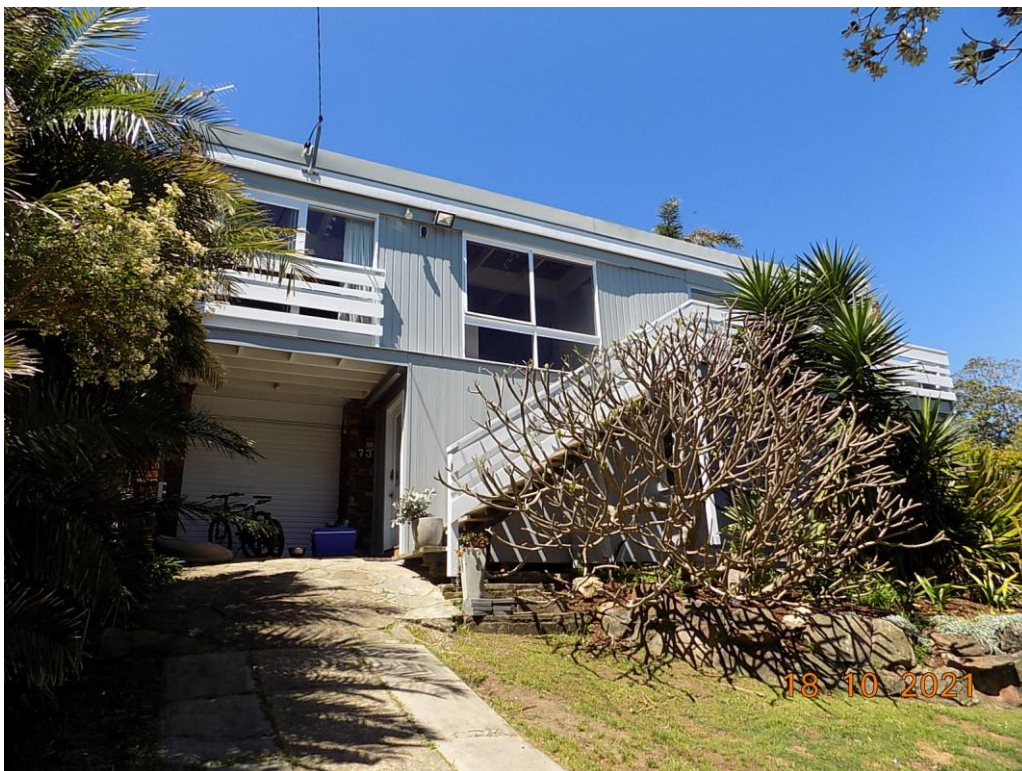
Photo 5

supported directly onto outcropping sandstone bedrock and will be demolished as part of the proposed works (Photos 5 & 6). A gentle to moderately-sloping garden area extends off the uphill side of the house (Photo 7). Sandstone bedrock was observed to be outcropping through the slope in multiple places (Photo 8). A near-level brick-paved fill has been placed at the top of the property (Photo 9). The fill is battered to stable angles and the fill batter is lined with large sandstone boulders (Photo 10). A ~50m high sea cliff falls from the top of the property. The sea cliff was observed from the rock platform below (Photo 11). It consists mainly of massive competent Medium Strength Sandstone with some, alternating thinly bedded shale/laminite layers. The cliff face below the property displays no significant undercutting or other significant geological defects that could affect its stability. The rock platform has a covering of dislodged sandstone boulders at the cliff base.

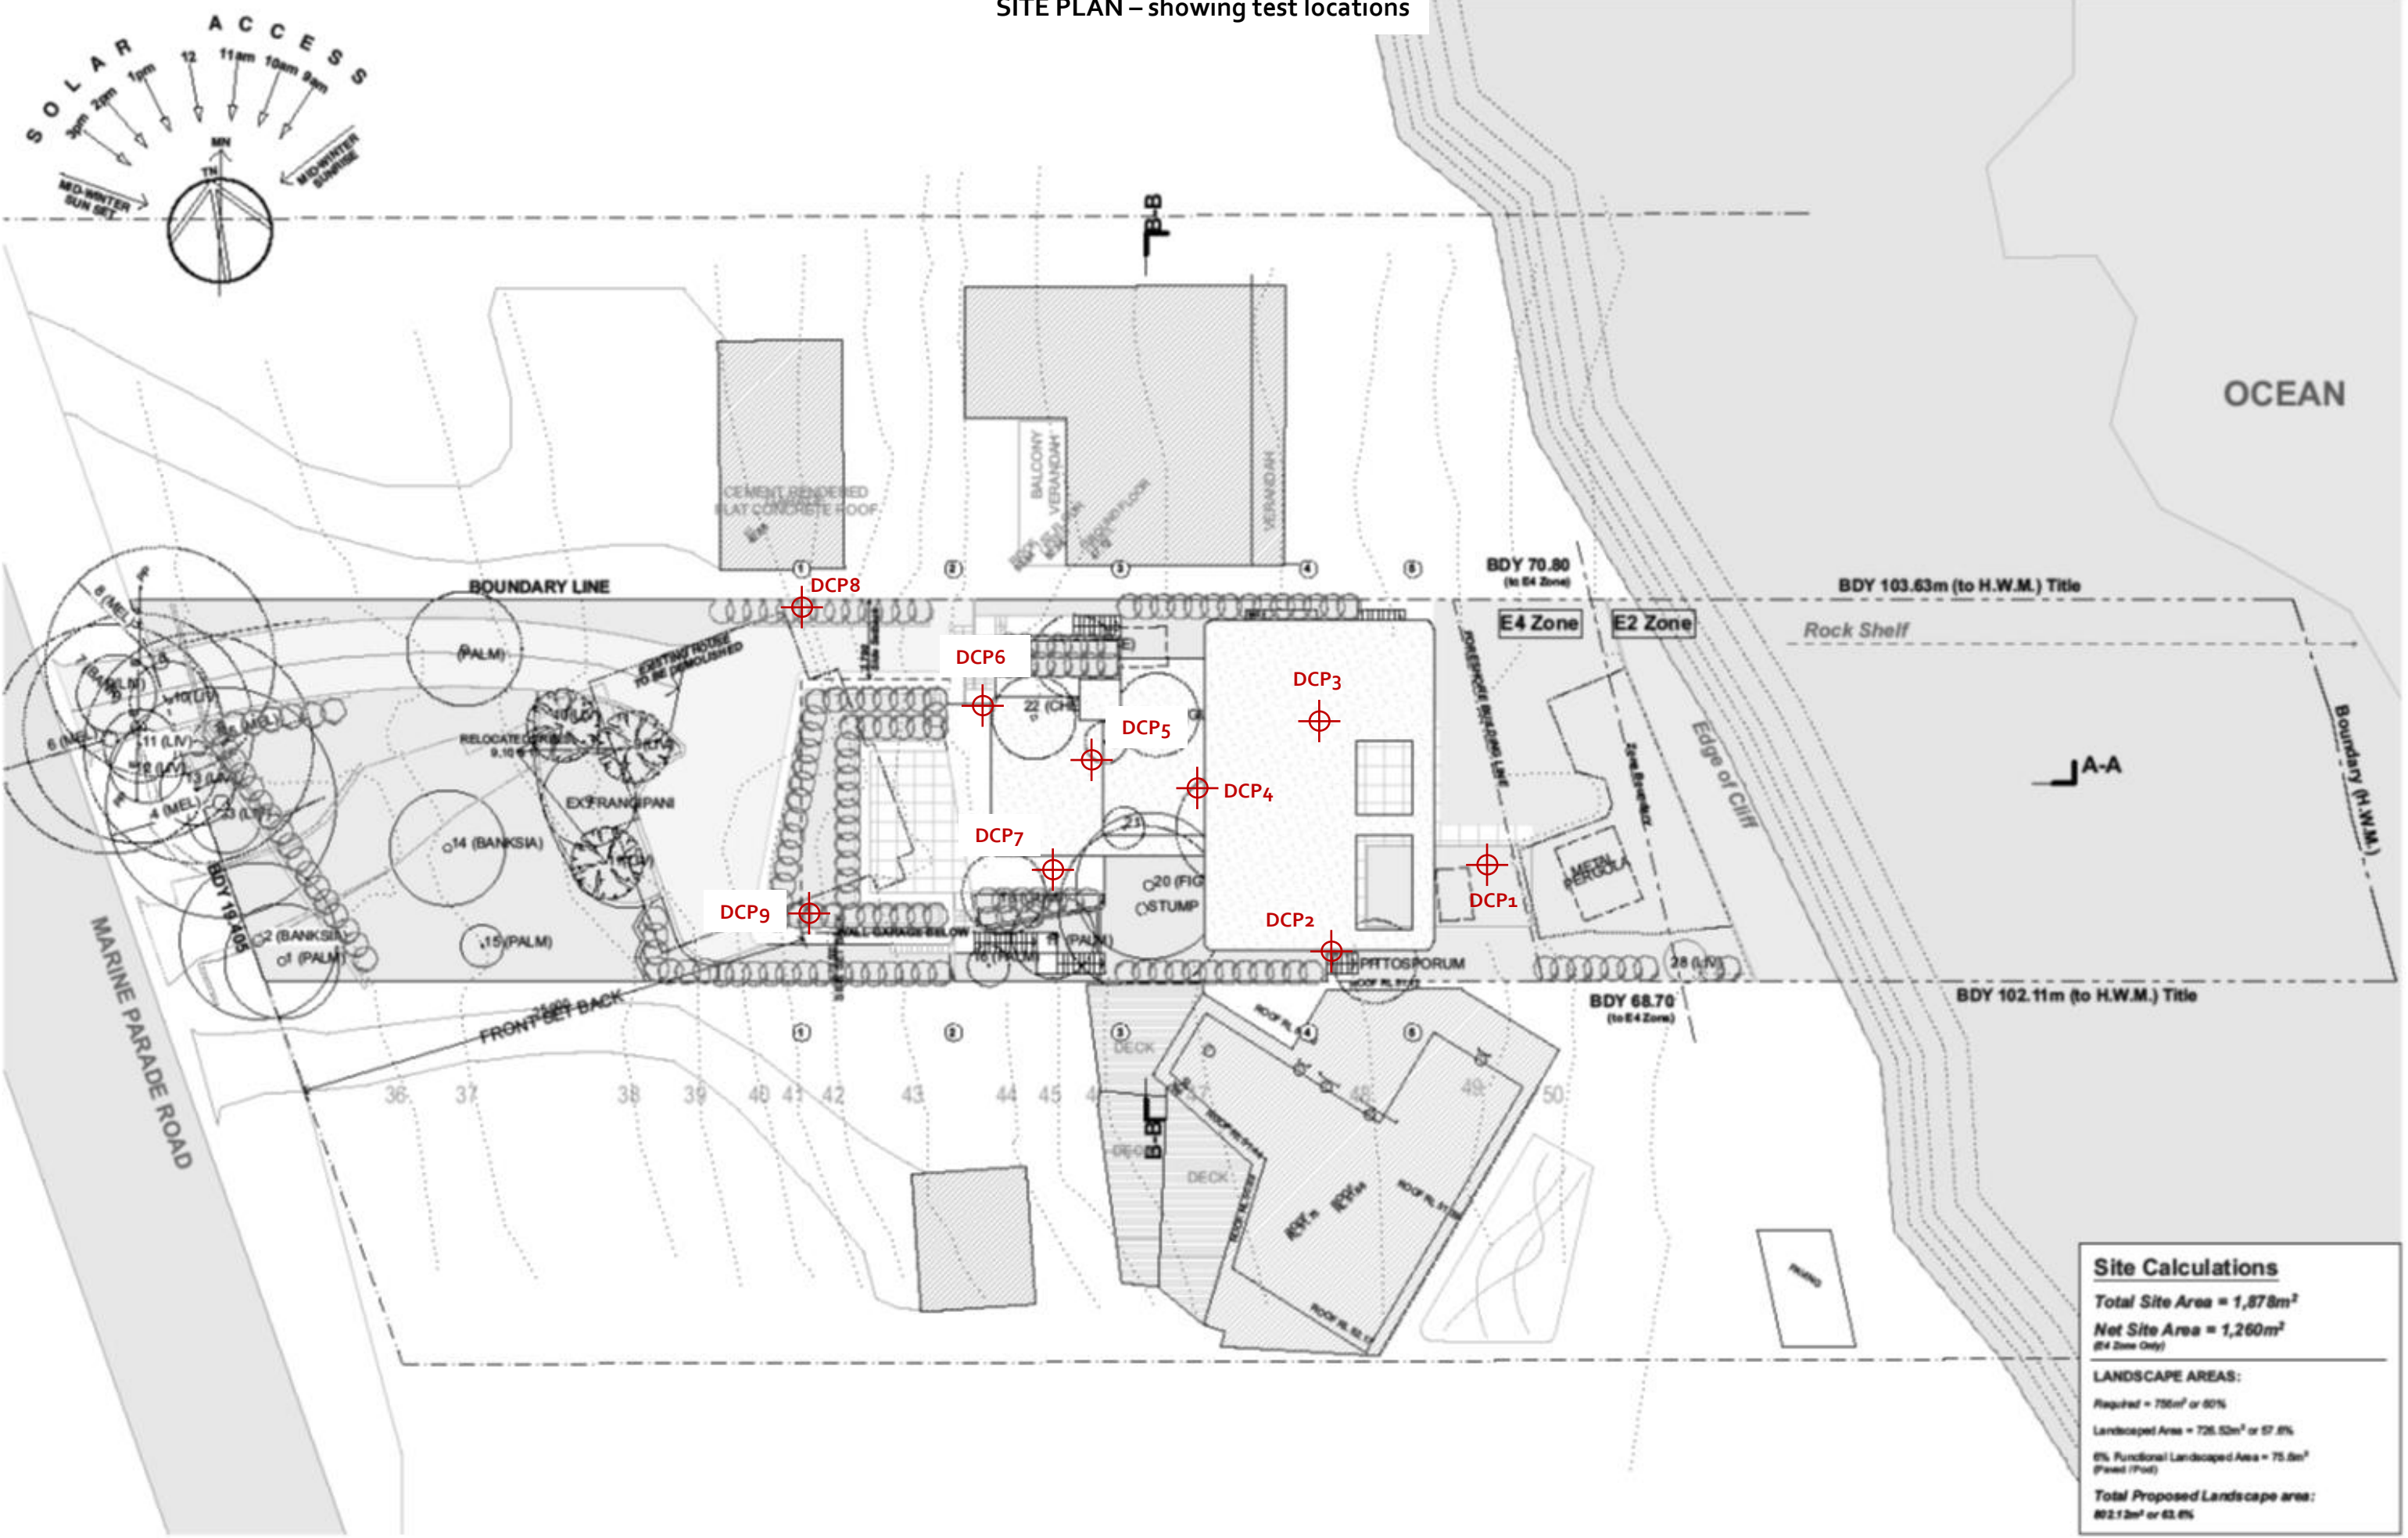
SITE PLAN – showing test locations

Nine Dynamic Cone Penetrometer (DCP) tests were put down to determine the relative density of the overlying soil and the depth to bedrock. The locations of the tests are shown on the site plan attached. It should be noted that a level of caution should be applied when interpreting DCP test results. The test will not pass through hard buried objects so in some instances it can be difficult to determine whether refusal has occurred on an obstruction in the profile or on the natural rock surface. This is not expected to be an issue for the testing on this site. However, excavation and foundation budgets should always allow for the possibility that the interpreted ground conditions in this report vary from those encountered during excavations. See the appended "Important information about your report" for a more comprehensive explanation. The results are as follows:

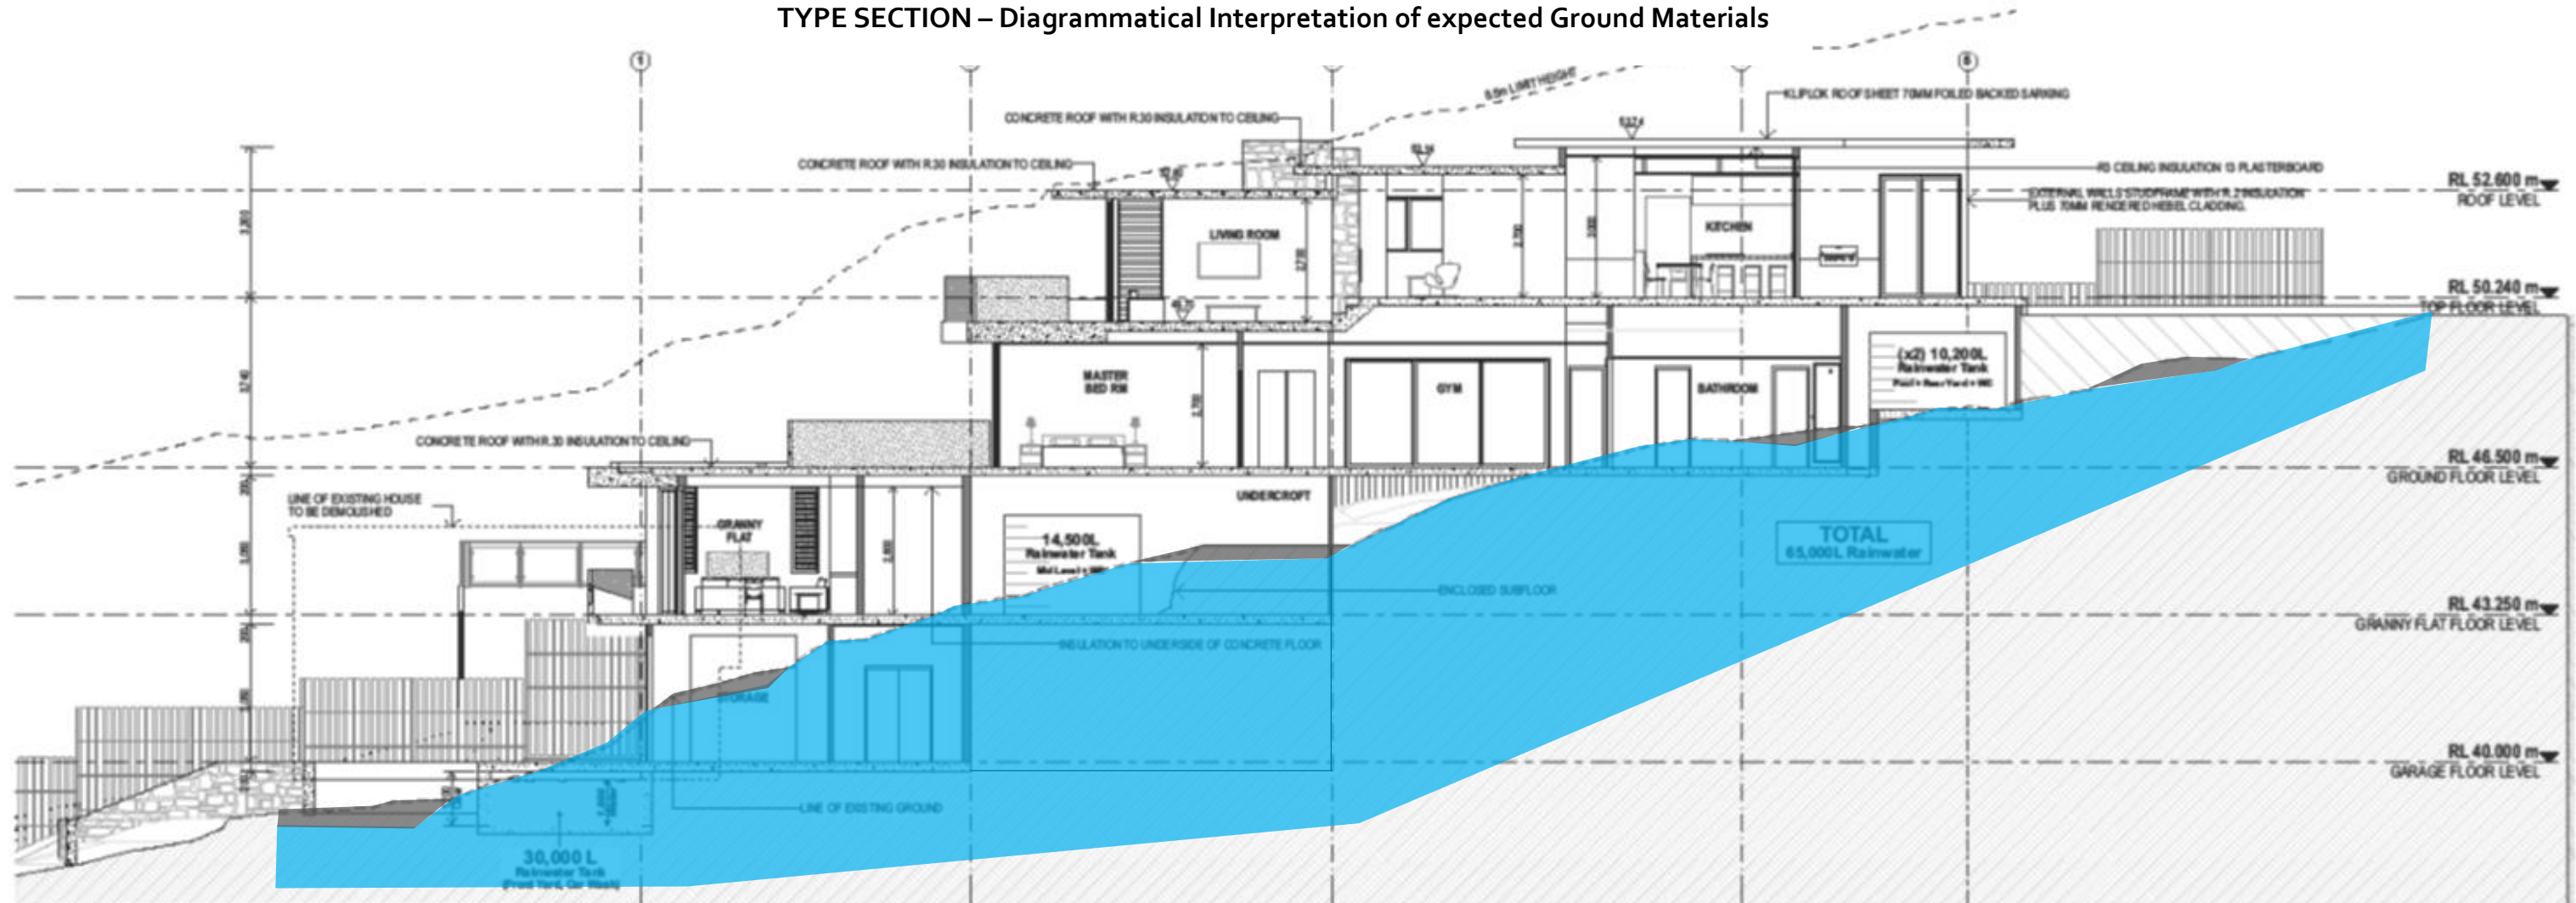
SECTION A-A

adjacent to the sea cliffs. The vertical extent of the band is not known; however, the sandstone was observed to be outcropping and was encountered in the ground testing across the entire footprint of the proposed house. Where the rock is not exposed, it is overlain by natural sandy soils and firm to very stiff sandy clays that fill the bench step formation. In the test locations, where it was not exposed, rock was encountered at depths of between 0.3 to 0.9m below the current surface. The exposed sandstone across the site is estimated to be Medium Strength and a similar strength rock is expected to underly the entire site. See Type Section attached for a diagrammatical representation of the expected ground materials.

- Topsoil
- Band of Medium Strength Sandstone. Extent of band is not known.
