316 Hudson Parade, Clareville

GEOTECHNICAL INVESTIGATION:

Alterations and Additions at 316 Hudson Parade, Clareville

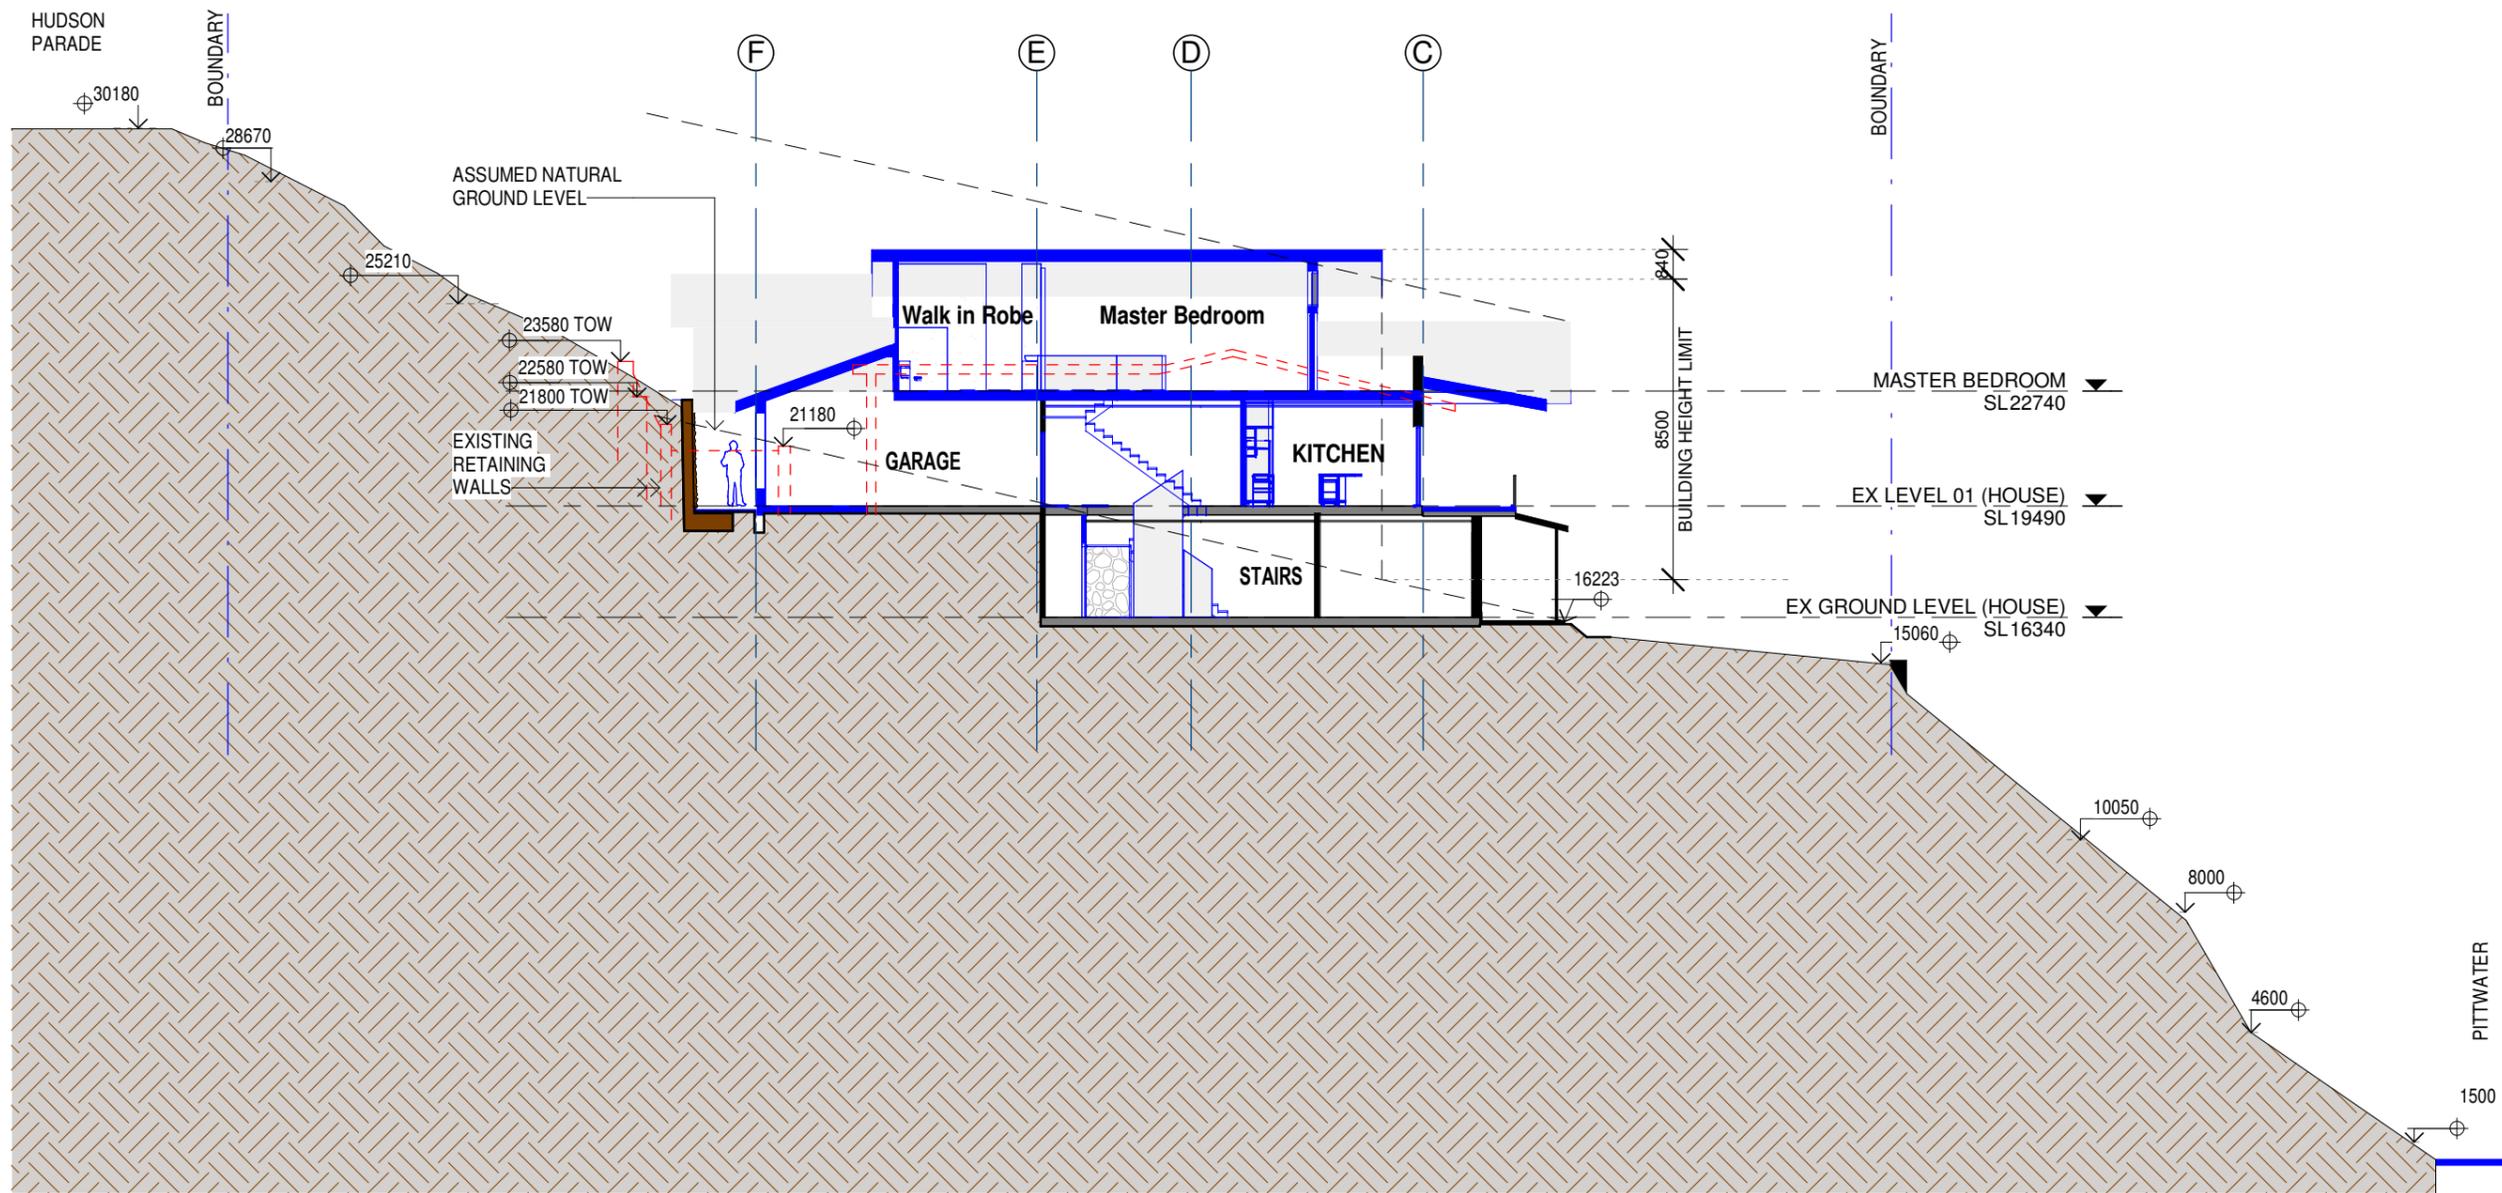
Long Site section

We have reviewed the assumed natural ground line shown by a dashed line on the plan by Baster and Jacobson, drawing number DA 30.05, issue 3, and dated 3/3/21. In our opinion the interpreted natural ground line shown on the plans is a very close approximation of where the natural ground surface was and is suitable as a base to measure the “8.5 meter building height limit” from.

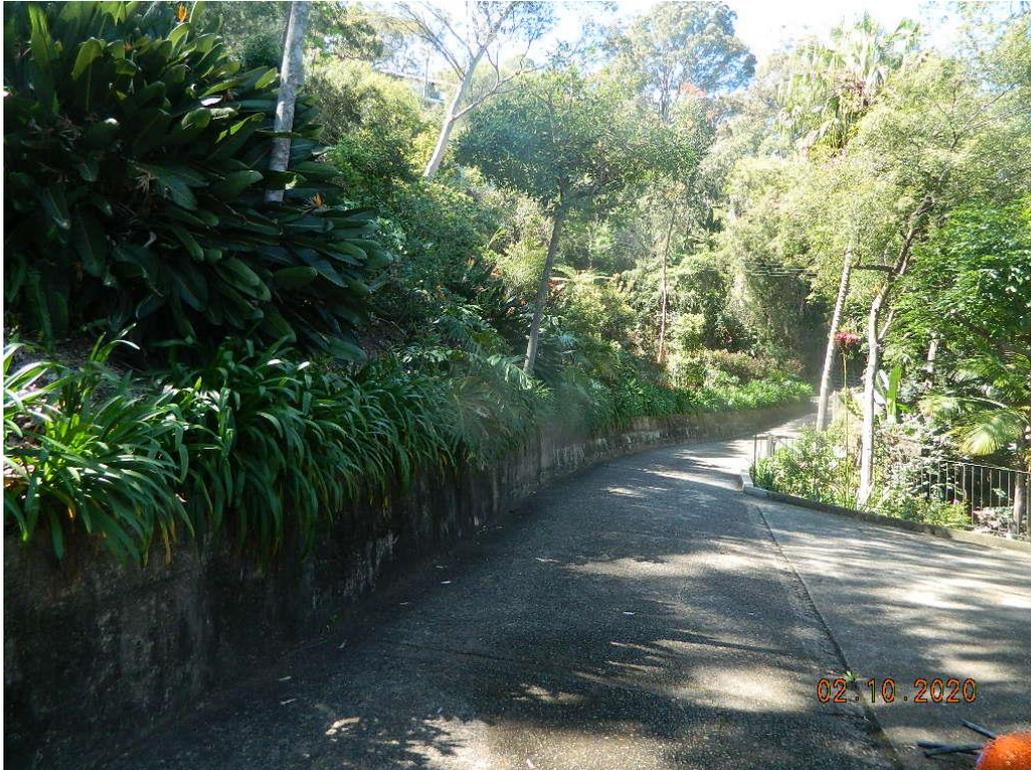
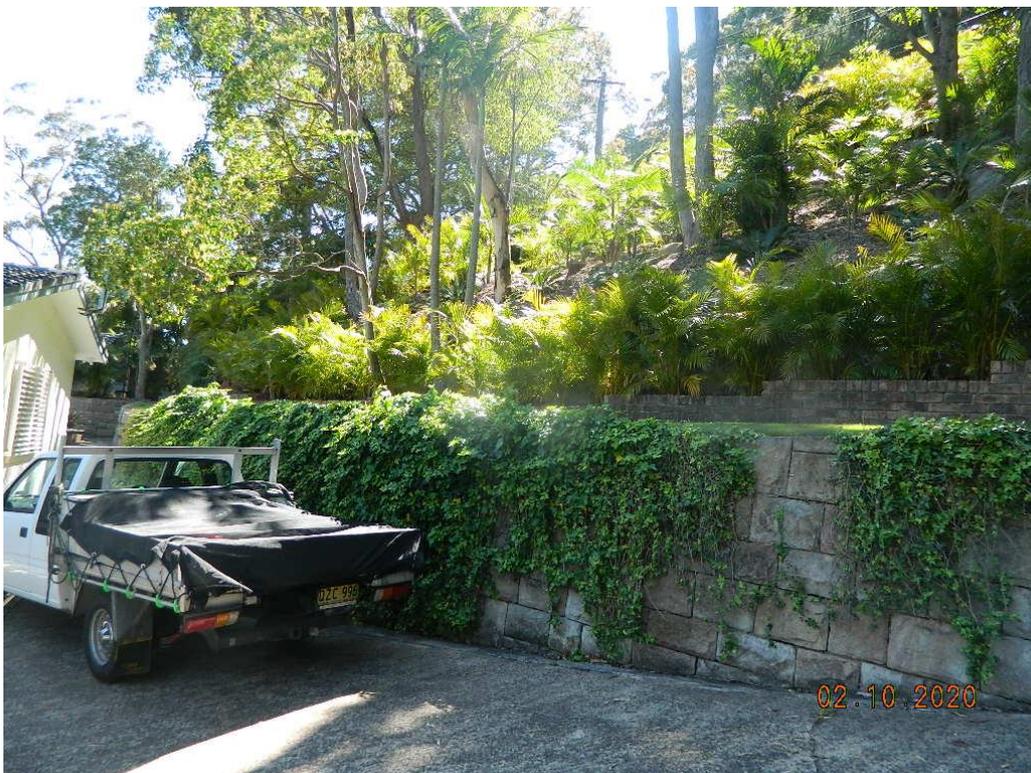
2.3 At the road frontage a steeply graded slope falls to the uphill side of the subject house (Photos 1 & 2). No significant signs of movement were observed in this area. Vehicular access to the property is provided by a shared driveway from the S that cuts across the slope and runs to the existing house and a detached brick garage/studio beside the house (Photos 2 & 3). On the downhill, external supporting wall of the detached garage a vertical crack runs through the supporting concrete footing and brick wall (Photo 4). No deflection was measured in the wall. The structure is currently considered stable and will be demolished as part of the proposed works. Below the detached garage/studio is a sandstone flagging retaining wall that is estimated to be battered back at an angle of $\sim 40^\circ$ from vertical (Photo 5).

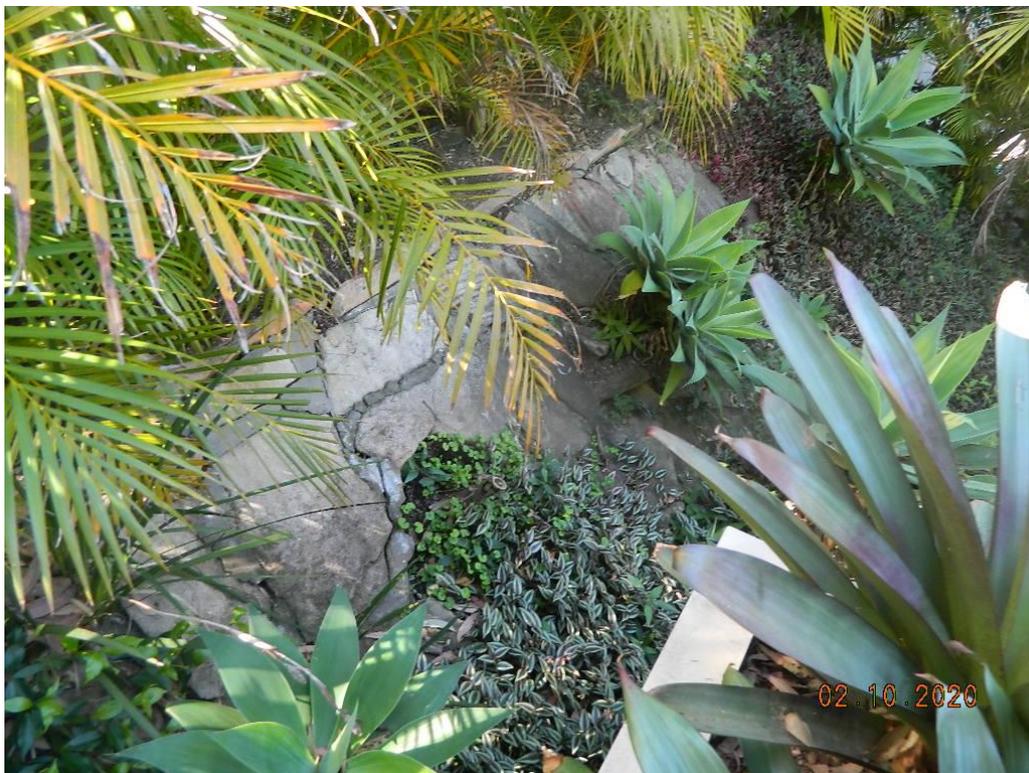
Photo 5

HAZARDS	Hazard Three	Hazard Four
TYPE	The additional surcharge loads from the proposed detached garage/studio transferring onto the existing sandstone flagging retaining wall that leads to failure (Photo 5).	Further movement of the gabion basket retaining wall that lines the S common boundary and leads to failure (Photo 8).
LIKELIHOOD	'Possible' (10^{-3})	'Unlikely' (10^{-4})
CONSEQUENCES TO PROPERTY	'Medium' (35%)	'Medium' (30%)
RISK TO PROPERTY	'Moderate' (2×10^{-4})	'Low' (2×10^{-5})
RISK TO LIFE	5.6×10^{-6} /annum	5.6×10^{-6} /annum
COMMENTS	This level of risk to life and property is 'UNACCEPTABLE'. To move the risk to 'ACCEPTABLE' levels the recommendations in Section 15 are to be followed.	This level of risk to life and property is 'ACCEPTABLE' provided the recommendations in Section 16 are followed.

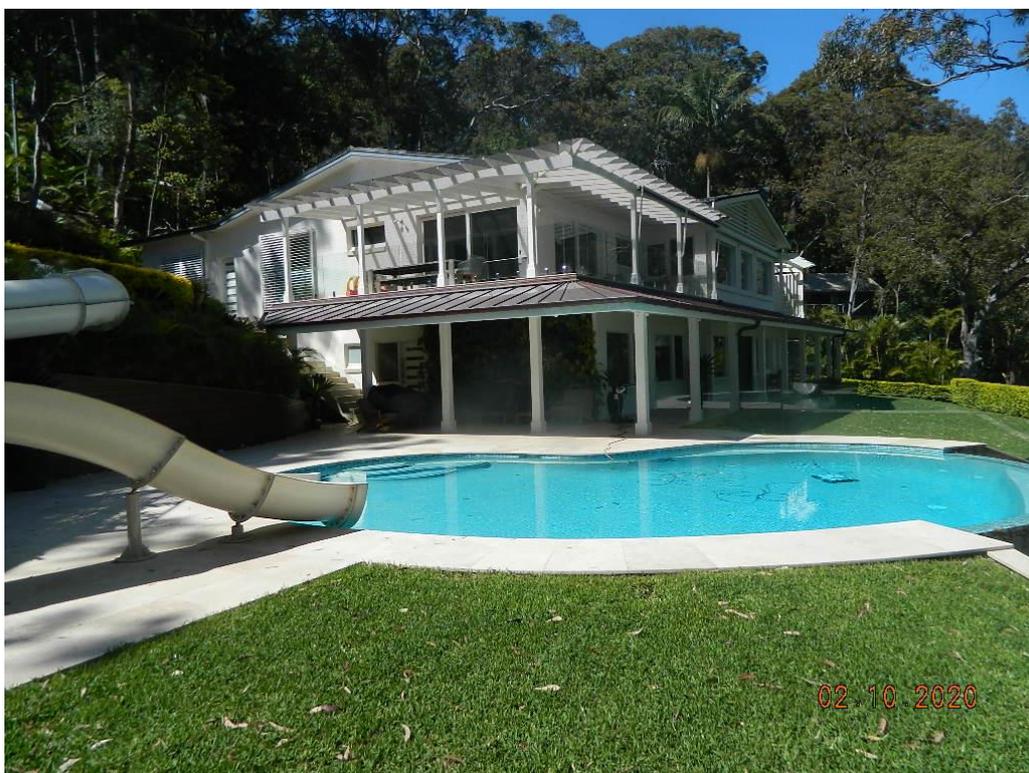
Photo 6

The two storey brick house displays no significant movement in the external supporting walls that could be associated with slope instability (Photo 6). A concrete pool is located below the N side of the house. The pool shell displays no visible signs of movement. The area below the house and beside the pool has been filled for a level lawn area. From visual observations on site the fill reaches a maximum height of $\sim 5.0\text{m}$ on the S side and reduces to $\sim 1.4\text{m}$ on the N end. The S side of the fill is supported by a gabion basket retaining wall (Photos 7 & 8). Where the wall lines the S common

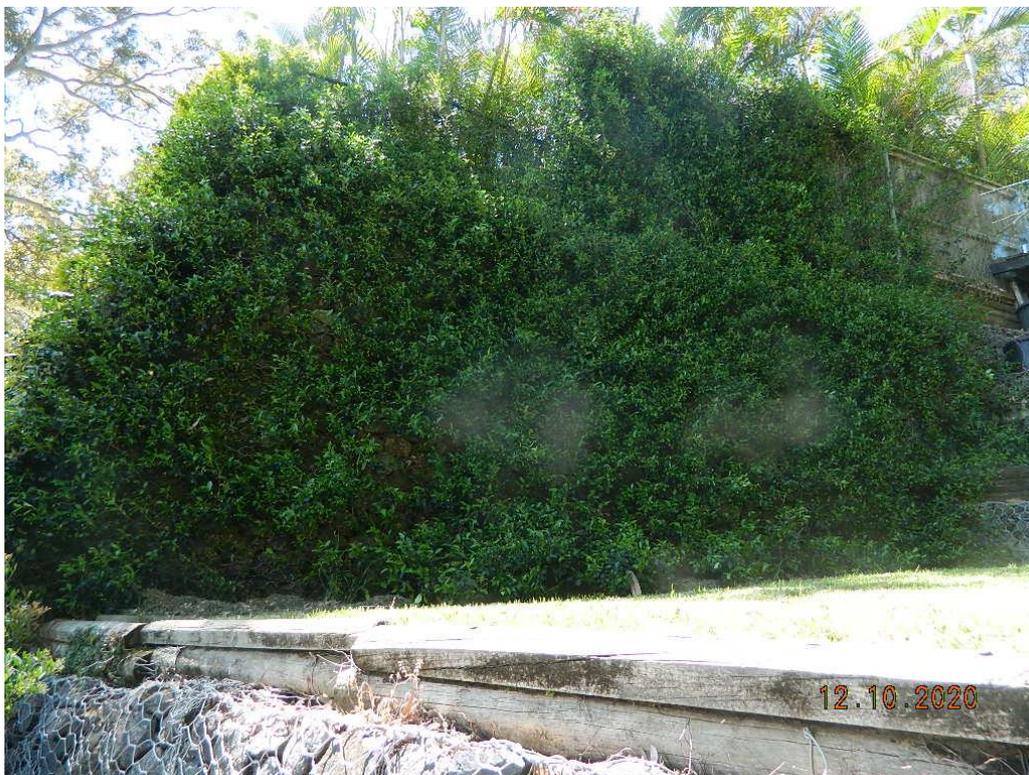
Photo 8

boundary the baskets are slightly bulging. To ensure the ongoing stability of the wall into the future the recommendation in **Section 16** are to be followed. The remaining areas of the wall show no obvious bulging. The N side of the fill is supported by a concrete crib retaining wall that is obscured by thick vegetation (Photo 9). From what could be seen of the wall it appears stable.

The S side of the gabion basket retaining wall is slightly bulging (Photo 8). This structure is currently considered stable but to ensure the ongoing stability into the future we recommend they be inspected by the owners on a biennial basis or after heavy prolonged rainfall, whichever occurs first. A photographic record of the inspections is to be kept. We can carry out these inspections upon request. Should further movement be observed the Geotechnical Consultant is to be engaged to assess the structure and provide remedial advice should it be required.

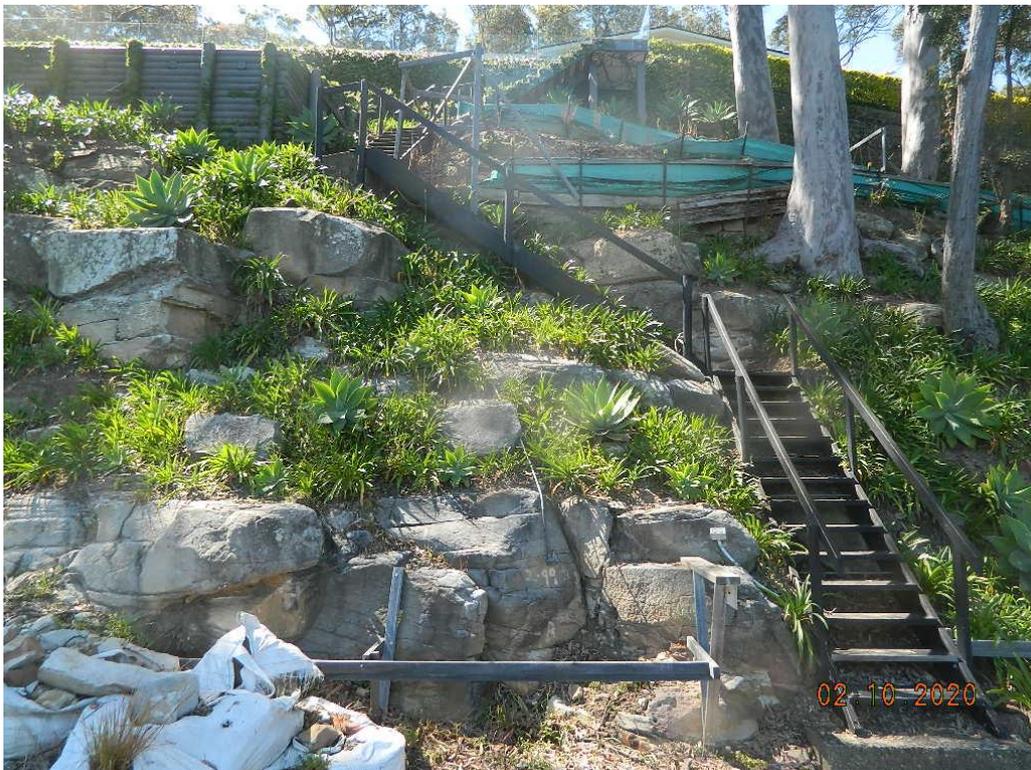
Photo 10

2.4 The area below the property has been partly terraced with treated pine retaining walls that appear well constructed. Below the walls the slope falls steeply to the waterfront. Bands of medium strength sandstone outcrop in this area (Photo 10). The exposed sandstone is fractured and is relatively thinly bedded. The exposed rock does not display any significant undercutting or geological defects that could lead to a significant failure that could impact the retaining walls or house above.
