# Arboricultural Impact Assessment

8 Orara Road, Allambie Heights  
NSW, 2100  
3/-/DP622166  
Job No: 25122  
21/08/2025

**Temporal Tree Management Pty Ltd.**

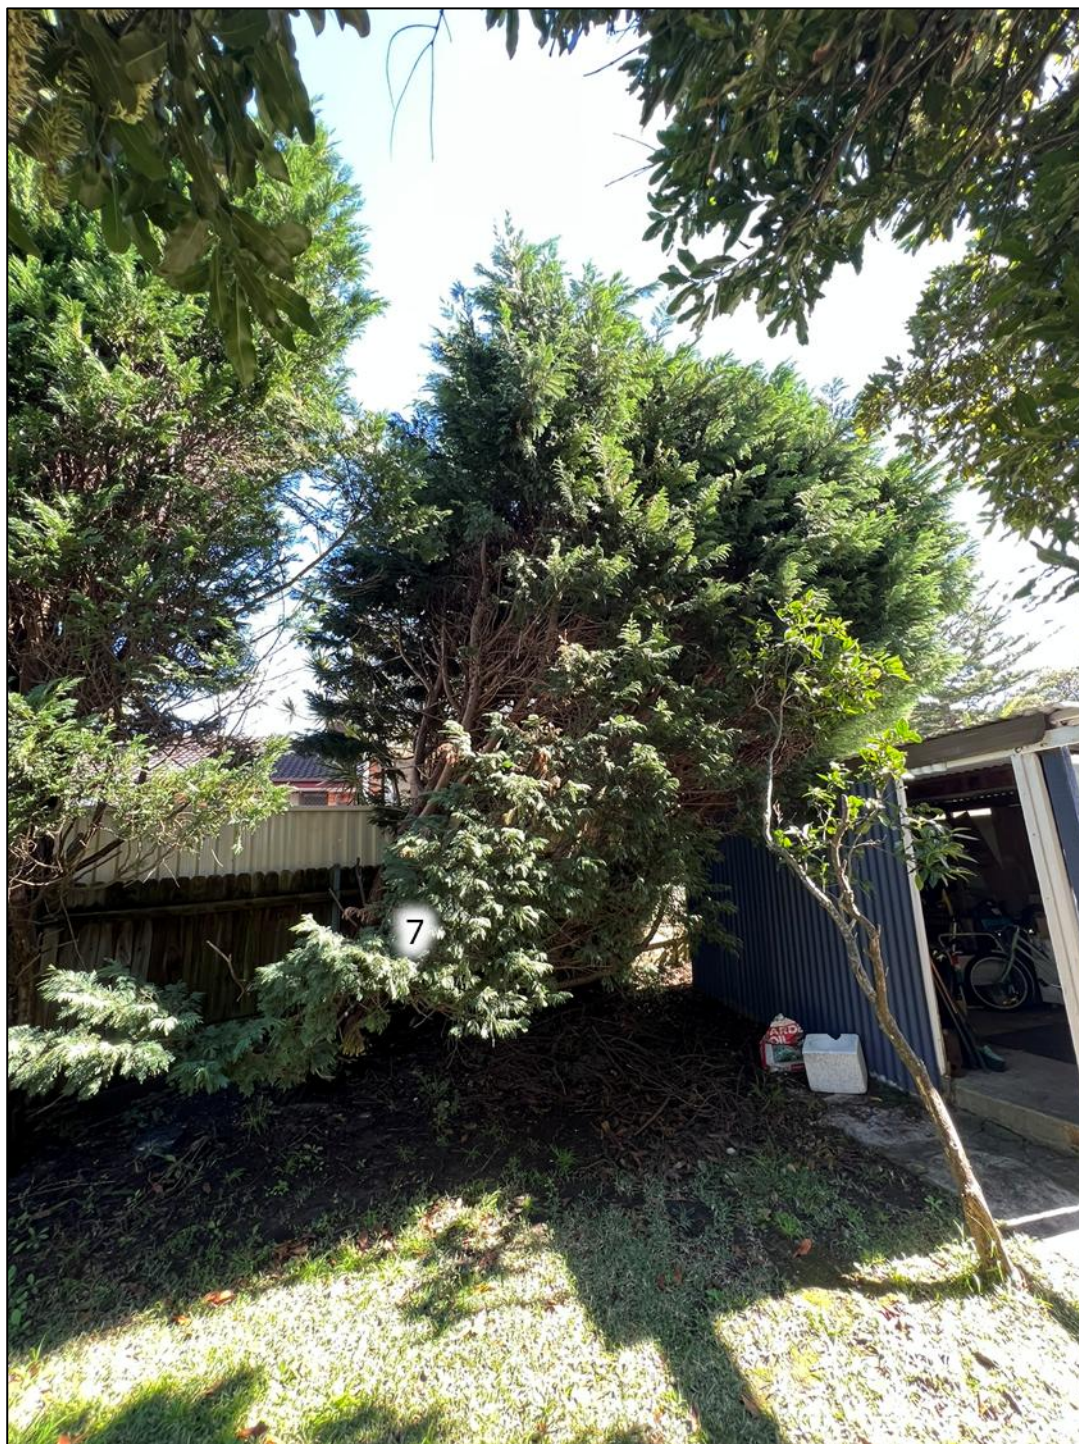
Tree 7 is a medium-sized tree of low species significance. This tree's stem has severe northerly orientation and ground surface bulging around the base of its stem. These factors underpinned the Negligible ULE estimate and Very Low Retention Value rating determined for this tree. Tree 7 should be prioritised for removal as part of any proposed development within this property.

Figure 8. Tree 7 with signs of partial root plate failure.

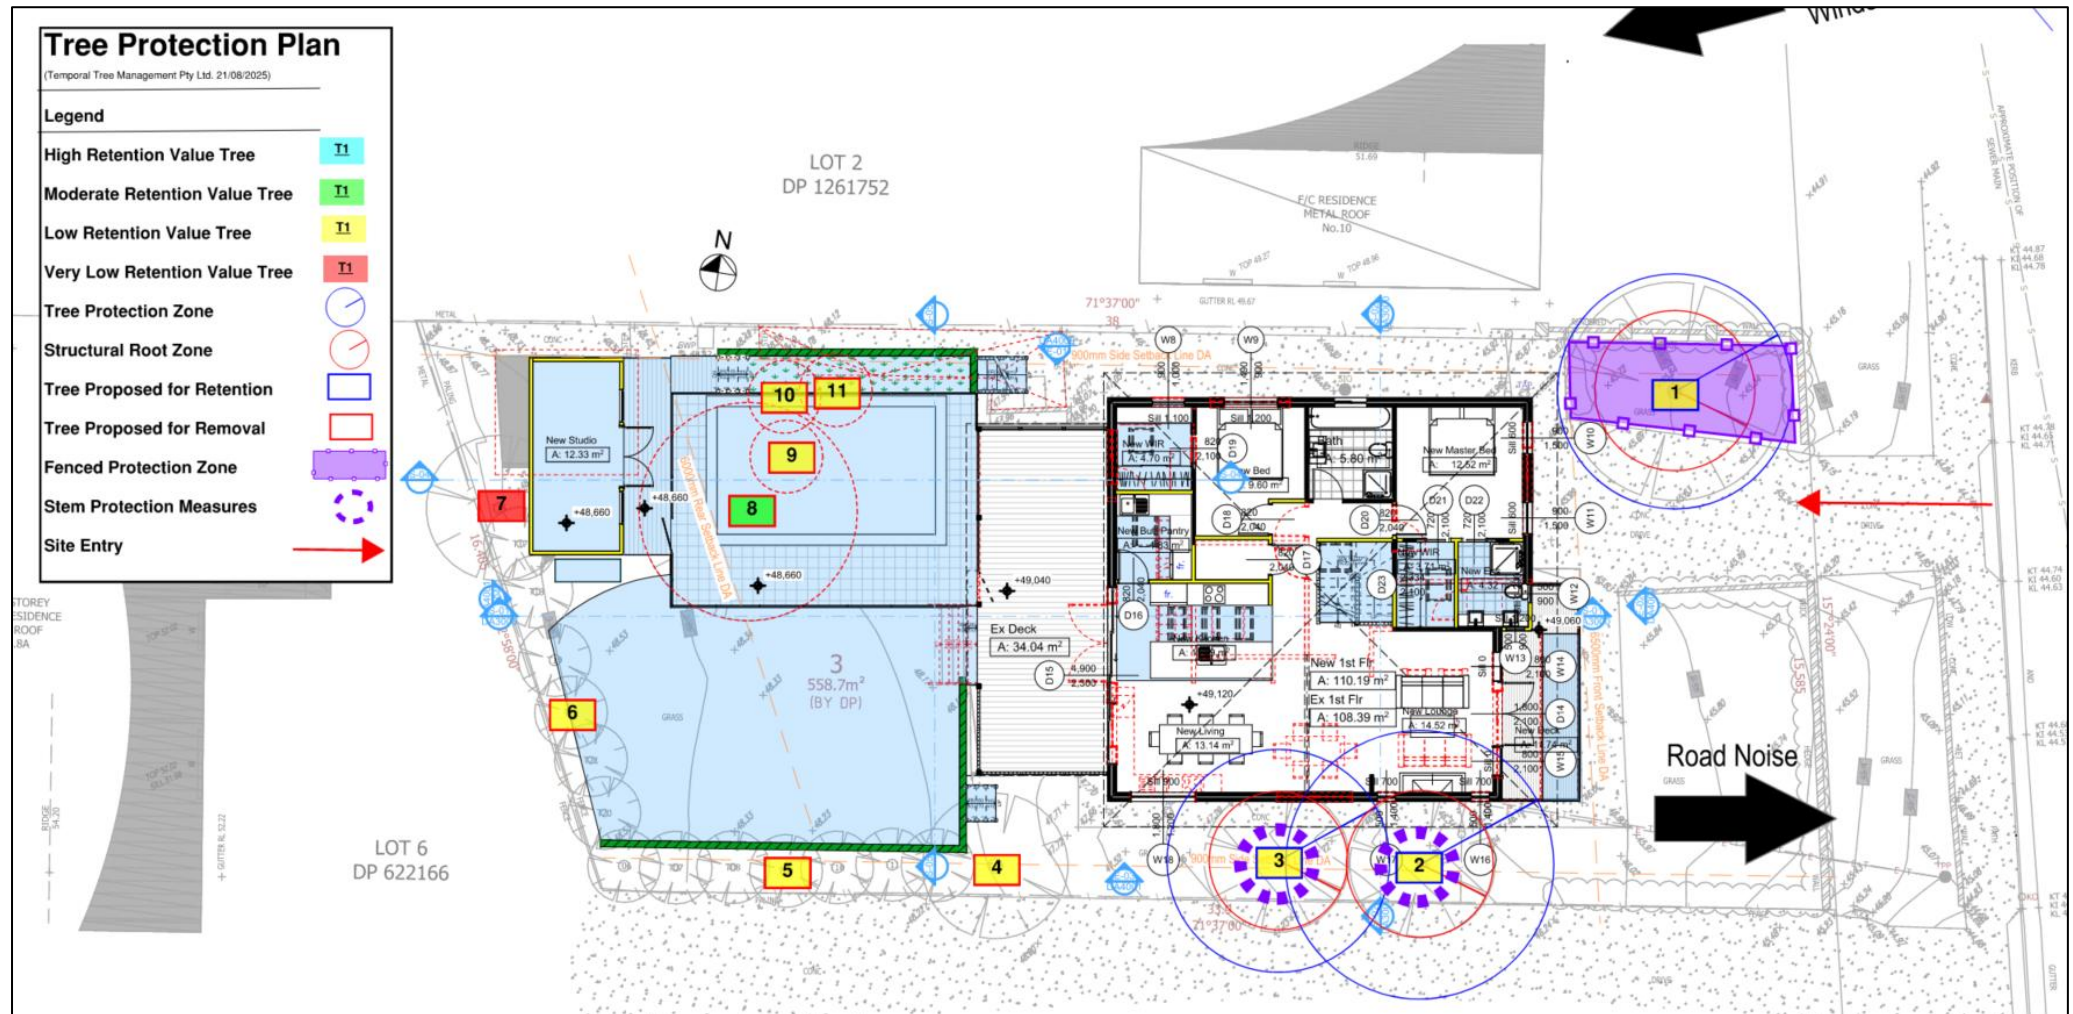
Figure 11. Tree Protection / Removal Plan. Site Plan, prepared by: *Rapid Plans* (Drawing No: DA1003, Rev: -, drawn: 14/07/2025). Annotated by Temporal Tree Management Pty Ltd. (21/08/2025).

Three assessed trees (Trees 1, 2 and 3) will not be directly impacted as part of the proposed development and are suitable for retention. These three trees are specimens of two species (*Robinia pseudoacacia* and *Ficus macrocarpa* var. 'Hillii') that are listed in *Table 1 – Exempt Species of Part E – The Natural Environment, Chapter 1 – Preservation of Trees or Bushland Vegetation* of the Warringah Development Control Plan (WDCP 2011) (Northern Beaches Council 2025). Despite this, their retention and protection as part of the development is recommended. The following protection measures must be in place at the specified stages of construction to ensure the viability of the nine retained trees is not impacted (Figure 11):

- Fenced protection zones will not be suitable for Trees 2 and 3 due to the confined pathway area between their stems and the western dwelling wall.
- It is therefore recommended that stem protection measures are installed on Trees 2 and 3 in accordance with *Section 4.5.3 of AS4970 (2025)* (Figure 10 and Figure 11).

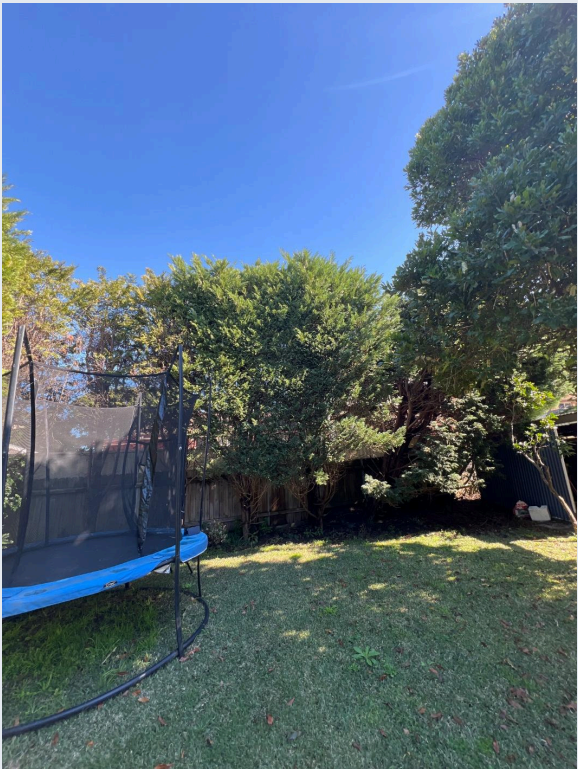
Tree Comments:GROUP of 6 closely positioned specimens of the same size and species have been planted as a boundary hedge. Trees of low species significance in LGA. Canopies have been lopped in past to maintain hedge height. Southern-most trees with signs of dieback. Northern-most trees in group have partially failed at base.

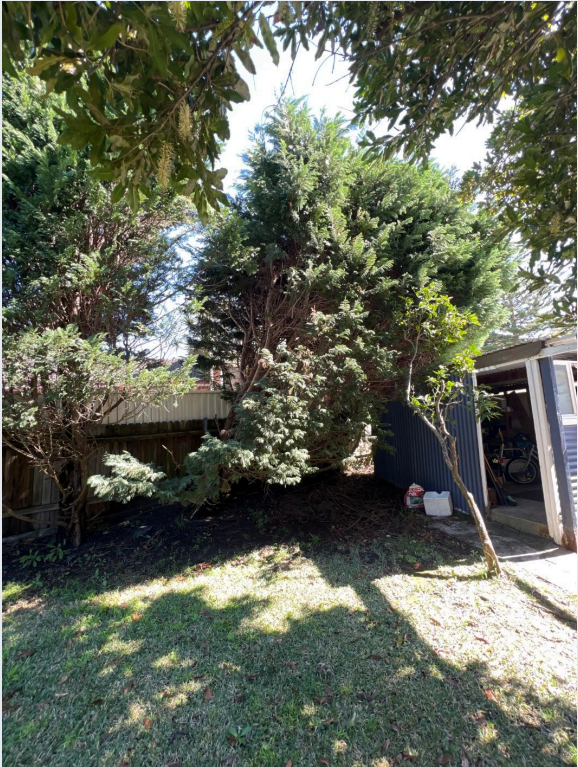
<div>Leyland Cypress Primary ID #1078902</div> <div>8A Orara Road</div>	
Tree Details	
Tree Id:	7
Scientific Name:	Cupressocyparis leylandii
Common Name:	Leyland Cypress
Health:	Good
Status:	Alive
DBH [cm]:	36
Tree Height (Estimated) [m]:	6
Risk Rating:	Low
Priority:	None
Canopy Width (m):	4
Useful Life Expectancy:	1-5 years
Maturity:	Mature
Structure:	Has Failed
Retention Value:	Low
Tree Work:	Removal
Last Modified:	21/08/2025
Observations:	RUnstable, TIncluded bark, CLopped
Tree Comments:	Northern-most specimen in boundary hedge. Tree of low species significance in LGA. Stem with severed northerly orientation and ground surface bulging around stem. Suggests tree has partially failed at base. Canopy has been lopped in past to maintain hedge height.

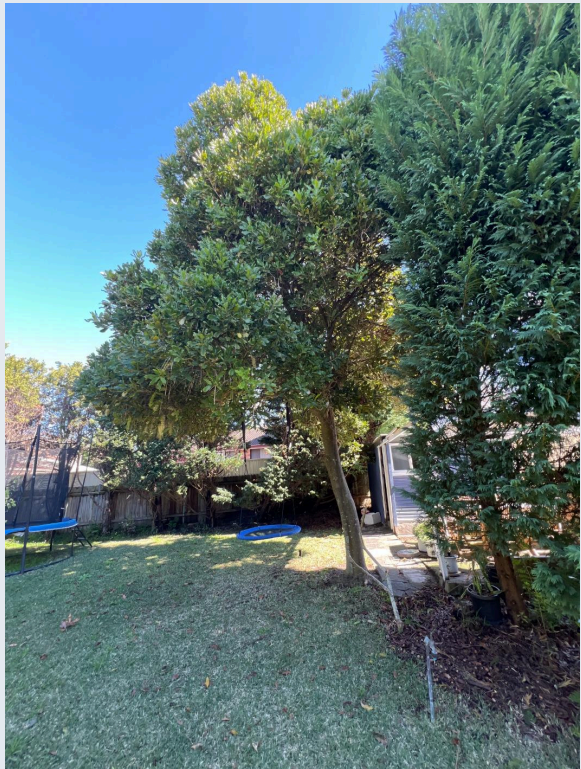
Tree 8 was determined to be of Moderate Retention Value. This maturing *Macadamia integrifolia* specimen showed signs of high vitality. This tree becomes multi-stemmed at 3 metres. This structural feature is common for this species. These factors underpinned the Long ULE estimate determined for this tree. However, due to its smaller size and increased suitability for replacement, this tree was determined to be of Moderate Landscape Significance. Tree 8 should be retained and protected as part of the proposed development if feasible. If required for removal, Tree 8 must be suitably replaced as part of the proposed Landscape Plan.

Tree Id:	8
Scientific Name:	Macadamia integrifolia
Common Name:	Macadamia Tree
Health:	Good
Status:	Alive
DBH [cm]:	21
Tree Height (Estimated) [m]:	7
Risk Rating:	Low
Priority:	None
Canopy Width (m):	6
Useful Life Expectancy:	40+ years
Maturity:	Mature
Structure:	Good
Retention Value:	Medium
Tree Work:	Removal
Last Modified:	21/08/2025
Observations:	
Tree Comments:	Maturing tree of native species in mostly good condition. Becomes multi-stemmed at 3 metres. Stem positioned 3.3 meters red from garden shed.

It is recommended that Tree 8 is suitably replaced as part of the proposed Landscape Plan. It is recommended that a minimum of one specimen of a suitable indigenous or native tree species capable of growing to a mature height of no less than 8 metres is planted within the subject site in a position within the northern portion of the site that will ensure its ULE is entirely fulfilled. The replacement trees must come in a 75L pot and in compliance with the *Australian Standard for Tree Stock for Landscape Use (AS 2303 2015)*.

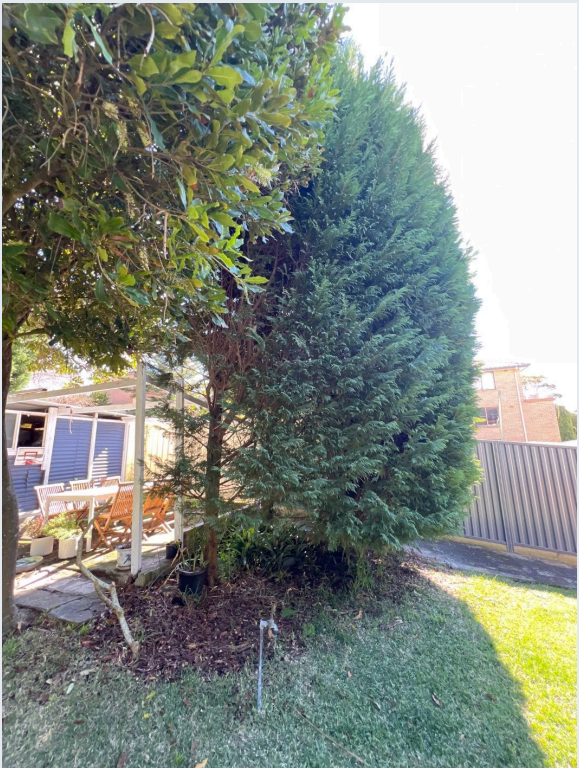
<div>Leyland Cypress Primary ID #1078906</div> <div>10 Orara Road</div>	
Tree Details	
Tree Id:	10
Scientific Name:	Cupressocyparis leylandii
Common Name:	Leyland Cypress
Health:	Good
Status:	Alive
DBH [cm]:	18
Tree Height (Estimated) [m]:	8
Risk Rating:	Low
Priority:	None
Canopy Width (m):	5
Useful Life Expectancy:	20-40 years
Maturity:	Semi mature
Structure:	Fair
Retention Value:	Low
Tree Work:	Removal
Last Modified:	21/08/2025
Observations:	
Tree Comments:	Tree of low species significance in LGA. Partially suppressed by closely positioned trees.
Tree Location	
Longitude:	151.262469
Latitude:	-33.774686
Address:	10 Orara Road
City:	Allambie Heights
Photos Street View Map View	
<div>

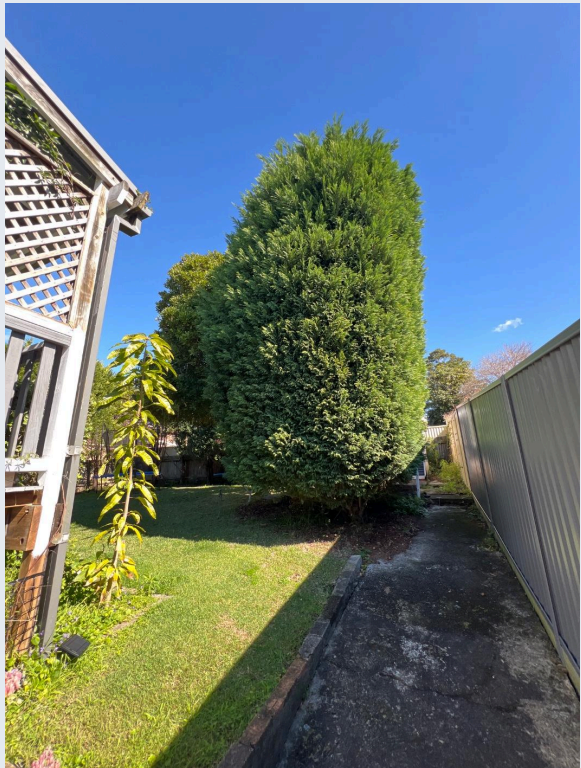
<div>Leyland Cypress Primary ID #1078907</div> <div>10 Orara Road</div>	
Tree Details	
Tree Id:	11
Scientific Name:	Cupressocyparis leylandii
Common Name:	Leyland Cypress
Health:	Good
Status:	Alive
DBH [cm]:	31
Tree Height (Estimated) [m]:	8
Risk Rating:	Low
Priority:	None
Canopy Width (m):	5
Useful Life Expectancy:	20-40 years
Maturity:	Semi mature
Structure:	Fair
Retention Value:	Low
Tree Work:	Removal
Last Modified:	21/08/2025
Observations:	
Tree Comments:	Tree of low species significance in LGA. Partially suppressed by closely positioned trees.
Tree Location	
Longitude:	151.262475
Latitude:	-33.774667
Address:	10 Orara Road
City:	Allambie Heights
Photos Street View Map View	
<div>
