## **GEOTECHNICAL REPORT**

### **PROPOSED SUBDIVISION AND CONSTRUCTION OF AN ACCESS DRIVEWAY AND NEW DWELLINGS**

**14 MIRROOL STREET, NORTH NARRABEEN, NSW**

**Project No.: 2016-049**

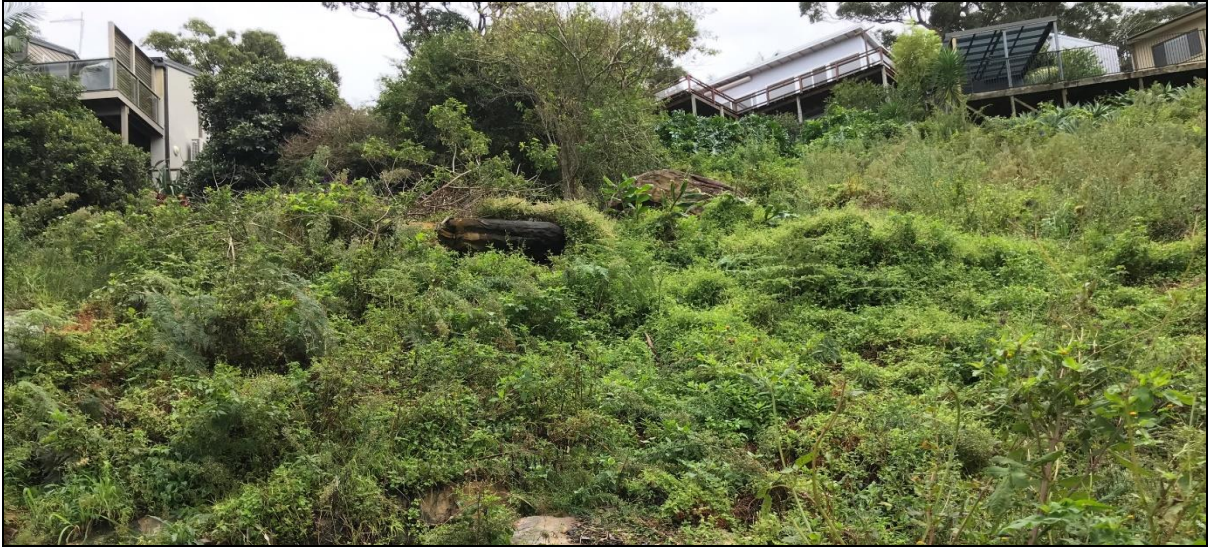
*Photograph 2: View looking west from the north end of the site.*

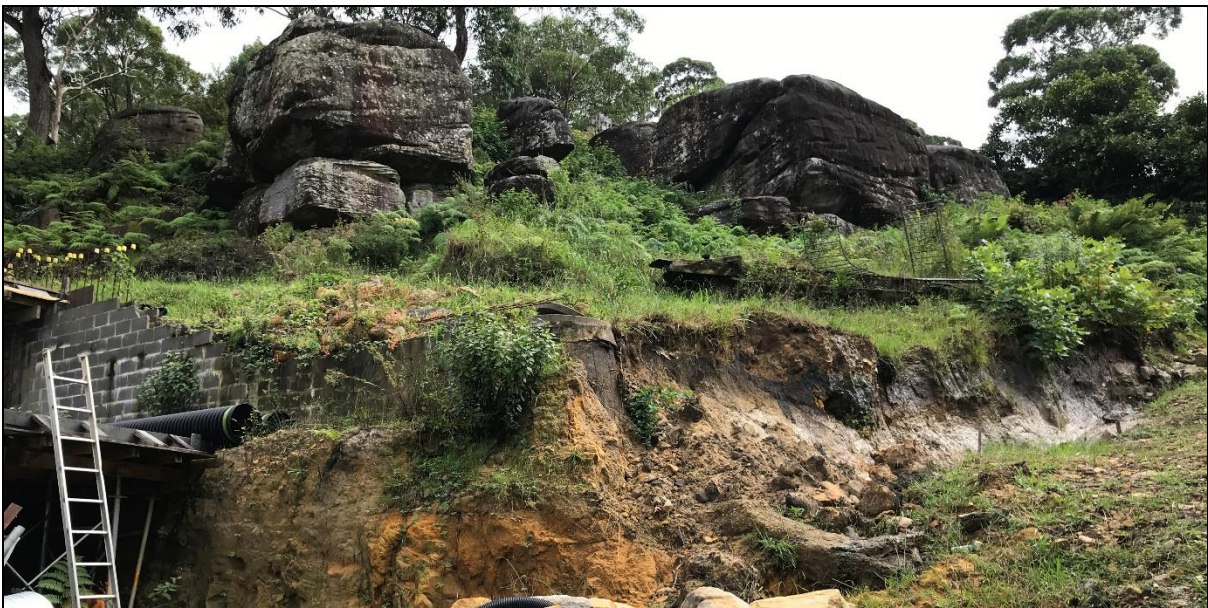
*Photograph 3: View looking north from the south end of the site.*

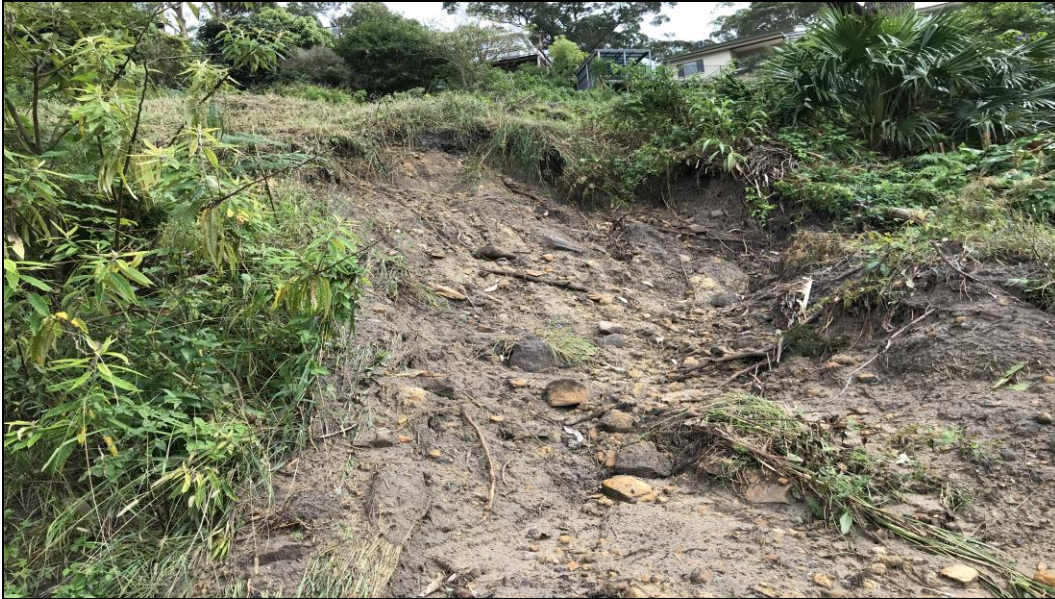
Inspection undertaken of the site indicated that fill has been stockpiled within the north of the site within the smaller proposed subdivision. Following a recent heavy rainfall event one of the fill stockpiles appears to have slumped. The fill stockpiles and slumping are shown in Photographs 4 and 5.

*Photograph 4: View under the slumped stockpile in the north of the site*

Hazard A was estimated to have a **Risk to Life** of  $2.60 \times 10^{-9}$  for a single person, while the **Risk to Property** was considered to be 'Very Low'.

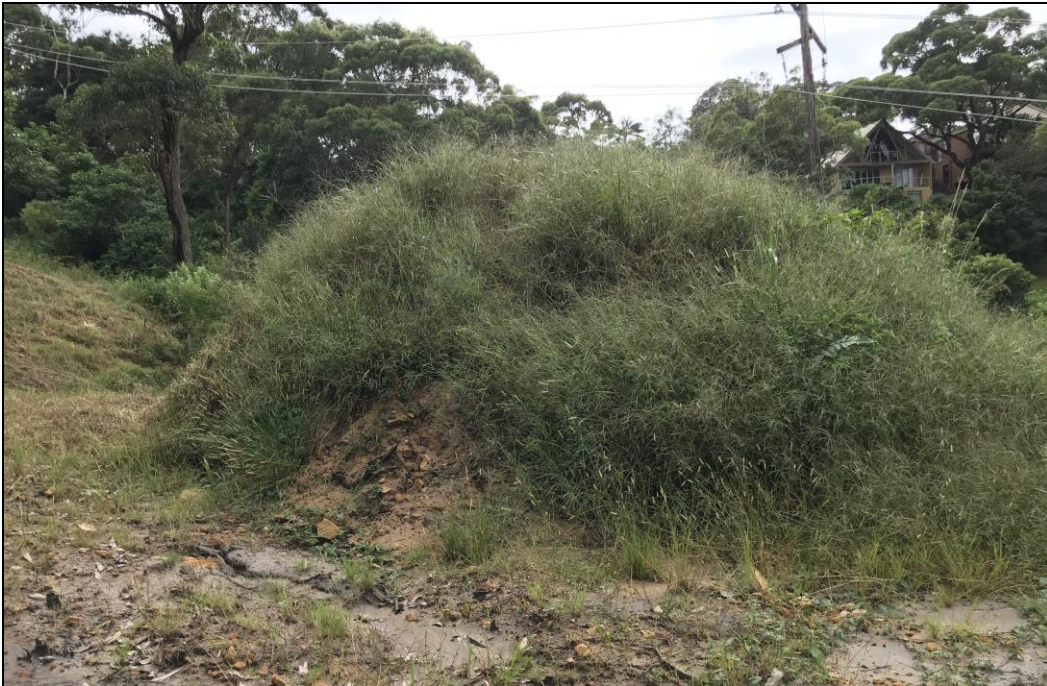
*Photograph 5: View of one of the intact stockpiles*

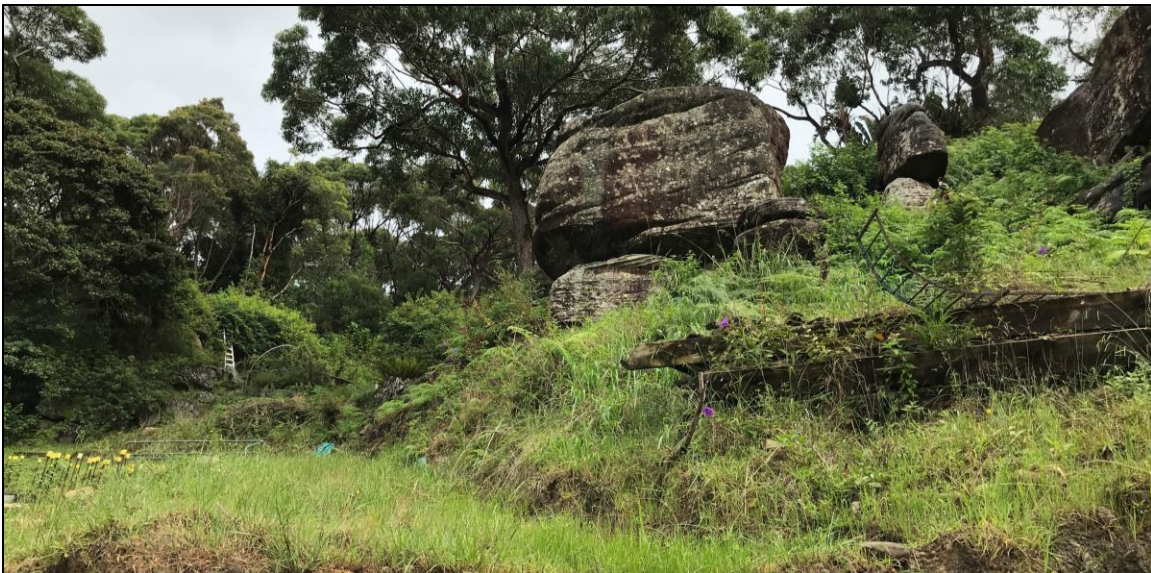
Further downgradient and within the larger block a large potentially unstable boulder was observed and is shown in Photograph 6.

CGC has previously undertaken detailed assessment of this boulder (See Section 1) and it was assessed as being a significant hazard with “Unacceptable” risk. The stabilising measures recommended in CGC previous report have not yet been constructed. The boulder does not appear to have moved since the inspection undertaken in March 2022 previously however it is not considered stable and will require works to stabilise.

*Photograph 6: View of a potentially unstable boulder within the south of the proposed subdivision.*

Hazard C was estimated to have a **Risk to Life** of up to  $2.34 \times 10^{-4}$  for a single person, while the **Risk to Property** was considered to be 'High'.

CGC has previously provided an assessment and possible remediation strategies for the boulder. Based on that assessment and subsequent inspections it was determined that the boulder would unlikely impact the proposed new driveway and that providing the boulder is stabilised using one or more of the measures recommended, the driveway and subdivision development achieve the 'Acceptable Risk Management' criteria and that geotechnical risk within the wider site can be reasonably avoided. It is strongly

recommended that the stabilisation of the boulder is completed before (re) commencement of construction works within the site.

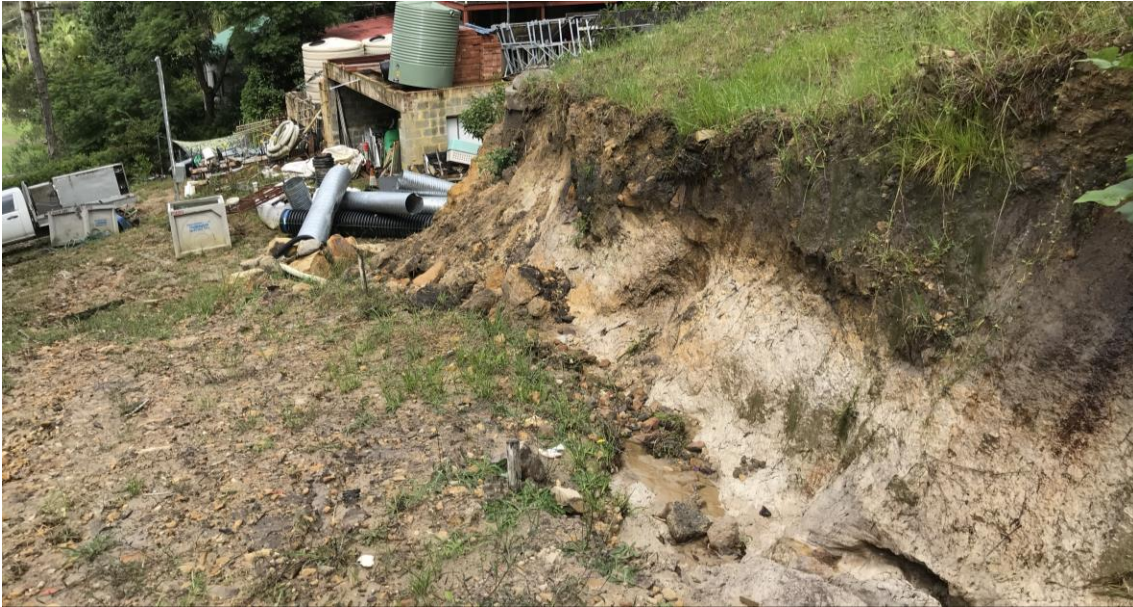
Directly adjacent to the unformed Mirrool Street a cut has been made within the larger subdivision running broadly north south. The cut appears to be around 2.5m in height and comprises a combination of fill (up to approximately 1.0m in thickness), below which clay soils appear to be present in turn underlain by extremely low strength bedrock.

Some minor slumping of the cut was observed however significant failure did not appear imminent.

*Photograph 7: View of the cut batter*
